RAILROAD ACCIDENT INVESTIGATION

Report No 3897

CHICAGO, BURLINGTON AND QUINCY RAILROAD COMPANY

AUGUST 22, 1960

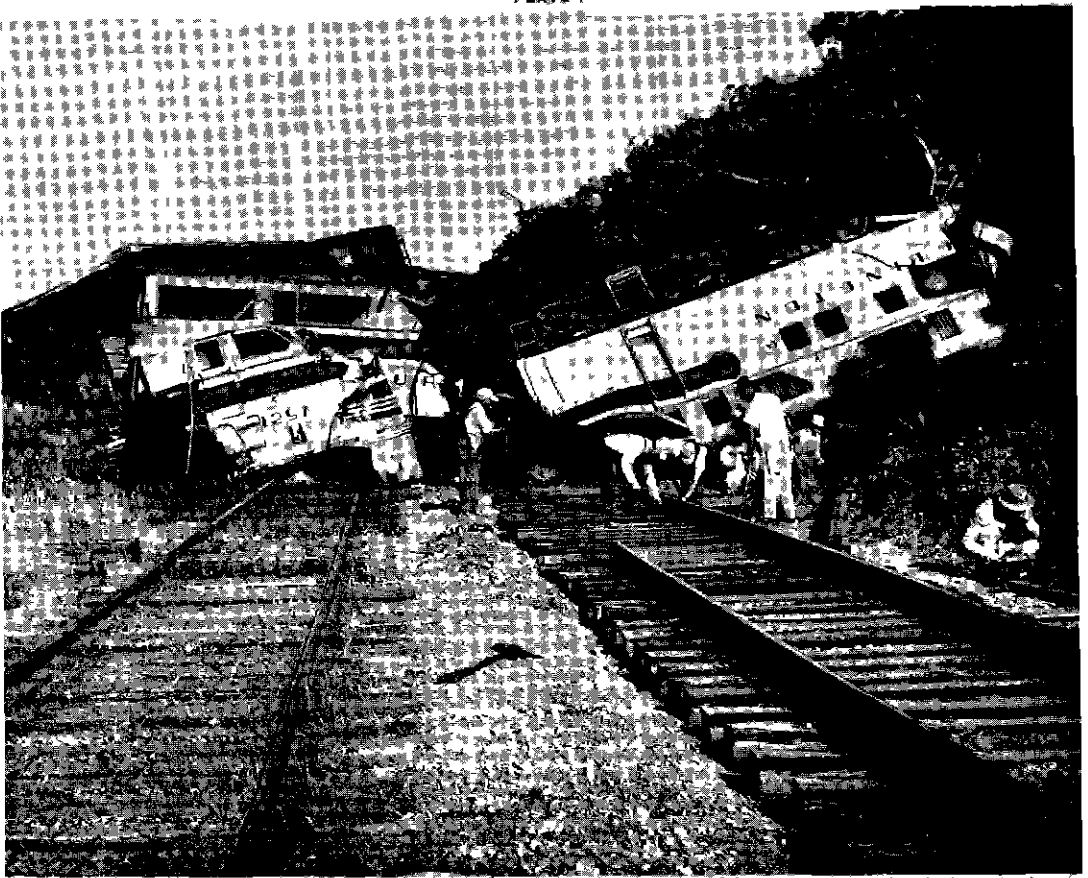
First diesel electric unit of No. 70 shown at right of picture. Torn-off control compartment of this unit is on ground at the left, after having been removed by wrecking operations from top of front end of the locomotive of No. 23. Second unit of the locomotive of No. 20 is shown beyond the torn-off control compartment.

Both diesel-electric units of No. 70 and the 1st to the 9th cars, inclusive, were derailed. The 1st unit stopped upside down on the east side of the main track and at right angles to the track structure (PLATE 1). The control compartment at the front end of the locomotive was torn loose from the underframe and stopped on top of the control compartment at the front of the locomotive of No. 23. The 2nd unit stopped upright across the main track and the siding, and adjacent to the 1st unit. The derailed cars stopped in various positions on or near the structures of the main track and the siding. The 1st diesel-electric unit was destroyed and the 2nd unit was heavily damaged. Of the derailed cars, 4 were destroyed, 2 were somewhat damaged, 2 were slightly damaged, and 1 was undamaged.

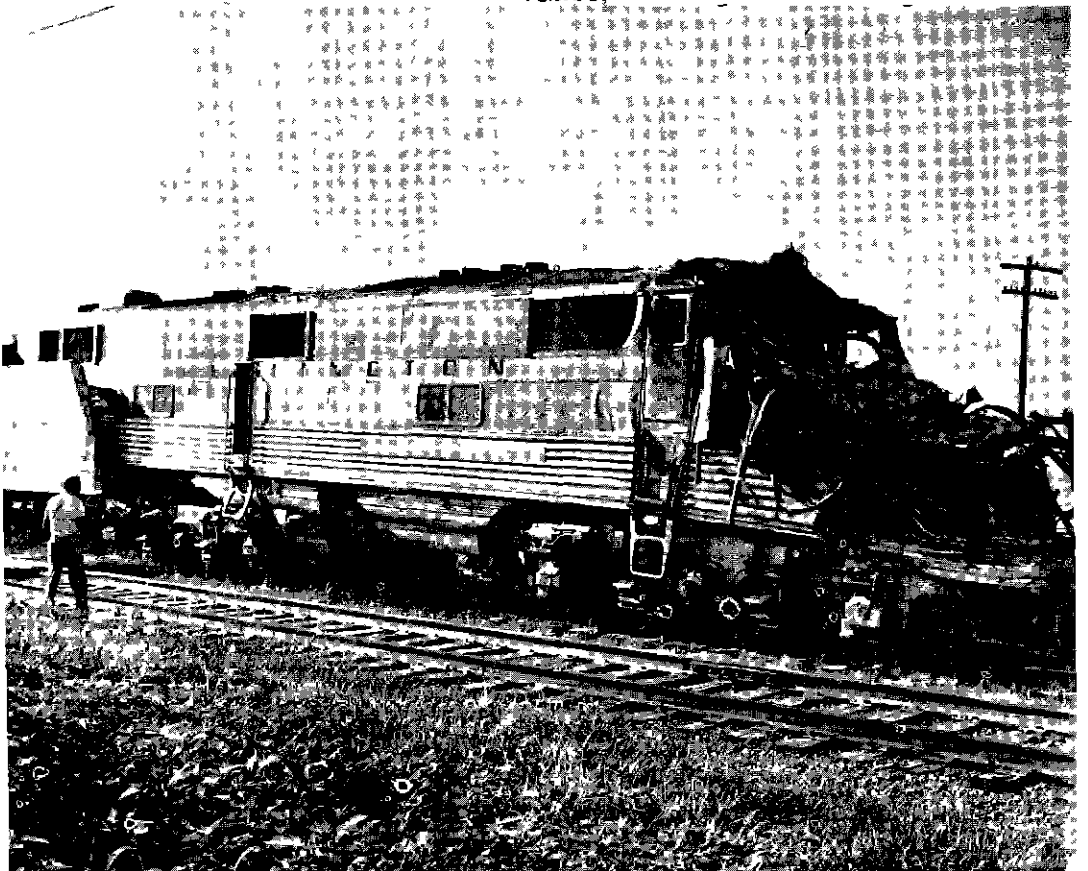
Locomotive of No. 23

No. 23 was moved southward approximately 50 feet by the force of the impact. None of the equipment was derailed. The superstructure at the front end of the locomotive was crushed by the front end of No. 70 throughout a distance of about 12 feet (PLATE 2). The front end of the 1st car

was telescoped throughout a distance of about 15 feet by the rear end of the locomotive. The locomotive and the 1st car were heavily damaged, the 2nd car was somewhat damaged, and the 3rd and the 5th cars were slightly damaged.
