INVESTIGATION NO. 2972  
CHICAGO, MILWAUKEE, ST. PAUL AND PACIFIC  
RAILROAD COMPANY  
REPORT IN RE ACCIDENT  
NEAR NEW LISBON, WIS , ON  
FEBRUARY 5, 1946

Kind of accident: Rear-end collision.

INVESTIGATION NO. 2972

Inv. No. 2972  
Chicago, Milwaukee, St. Paul and Pacific Railroad  
New Lisbon, Wis.  
February 5, 1946

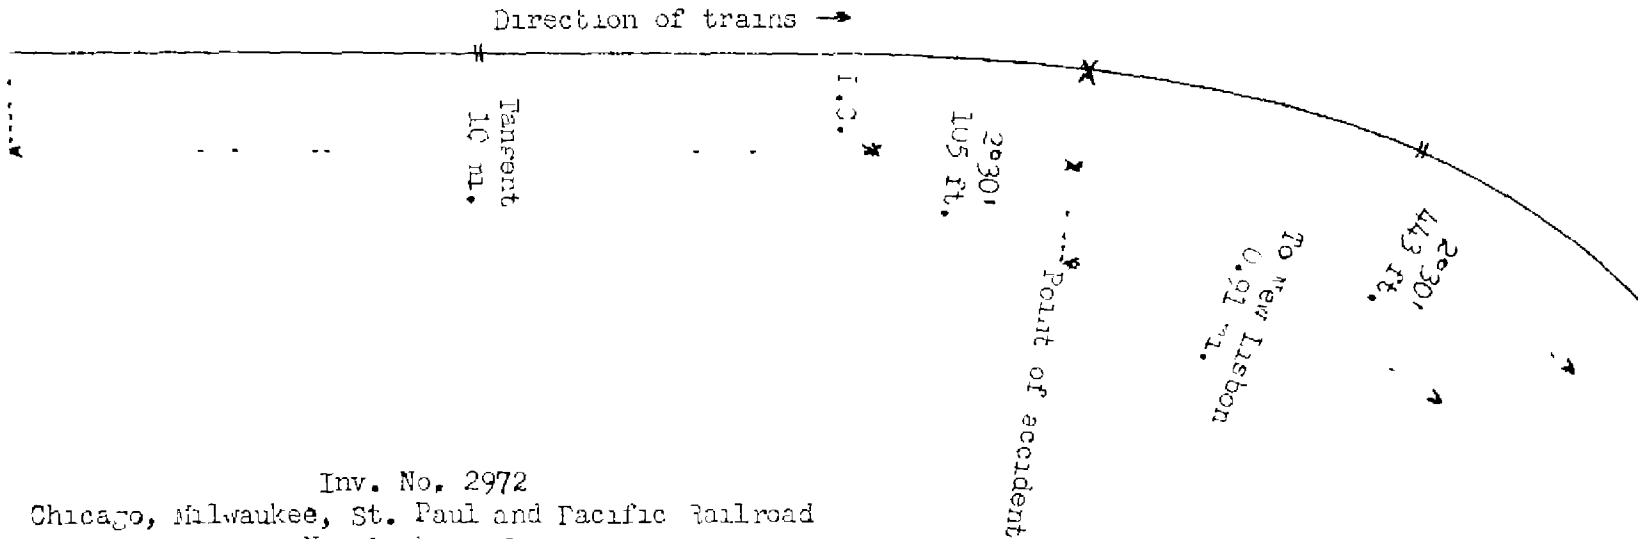
No. 272, an east-bound second-class freight train, consisting of engine 1285, 42 cars and a caboose, departed from Wisconsin Rapids, the last open office, at 9:43 p. m., 2 hours 13 minutes late, and stopped about 11:20 p. m. on the main track, with the rear end standing 0.91 mile west of the station at New Lisbon. About 1 hour 10 minutes later the rear end was struck by No. 256.

The caboose and the rear three cars of No. 272 and the engine of No. 256 were derailed. The engine of No. 256 stopped practically upright and in line with the track, with the front end 151 feet east of the point of collision. The caboose and the second car ahead of the caboose of No. 272 were demolished.

The block system in effect in this territory is inadequate. Under the special instructions governing the blocking of following trains a passenger train may be permitted to enter a block that is occupied by a preceding train when authorized by train order. The train order authorizing No. 256, a passenger train, to enter the block involved, which extended between Wisconsin Rapids and New Lisbon, 49.3 miles, required this train to proceed within the block prepared to stop short of a train ahead at any point between these stations. This order was not addressed to the crew of the preceding train. The train order contained also the information that the preceding train had departed from Wisconsin Rapids, 48.39 miles west of the point where the accident occurred, at 9:43 p. m. No. 256 departed from Wisconsin Rapids at 10:46 p. m. Under an adequate manual block system a passenger train would not be permitted to enter an occupied block, and had such a system been in effect this accident could have been prevented.

It is found that this accident was caused by failure of the railroad to provide adequate safeguards for the movement of the trains involved.

It is recommended that the Chicago, Milwaukee, St. Paul and Pacific Railroad Company establish an adequate block system on the line on which this accident occurred.
