REPORT OF THE DIRECTOR  
BUREAU OF SAFETY

ACCIDENT ON THE  
CHICAGO, MILWAUKEE, ST. PAUL & PACIFIC RAILROAD

ASTICO, WIS.

MAY 26, 1939

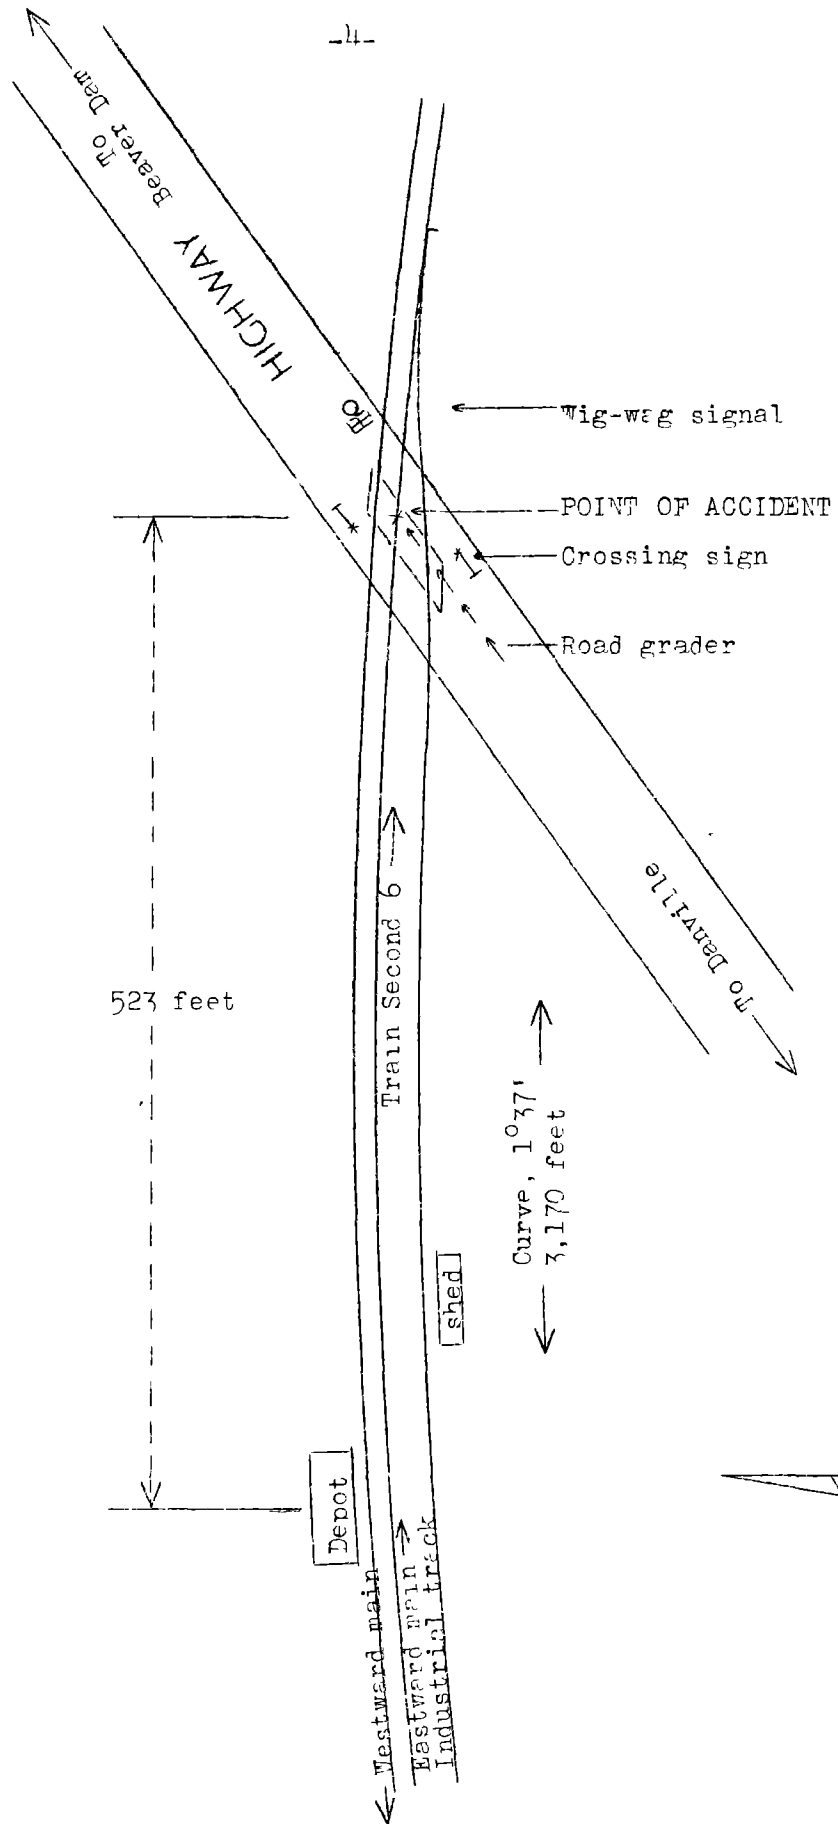
Inv. No. 2355  
 C.M.St.P.& P. R.R.  
 Astico, Wisconsin  
 May 26, 1939

The highway extends southwest and northeast and the railroad extends almost east and west. The highway is graveled; the crossing is 16 feet wide and it is fully planked between the rails of each of the three tracks and there is one plank on the outside of each rail; the remainder of the surface of the crossing is graveled; the approach from the southwest is practically level. The crossing is protected by an automatic electric wig-wag crossing signal located north of the tracks and east of the highway, the center of the swinging electrically lighted banner being 12 feet above the road level. The control circuit for east-bound trains extends approximately 3,550 feet west of the crossing, and when the wig-wag is in motion an electric crossing bell rings continuously. There are also two

The depot is north of the tracks. A coal shed 152 feet in length, located south of the industrial track and 292 feet west of the crossing, and other buildings farther west and track curvature restrict the view of an approaching east-bound train to be had by the driver of a vehicle approaching the crossing from the southwest on the highway. When 40 feet south of the eastward main track the view westward is restricted to 814 feet, and when between 30 and 20 feet from that track the view is limited to 940 feet. The engineman's view of the crossing from an east-bound engine is limited to about 940 feet.
