INTERSTATE COMMERCE COMMISSION
WASHINGTON

REPORT OF THE DIRECTOR
BUREAU OF SAFETY

ACCIDENT ON THE
CHICAGO, MILWAUKEE, ST. PAUL AND PACIFIC RAILROAD

AVEFY, IDAHO

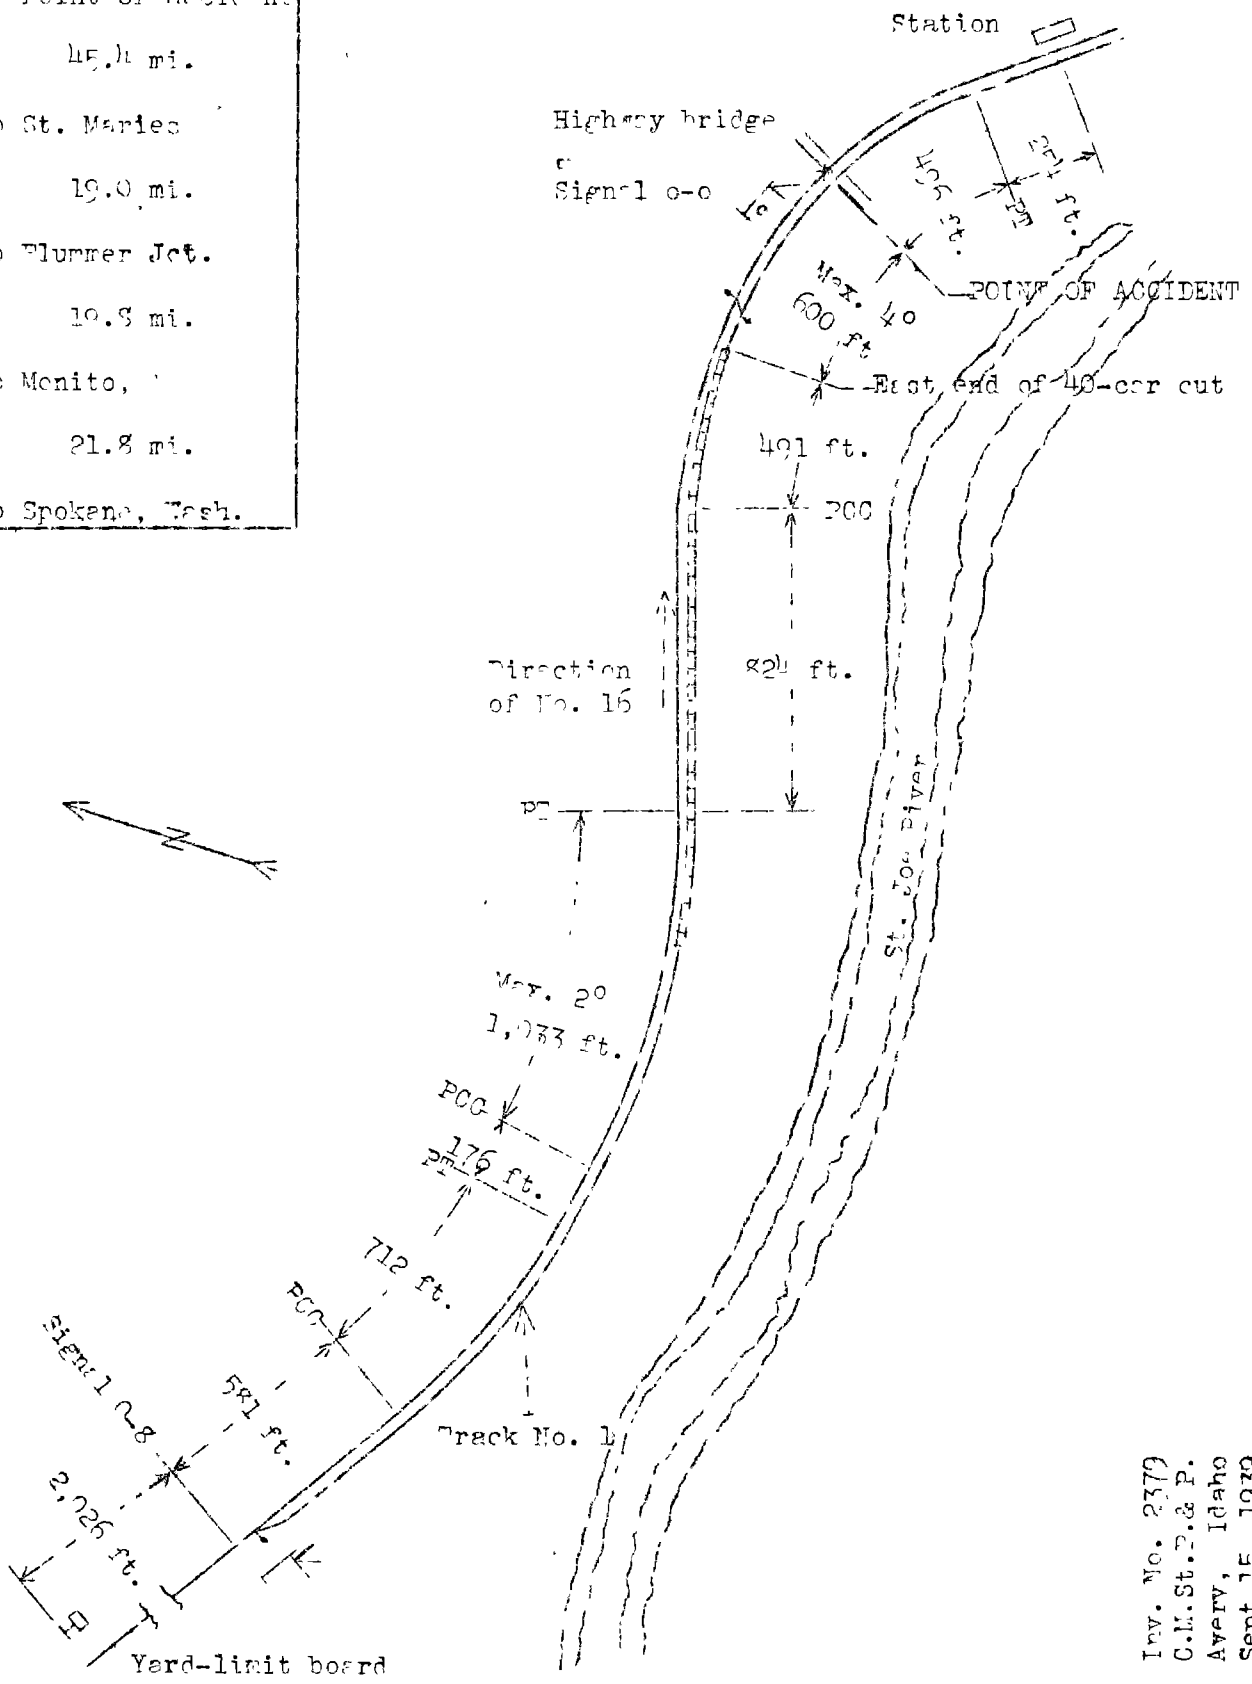
Inv. No. 2379
 C.M. St. P. & P.
 Avery, Idaho
 Sept 15, 1919

o	Avery, Idaho
▼	Point of accident
	45.4 mi.
o	St. Maries
	19.0 mi.
o	Flummer Jct.
	10.8 mi.
o	Monito,
	21.8 mi.
o	Spokane, Wash.
