## INTERSTATE COMMERCE COMMISSION

REPORT OF THE DIRECTOR OF THE BUREAU OF SAFETY CONCERNING  
AN ACCIDENT WHICH OCCURRED ON THE CHICAGO, MILWAUKEE,  
ST. PAUL & PACIFIC RAILROAD NEAR DURAND, ILL., ON  
JUNE 6, 1932.

Inv. No. 1767  
Chicago, Milwaukee, St. Paul & Pacific  
Durand, Ill.  
June 6, 1932

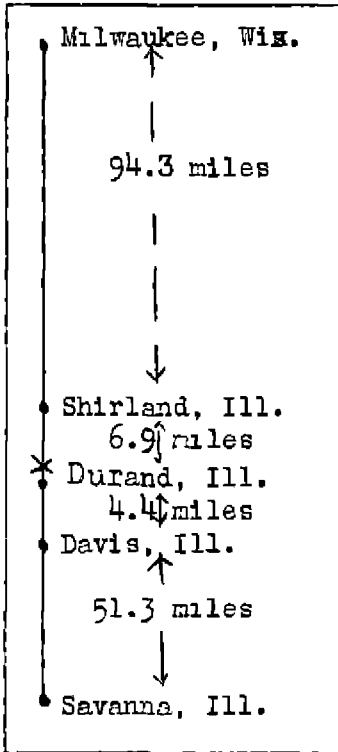
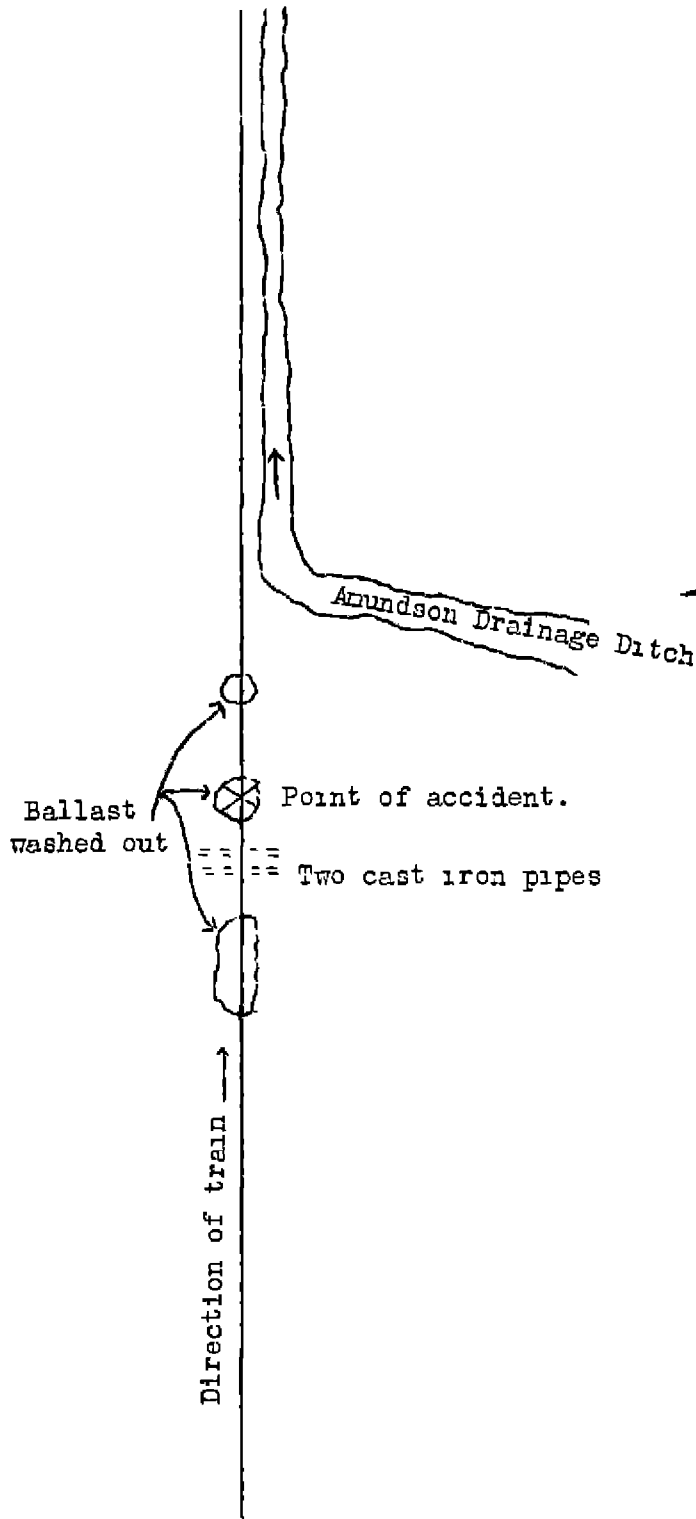
such water as drains from the west, as well as from a few hundred feet to the east, is diverted under the track from south to north through two 24-inch pipes, which were installed in 1904. The derailment occurred about 18 feet east of these pipes.

A drainage ditch, known as the Amundson drainage ditch, cuts across the fields from southwest to northeast on the south side of the track and reaches the track at a point about 480 feet east of the two cast-iron pipes; in the fields this ditch is about 10 feet wide and 2 feet deep, then narrows to about 5 feet and deepens to 3 feet, and continues eastward on the south side of the track.

This accident was caused by a washout.

under the track were unable to take care of the abnormal volume of water which spread out over the fields, resulting in the water backing up against and scouring out the roadbed in three different places near the two pipes, thereby causing the derailment.
