REPORT NO. 3310
CHICAGO, MILWAUKEE, ST. PAUL AND PACIFIC
RAILROAD COMPANY
IN RE ACCIDENT
NEAR FREDONIA, WIS., ON
FEBRUARY 2, 1950

Kind of accident: Derailment

Cause: Broken rail

Accident near Fredonia, Wis., on February 2, 1950, caused
by a broken rail.

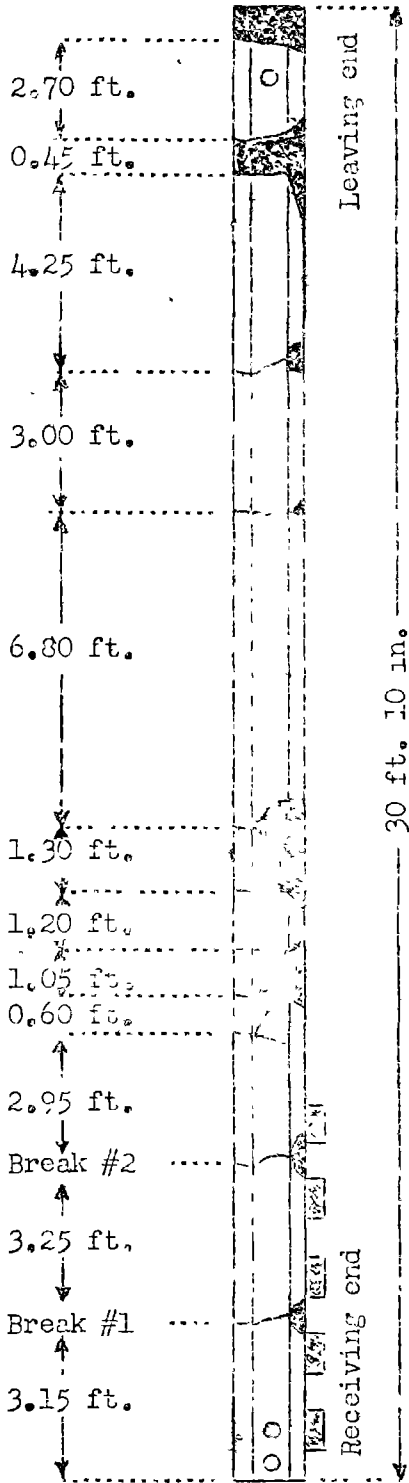
Sketch showing broken rail - north side of track

Shaded areas indicate missing portions of rail

After the accident occurred, a broken rail was found on the north side of the track. This rail was broken into many pieces, 12 of which were recovered. There were 12 angular breaks through the head, web and base of the rail. These breaks occurred at points 3.15 feet, 6.4 feet, 9.36 feet, 9.95 feet, 11 feet, 12.2 feet, 13.5 feet, 20.3 feet, 23.3 feet, 27.55 feet, 28 feet, and 30.7 feet from the receiving end of the rail. Break No. 2 occurred between tie locations, and the head of the piece of rail east of this break was considerably battered. There also were deep indentations near the outside edge of the west end of this piece of rail which apparently were caused by flanges. There was no indication of a transverse fissure or other defect in the rail involved. The rim of the left No. 1 driving wheel of the engine was scored. No condition of the engine or cars of No. 14 was found which would have caused or contributed to the cause of the derailment. The battered piece of rail east of break No. 2 indicates that the rail was broken prior to the derailment of No. 14, and the marks on the head of the rail and on the rim of the left No. 1 driving wheel indicate that break No. 1 occurred when the engine-truck wheels of the engine of No. 14 passed over the rail. Apparently, the piece of rail between breaks Nos. 1 and 2 was displaced by the left No. 1 driving wheel and then the derailment occurred.
