INTERSTATE COMMERCE COMMISSION

REPORT OF THE DIRECTOR OF THE BUREAU OF SAFETY CONCERNING AN
ACCIDENT ON THE CHICAGO, MILWAUKEE, ST. PAUL & PACIFIC
RAILROAD AT GLADWIN, IOWA, ON JULY 21, 1933.

Inv. No. 1936
Chicago, Milwaukee, St. Paul & Pacific R.R.
Gladwin, Iowa
July 21, 1933

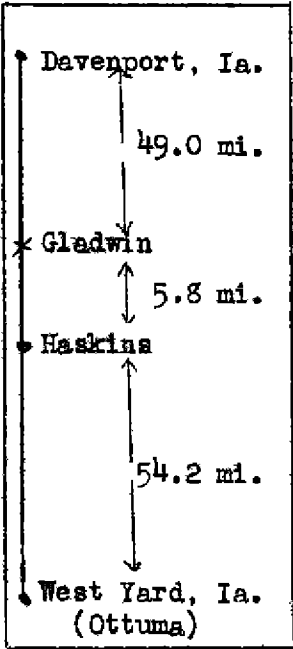
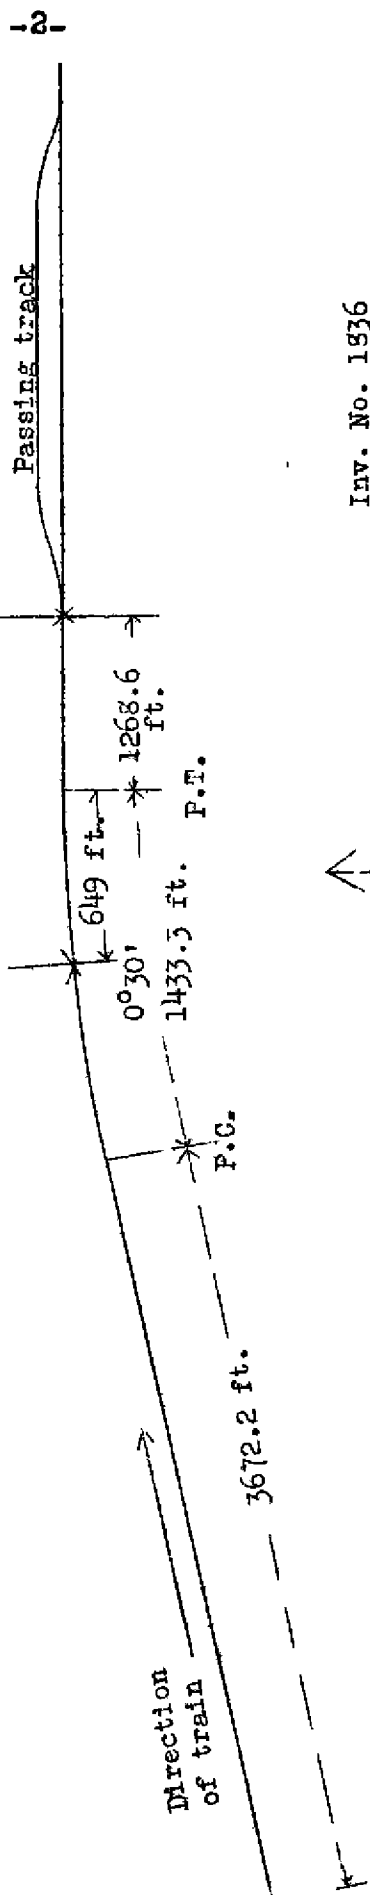
Point of final
derailment

Point of initial
derailment

Instrumentman Low stated that the first marks of disturbance were two flange marks on top of the north rail about $1/8$ inch apart. The first flange mark was $5/8$ inch from the gauge side of the rail and extended diagonally across the rail a distance of 15.3 feet to the point where the wheel dropped off the rail on the outside of the curve, the other began about the center of the running surface, east of the first-mentioned mark, and continued on the rail a shorter distance before dropping off on the outside. The first mark of derailment on the opposite side of the track was a flange mark on a tie on the inside of the south rail 5.9 feet east of where the wheel dropped off of the north rail. The marks on the ties then continued about 8 inches from the rails, and parallel to them, to the switch where the final derailment occurred. The gauge of the track for a distance of 12 rail lengths west of the point where the first mark appeared on the rail varied from gauge to $1/4$ inch wide, and the superelevation varied from 1 inch to $2\frac{1}{4}$ inches. The standard superelevation for this curve is 1 inch and this was the elevation at the joint a few inches west of where the first flange mark appeared on the north rail, the gauge at this point was 4 feet 8 $5/8$ inches.

According to the statements of the train crew they had no knowledge of anything wrong until the derailment occurred. The first marks of derailment were flange marks on top of the north rail of the curve which continued diagonally across the rail until they passed off on the outside; east of this point there were flange marks on the ties paralleling the rails and extending to the west passing-track switch, where the final derailment occurred, a distance of approximately 2,000 feet. It was thought these marks were made by a trailing pair of wheels, but it was not determined whether they were under the front or rear truck of the car. An examination of CB&Q box car 132658, the forty-first car in the train, subsequent to the accident disclosed that part of the flange was broken from the rear wheel on the south side of the truck, but the opinion was advanced that this flange was broken during the derailment; no other defects were found about this car that could have contributed to the cause of the accident. From the position of the derailed equipment, however, it seemed probable that one of the trucks of CB&Q car 132658 was the first to be derailed. The condition of much of the derailed equipment could not be determined as 23 cars were destroyed by fire. The gauge was uniformly maintained but the elevation on the curve was not uniform and it is possible that this irregular track condition, with the train traveling at a speed of 50 miles per hour, caused the car to rock sufficiently to result in the derailment.

The investigation developed that CB&Q car 132658 was received at Kansas City, 264.3 miles from the point of accident, and afterwards passed two terminals where no regular car inspectors are on duty, the only inspection the car received during that interval being by trainmen; it also appeared that no terminal test of the air brakes was made at West Yard and that it was not customary to make such a test. While the lack of inspection by competent car-inspection forces at terminals may not have contributed directly to the cause of the accident in this case, it would appear that the operation of trains for considerable distances without being properly inspected and at a maximum speed of 50 miles per hour is not a safe practice.
