INTERSTATE COMMERCE COMMISSION

REPORT OF THE DIRECTOR OF THE BUREAU OF SAFETY CONCERNING AN  
ACCIDENT ON THE CHICAGO, MILWAUKEE, ST. PAUL AND PACIFIC  
RAILROAD NEAR GUTTENBERG, IOWA, ON OCTOBER 11, 1934.

November 24, 1934.

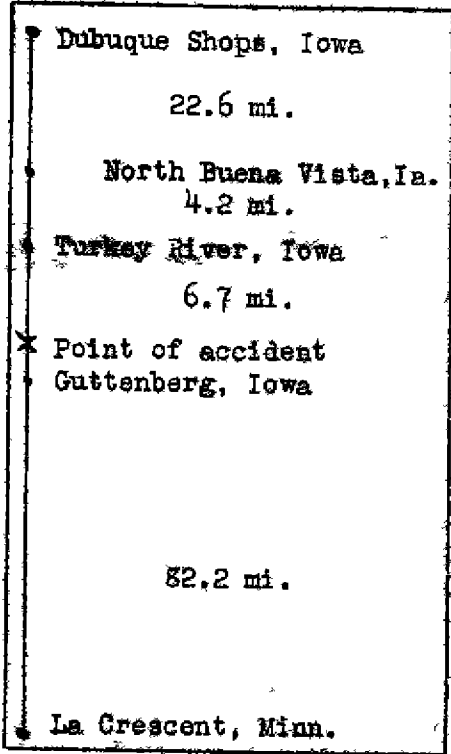
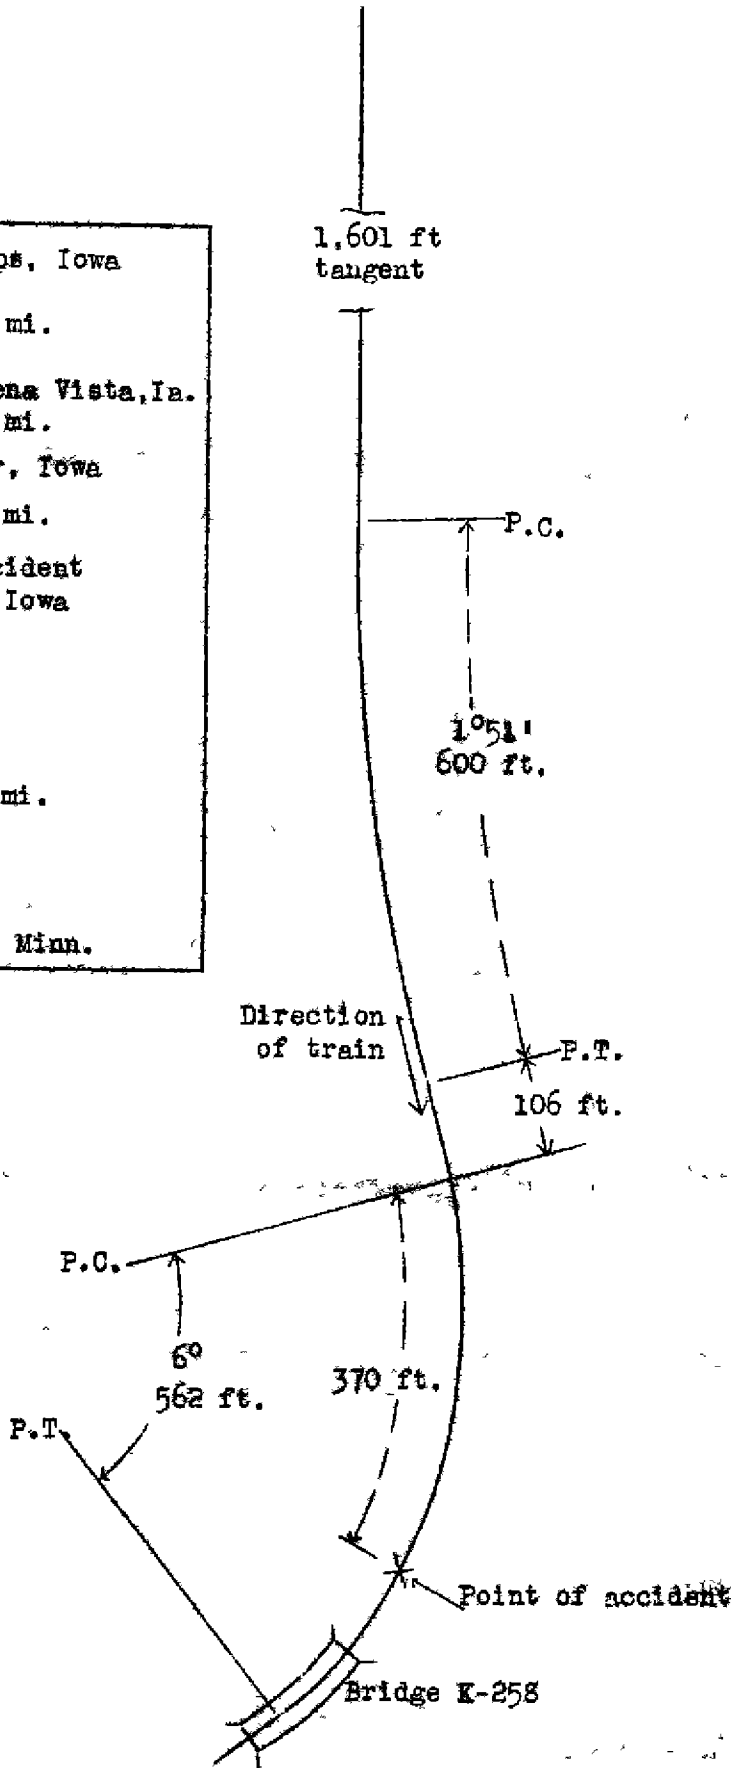
Inv. No. 1936  
Chicago, Milwaukee, St. Paul & Pacific R.R.,  
Guttenberg, Iowa  
October 11, 1934

1,601 ft  
tangent

According to the statements of Division Engineer Johnson, the first mark of derailment was in the ballast on the outside of the curve at a point 102 feet east of the bridge and 5.6 feet from the center of the track; this mark continued for a distance of 27.3 feet and then turned back toward the south rail, the first tie to be marked being about 65 feet from the bridge. The south ends of the ties then were badly damaged to the bridge and also for a distance of 72 feet on the bridge, several of them being broken under the south rail. The track was out of line toward the outside of the curve, beginning opposite the first mark in the ballast and extending upon the bridge for a distance of 96 feet; about 50 feet from the bridge it was 8 inches out of line and the maximum variation was 10 inches, at a point on the bridge near its eastern end. In addition, the first rail east of the bridge on the south side of the track had been broken, apparently by force applied from the gauge side and it also had been bent downward. The initial mark in the ballast was a few feet from the leaving end of the fourth rail east of the bridge; there were no marks on this rail but the third rail from the bridge apparently had been subjected to a heavy blow on the ball of the rail, grease and rust having been disturbed from the web and also a portion of the head; the second rail had similar indications at two points which were about 16 feet apart and it also was twisted slightly, raising the inside spikes for a distance of 8 feet at its leaving end; on the ball of the broken rail there were marks which indicated where wheels might have passed over it at its receiving end, although these marks were more in the nature of abrasions than flange marks; the division engineer thought that if made by flanges the trucks must have been slewed to one side in order to produce the abrasions. All of these marks terminated 5 feet from the receiving end of this rail, but beginning about 6½ feet from the receiving end there was a shear mark starting at the gauge side and crossing diagonally toward the outside, this mark being about 5 feet in length and from ¾ of an inch to 1 inch in width. Close to
