INTERSTATE COMMERCE COMMISSION

REPORT OF THE DIRECTOR OF THE BUREAU OF SAFETY CONCERNING AN ACCIDENT ON THE CHICAGO, MILWAUKEE, ST. PAUL & PACIFIC RAILROAD NEAR IRON MOUNTAIN, MICH., ON FEBRUARY 22, 1934.

April 27, 1934

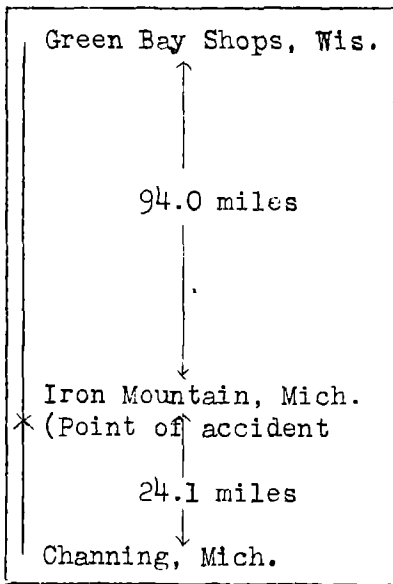
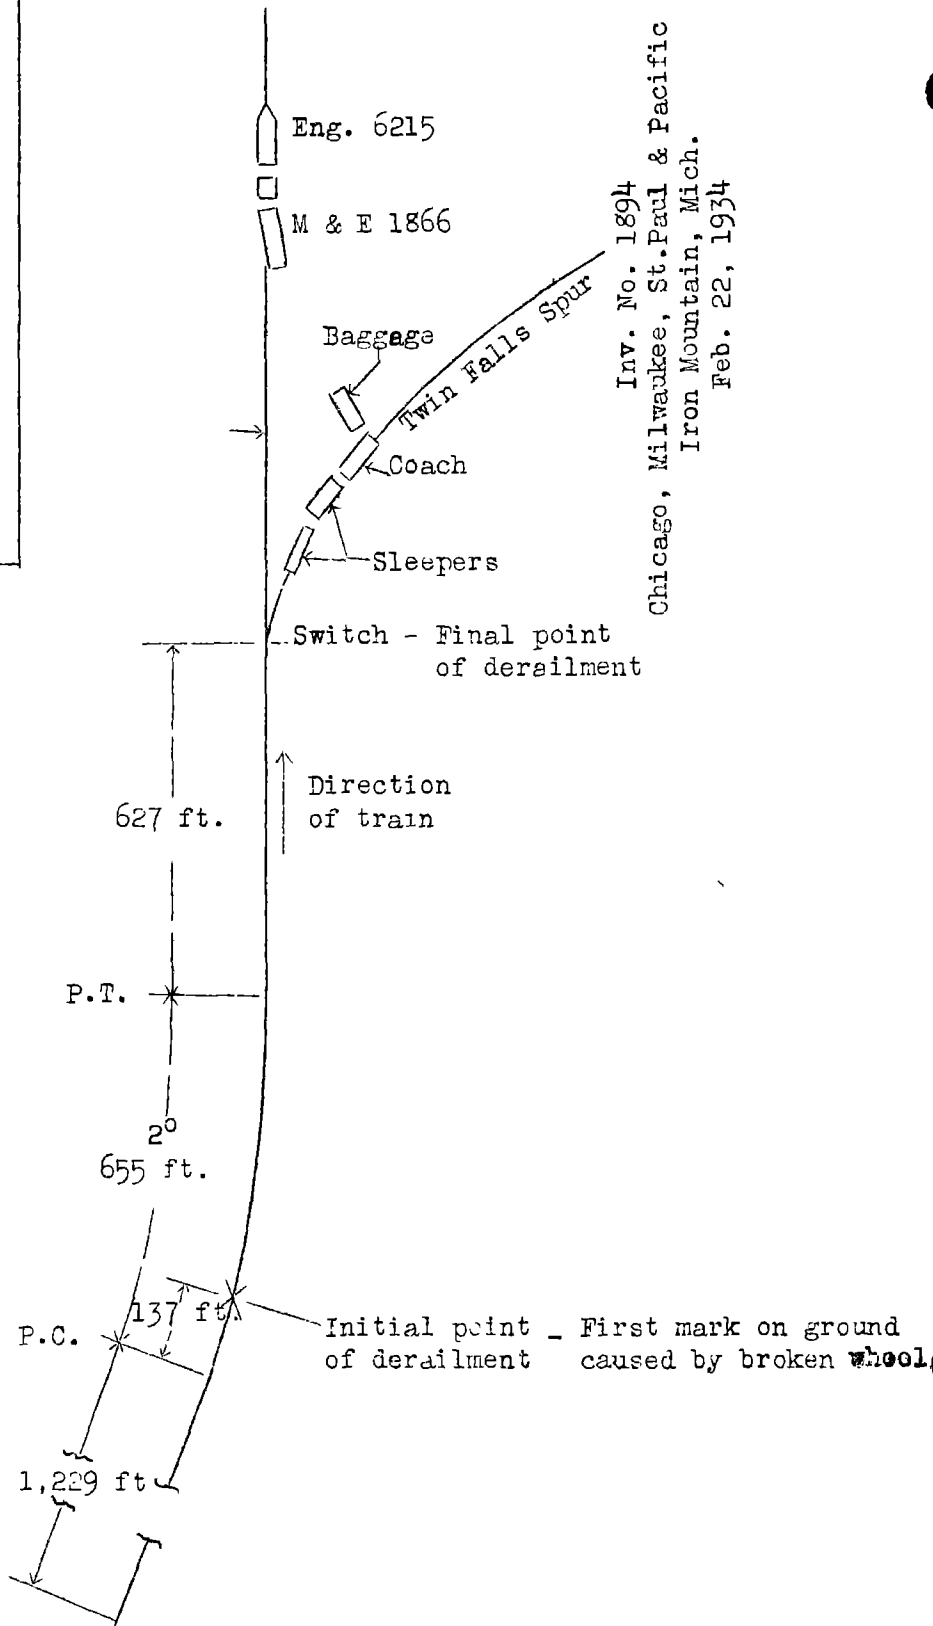
Inv. No. 1894
Chicago, Milwaukee, St. Paul & Pacific R.R.
Iron Mountain, Mich.
Feb. 22, 1934

Twin Falls Spur
