REPORT NO. 3514
CHICAGO, MILWAUKEE, ST. PAUL AND PACIFIC
RAILROAD COMPANY
IN RE ACCIDENT
NEAR LEWIS, IND. , ON
MARCH 28, 1953

Accident near Lewis, Ind., on March 28, 1953, caused by
a broken rail.

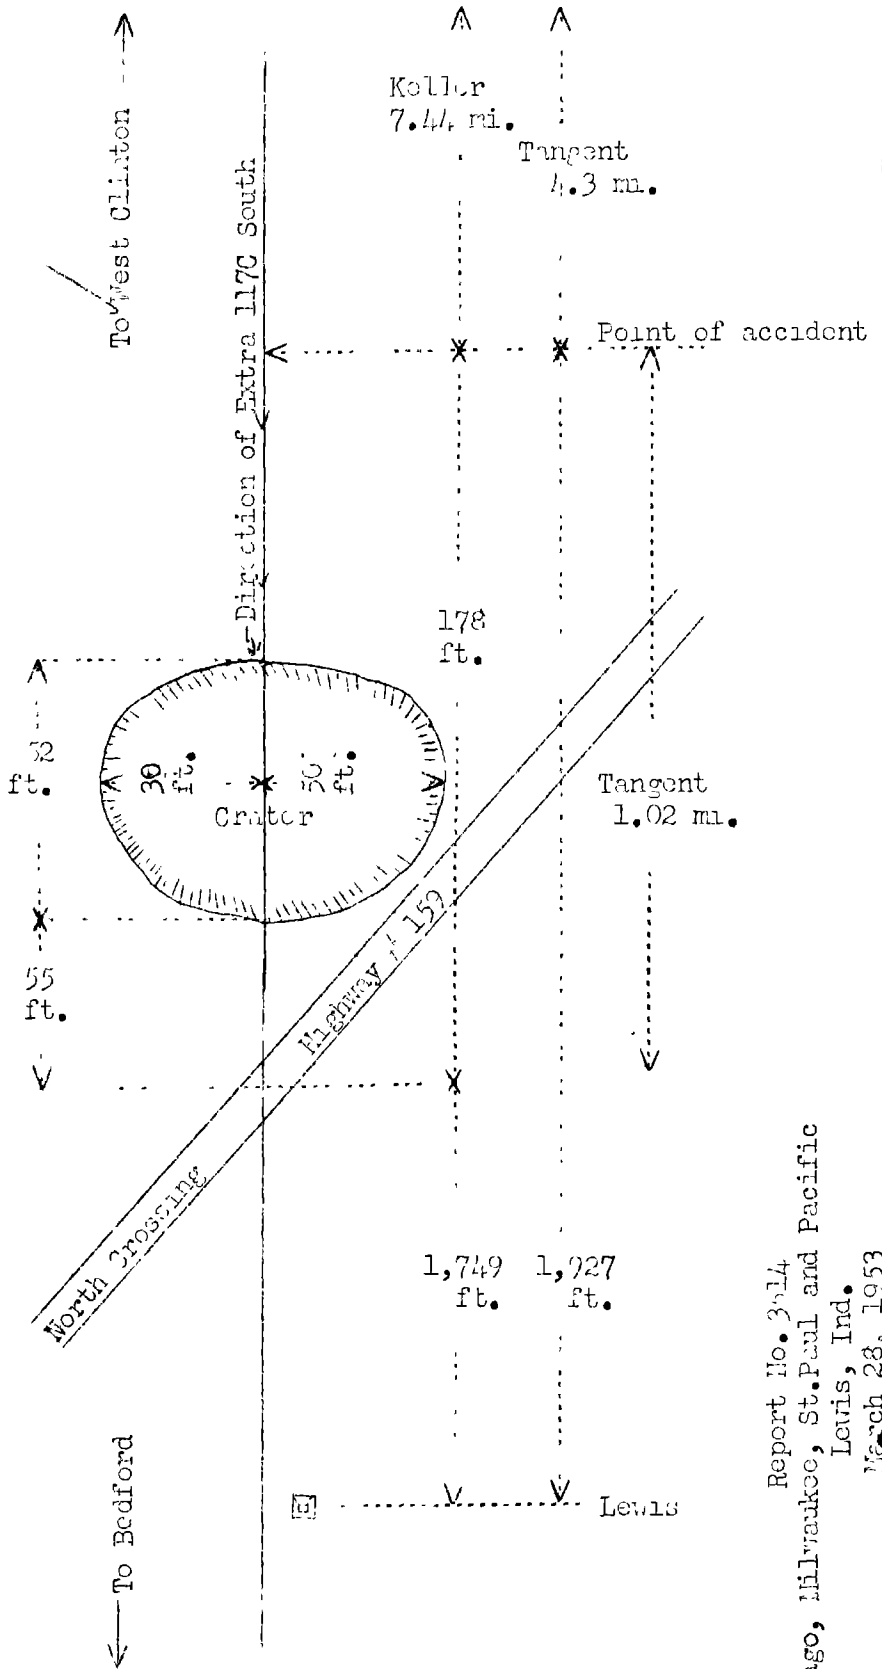
Remainder of rail not definitely identified

Leaving end Sketch showing broken rail

After the accident examination of the equipment which was not destroyed disclosed no condition that would have caused or contributed to the cause of the derailment. Journal boxes were examined and no indication of an overheated journal was found. There was no indication of dragging equipment nor of an obstruction having been on the track. A broken rail was found on the west side of the track. This rail was manufactured in November, 1906. It was broken at a point 15 feet from the receiving end. A progressive fracture extended through about 45 percent of the head. This fracture was 1-3/4 inches long at the top surface of the head of the rail and it extended downward to a depth of 1 inch. The fracture was discolored and evidently had existed for some time. The remainder of the break was new. There were three driving-wheel burns on the rail near the break. Two sections of rail, 17 1/2 inches and 7 feet in length, each of which bore batter marks, were found in the wreckage. The west and the east rails were missing throughout distances of 103 feet and 113 feet, respectively, immediately south of the point of accident. Because of the explosions which occurred in the wreckage, many portions of the rails were scattered over a wide area. All except about 85 lineal feet of the missing rail was found. Most pieces were found within a radius of 800 feet of the point of accident but one piece of rail was found at a distance of 2,000 feet from the center of the wreckage. However, because of the damage it was impossible to identify separated fragments of the rails or their previous positions in the track structure.

Apparently a piece of the failed rail was dislodged by the wheels of the fortieth car. The tread of the front wheel on the west side of the rear truck of the forty-first car was marked. Cuts 3/16 inch and 1/8 inch deep extended inward from the rim of the wheel. The marks were 15 inches

apart and other abrasions were found on the rim of the wheel. These marks apparently resulted from striking a broken rail. Scraping marks were found on the inner side of the flange of the companion wheel and on the bottoms of the drop-doors. The rear truck of this car was first derailed to the west. A separation occurred between this car and the forty-second car. The first clear marks of the derailment were found near the center of the north crossing of highway No. 159. At this point all wheels of the rear truck were outside the west rail. The point at which the wheels had crossed the west rail could not be determined. The marks on the west side of the track indicate that the truck continued parallel to the west rail south of the crossing and that the resultant fulcrum action on the front truck had caused it to become derailed to the east immediately south of the crossing. The car then overturned and stopped at a point about 110 feet south of the crossing. The knuckle at the front end of the car was broken. The forward portion of the train stopped 1,168 feet southward. The other derailed equipment stopped between the initial point of derailment and the crossing and the wreckage was shifted by the explosions which followed.
