INVESTIGATION NO. 2720

THE CHICAGO, MILWAUKEE, ST. PAUL AND PACIFIC  
RAILROAD COMPANY

REPORT IN RE ACCIDENT

AT MERRIAM PARK, MINN., ON

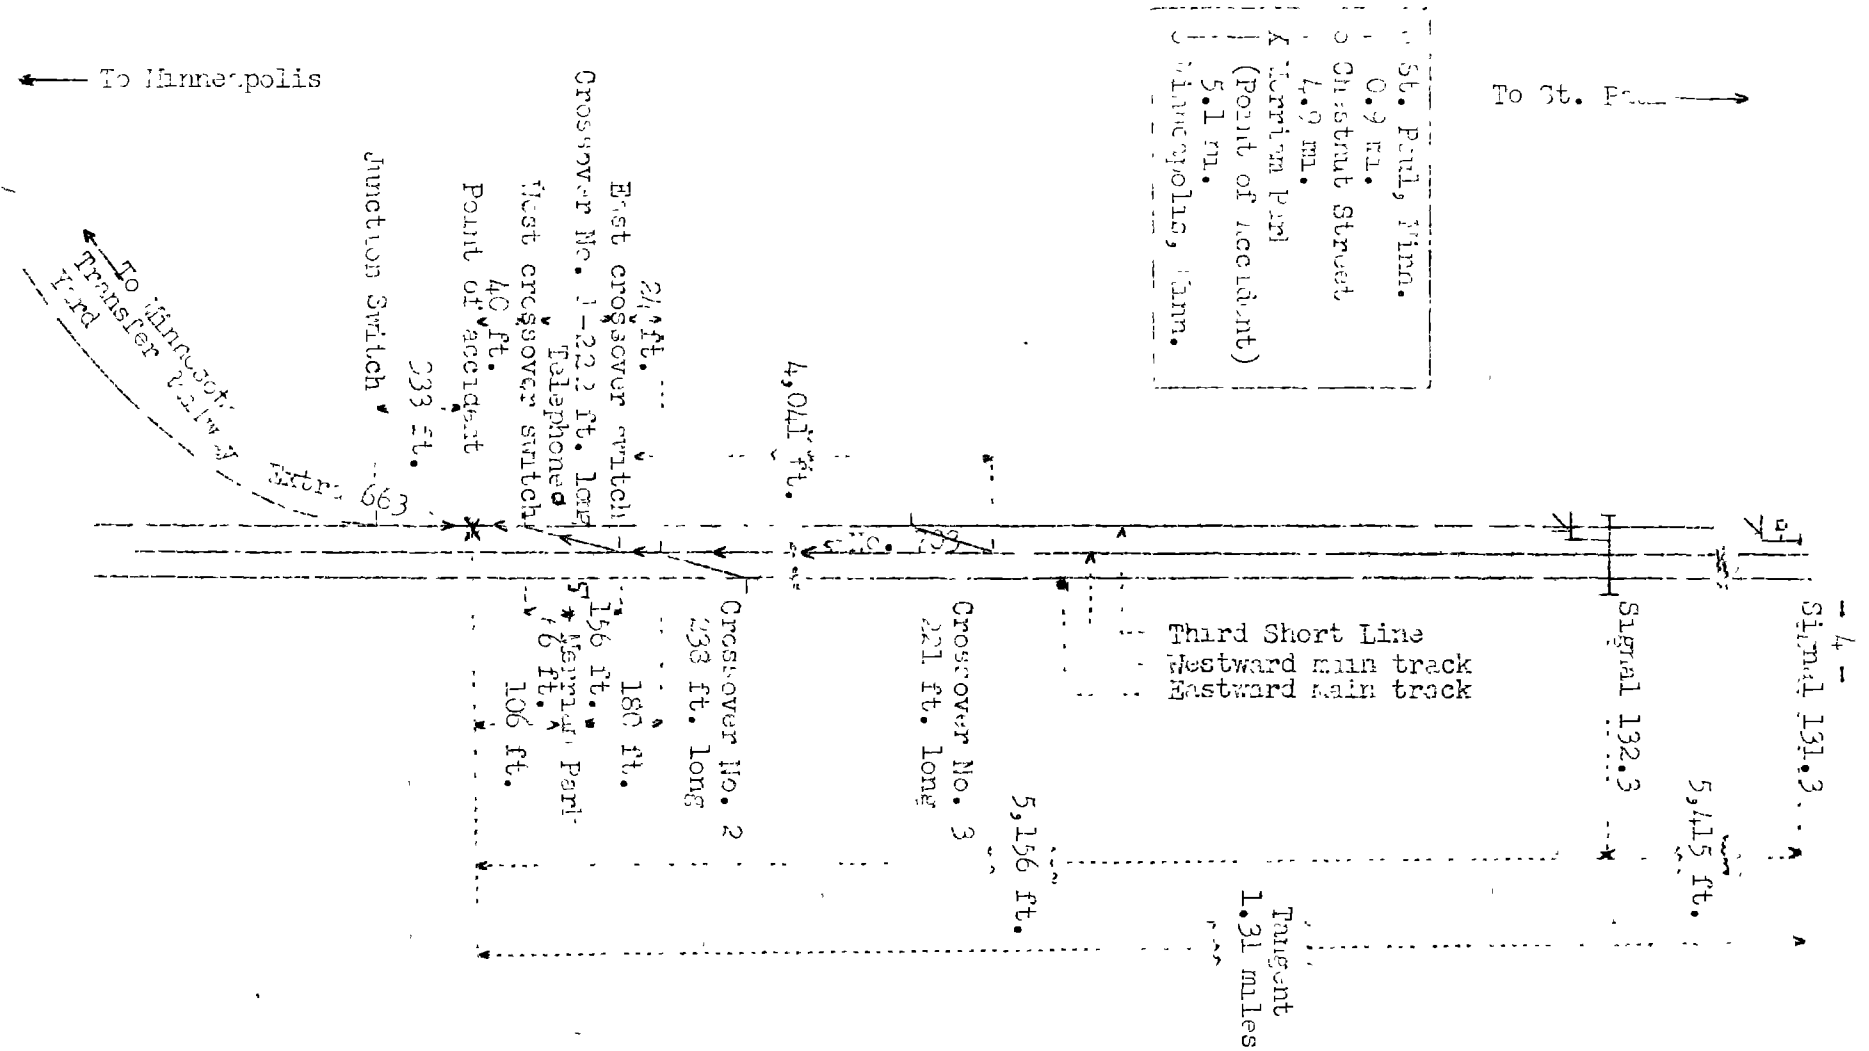
Inv-2726  
 Chicago, Milwaukee, St. Paul and Pacific Railroad  
 Merriam Park, Minn.  
 August 13, 1943

A line of the Minnesota Transfer Railway extended from the Third Short Line at Merriam Park to Minnesota Transfer. The junction switch was 439 feet west of the station. The east switch of a crossover 222 feet long, hereinafter referred to as crossover No. 1, which connected the westward main track and the Third Short Line, was 156 feet east of the station, and was facing-point for westward movements. The west switch of a trailing-point crossover 238 feet long, hereinafter referred to as crossover No. 2, which connected the eastward and westward main tracks, was 180 feet east of the station. The east switch of a crossover 221 feet long, hereinafter referred to as crossover No. 3, which connected the westward main track and the Third Short Line, was 4,197 feet east of the station and was facing-point for westward movements on the westward main track. The switch stand of the east switch of crossover No. 1 was between the westward main track and the Third Short Line. It was of the hand-throw, low-stand type, and was provided with an oil lamp. When this switch was lined for movement through the crossover a red flared-disk reflector and a red light were displayed. When lined for movement on the westward main track a green light was displayed. The centers of the lenses were 1 foot 3 inches above the ties and 4 feet 3 inches north of the gage side of the north rail of the westward main track. A switch indicator was provided at the west switch of crossover No. 1. There was no train register provided at Merriam Park. A telephone for communication between members of train crews and the operator at Chestnut Street was north of the Third Short Line and opposite the station.

Automatic signals 131.3 and 132.3, which governed west-bound movements on the westward main track, were located, respectively, 10,571 feet and 5,156 feet east of the point of accident. Signal 131.3 was mounted on a mast, and was of the one-arm, three-indication, upper-quadrant, semaphore type. It was provided with a permissive marker. Signal 132.3 was mounted on a signal bridge, and was of the one-arm, three-indication, upper-quadrant, semaphore type. The involved day aspects and corresponding indications and names of these signals were as follows:

Extra 663 East, an east-bound freight train, consisting of engine 663, headed westward, 26 cars and a caboose, entered the Twin City Terminal Division at the junction switch at Merriam Park. It had moved eastward 333 feet on the Third Short Line and had practically stopped when it was struck by No. 703 about 40 feet west of the west switch of crossover No. 1.
