REPORT NO. 3307  
CHICAGO, MILWAUKEE, ST. PAUL AND PACIFIC  
RAILROAD COMPANY  
IN RE ACCIDENT  
AT MONONA, IOWA, ON  
DECEMBER 28, 1949

Accident at Monona, Iowa, on December 28, 1949, caused  
by failure to obey a meet order.

Report No. 3307  
 Chicago, Milwaukee, St. Paul  
 and Pacific Railroad  
 Monona, Iowa  
 December 28, 1949

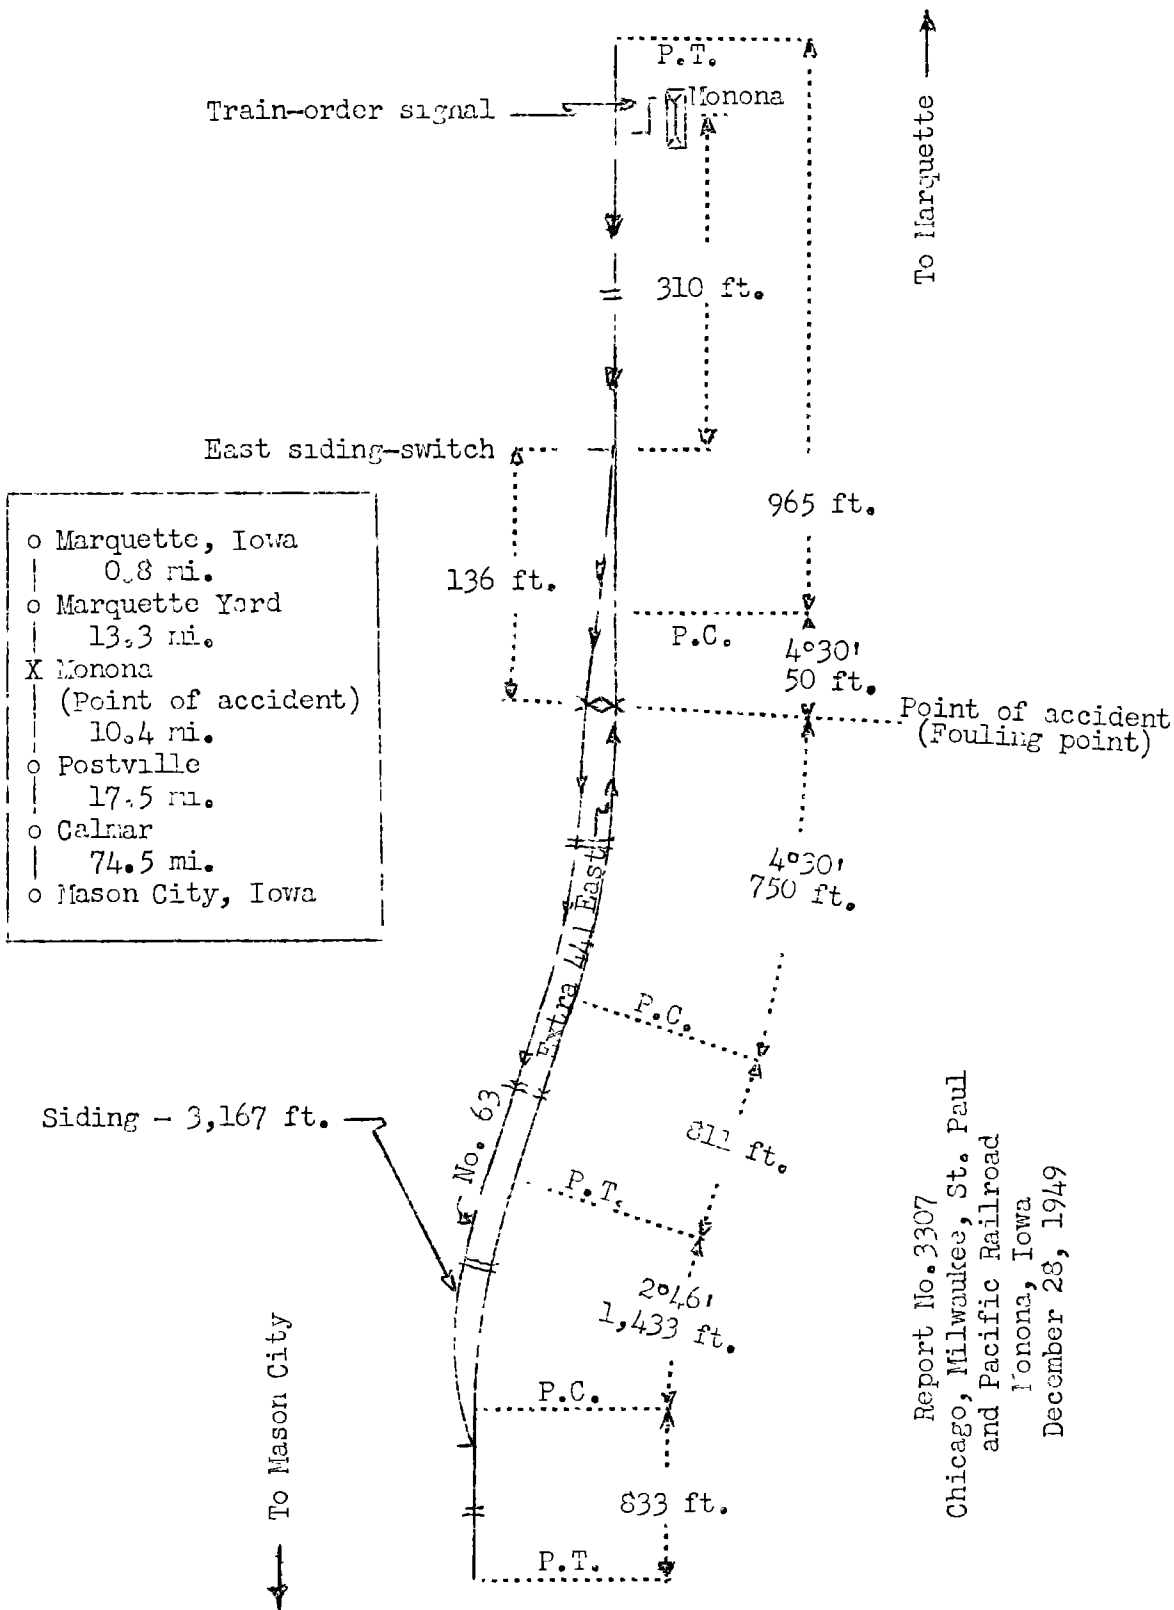
This accident occurred on that part of the Iowa and Dakota Division extending between Marquette and Mason City, Iowa, 116.5 miles. In the vicinity of the point of accident this is a single-track line, over which trains are operated by timetable, train orders and a manual-block system. At Monona, 14.1 miles west of Marquette, a siding 3,176 feet in length parallels the main track on the north. The east switch of this siding is 310 feet west of the station. The accident occurred at the fouling point of the main track and the turnout of the east siding-switch, at a point 136 feet west of the point-of-switch. From the east there is a tangent 965 feet in length and then a 4°30' curve to the right 50 feet to the point of accident and 750 feet westward. From the west there are, in succession, a tangent 833 feet in length, a 2°46' curve to the right 1,433 feet, a tangent 811 feet and the curve on which the accident occurred. At the point of accident the grade is 0.33 percent ascending eastward.

engine crew of No. 63 received copies of train order No. 73 and Clearance Form A. The clearance stated, "Block clear except Extra 441 East Stop indication displayed for No 63 to meet Extra 441 East." The train entered the block and then entered the siding at the east siding-switch. This train stopped with the front end near the clearance point at the west end of the siding and with the fifty-ninth, sixtieth and sixty-first cars occupying the east turnout of the siding. About 1:30 a. m. the cars on the turnout were struck by Extra 441 East.

The fifty-ninth car of No. 63 was slightly damaged. The sixtieth and sixty-first cars were derailed to the north. The sixtieth car was destroyed and the sixty-first car was somewhat damaged. The engine of Extra 441 East stopped on its right side and across the main track, with the engine cab 161 feet east of the point of collision. The tender was detached and stopped parallel to the rear portion of the engine. The first three cars were derailed. The engine was considerably damaged and the first three cars were somewhat damaged.
