INVESTIGATION NO. 2959
CHICAGO, MILWAUKEE, ST. PAUL AND PACIFIC
RAILROAD COMPANY
REPORT IN RE ACCIDENT
AT RED WING, MINN., ON
DECEMBER 17, 1945

Railroad: Chicago, Milwaukee, St. Paul
and Pacific

Date: December 17, 1945

Location: Red Wing, Minn.

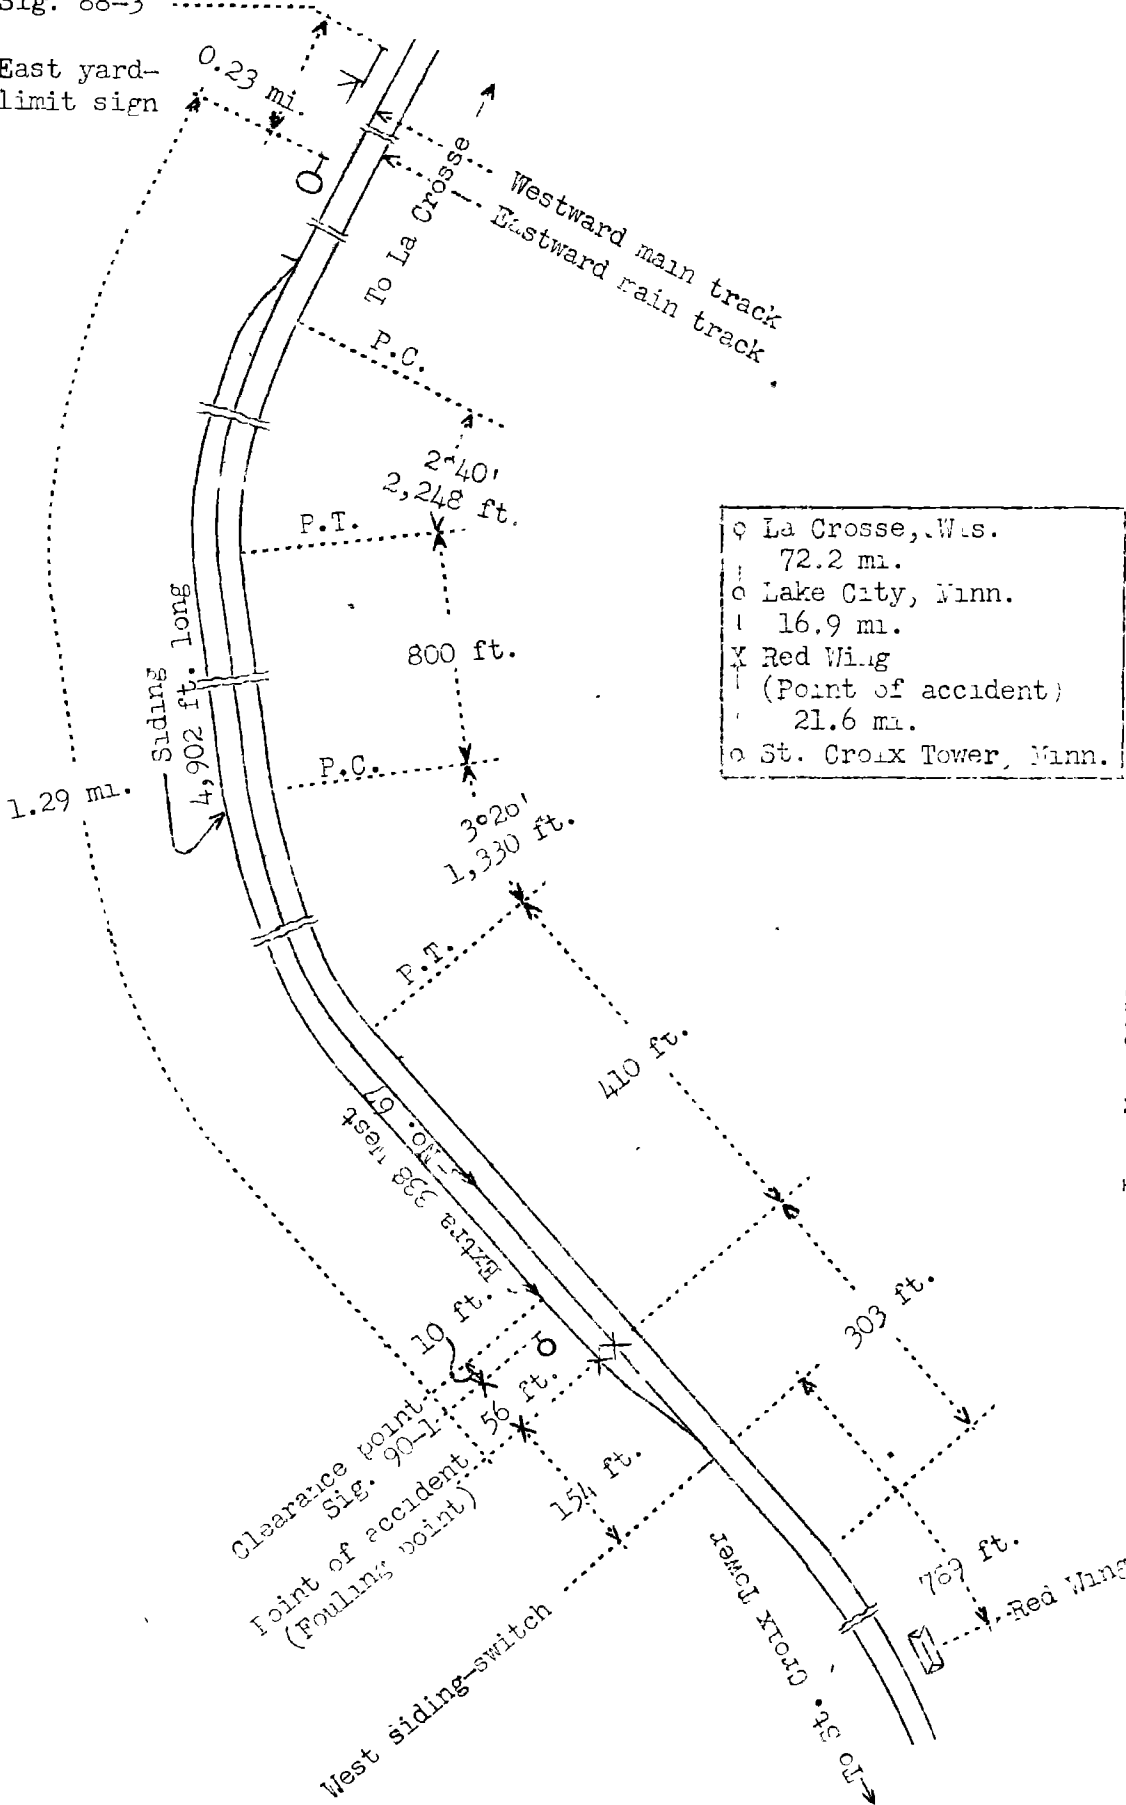
Div. No. 2959
 Chicago, Milwaukee, St. Paul and Pacific Railroad
 Red Wing, Minn.
 December 17, 1945

The right side of the engine of No. 67 struck the left side of the engine of Extra 338 West at the fouling point of the westward main track and the turnout of the west siding-switch. The engine and the engine in tow of Extra 338 and the engine and the first sixteen cars of No. 67 were derailed and damaged. The engine of Extra 338 stopped on its right side with the front end 6 feet north of the westward main track and 14 feet west of the west siding-switch. The engine of No. 67 stopped practically upright, with the front end 37 feet south of the westward main track and 124 feet west of the west siding-switch.

At the time Extra 338 started to move from the siding to the main track, signal 90-1 was displaying a red aspect. Under the rules, the spring switch at the west end of the siding was required to be operated by hand before Extra 338 proceeded west of signal 90-1. Had this been done, the employee who operated the switch probably would have been in position to see that conflicting movements were being made and to give stop signals in time to avert the accident.

Automatic block signal 88-3 is located 1.52 miles east of the point of accident. The speed of No. 67 was about 20 miles per hour, and, therefore, in order for the crew of this train to have received a warning at this signal the switch would have had to be thrown by hand more than 4 minutes before the time of the accident. However, had the automatic cab-signal equipment on the engine of No. 67 been in operation, a restrictive cab-signal indication would have been received at the time the spring switch was operated or when the engine of Extra 338 West entered the track circuit of the turnout of the west siding-switch.
