RAILROAD ACCIDENT INVESTIGATION

REPORT NO 4058

CHICAGO, MILWAUKEE, ST PAUL AND
PACIFIC RAILROAD COMPANY

AUGUST 28, 1965

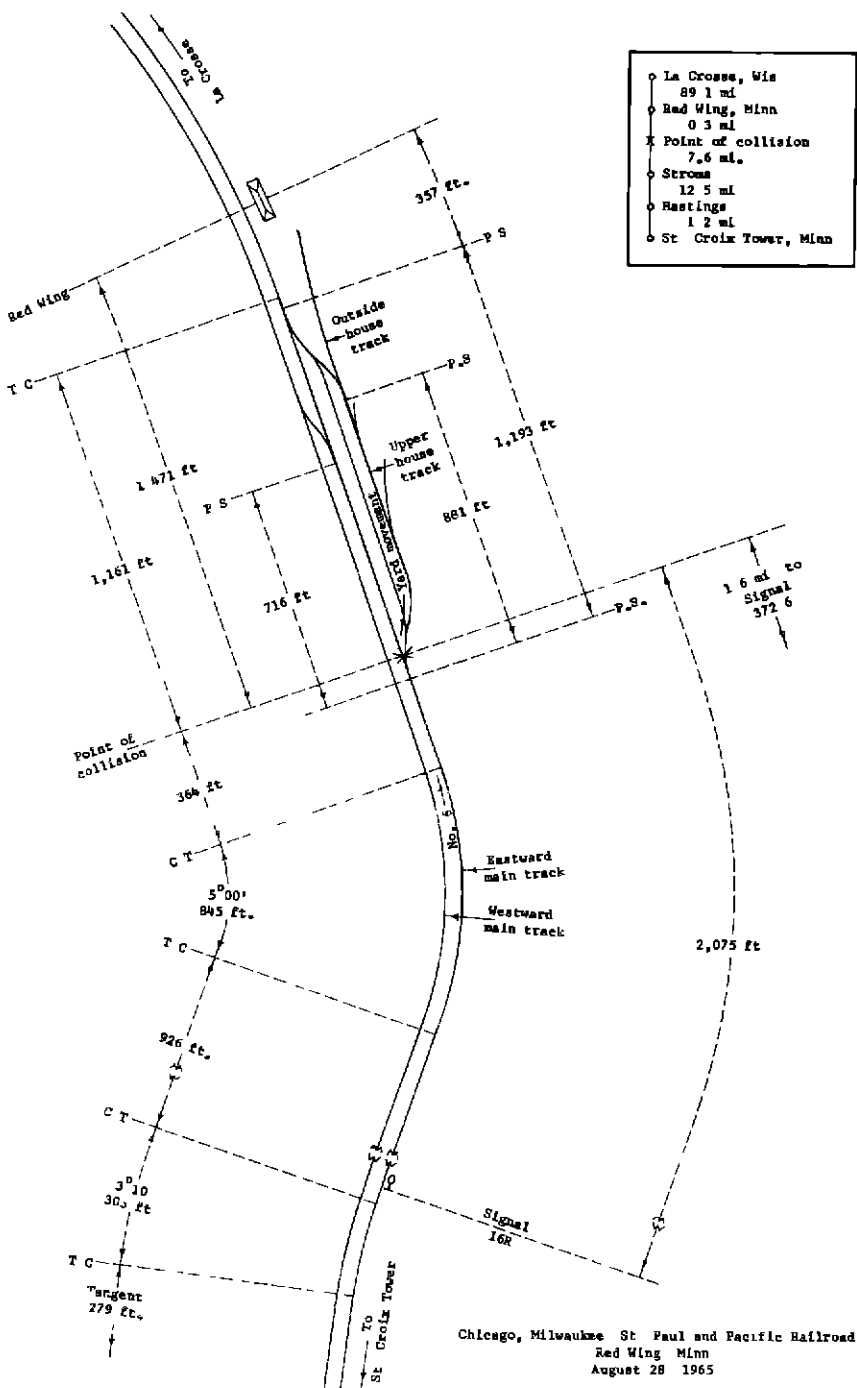
Chicago, Milwaukee St. Paul and Pacific Railroad
 Red Wing, Minn
 August 28, 1965

house track. The west switch of the outside house track is facing point for eastward movements on the upper house track and is 881 feet east of the switch connecting the upper house track to the eastward main track. Other auxiliary tracks are connected to the upper house track as shown in the sketch appended to this report.

The collision occurred 1,471 feet west of the Red Wing station, at the west turnout of the upper house track.
