ACCIDENT ON THE
CHICAGO, MILWAUKEE, ST. PAUL & PACIFIC RAILROAD

SAUGUS, MONT.

JUNE 19, 1938.

INVESTIGATION NO. 2278

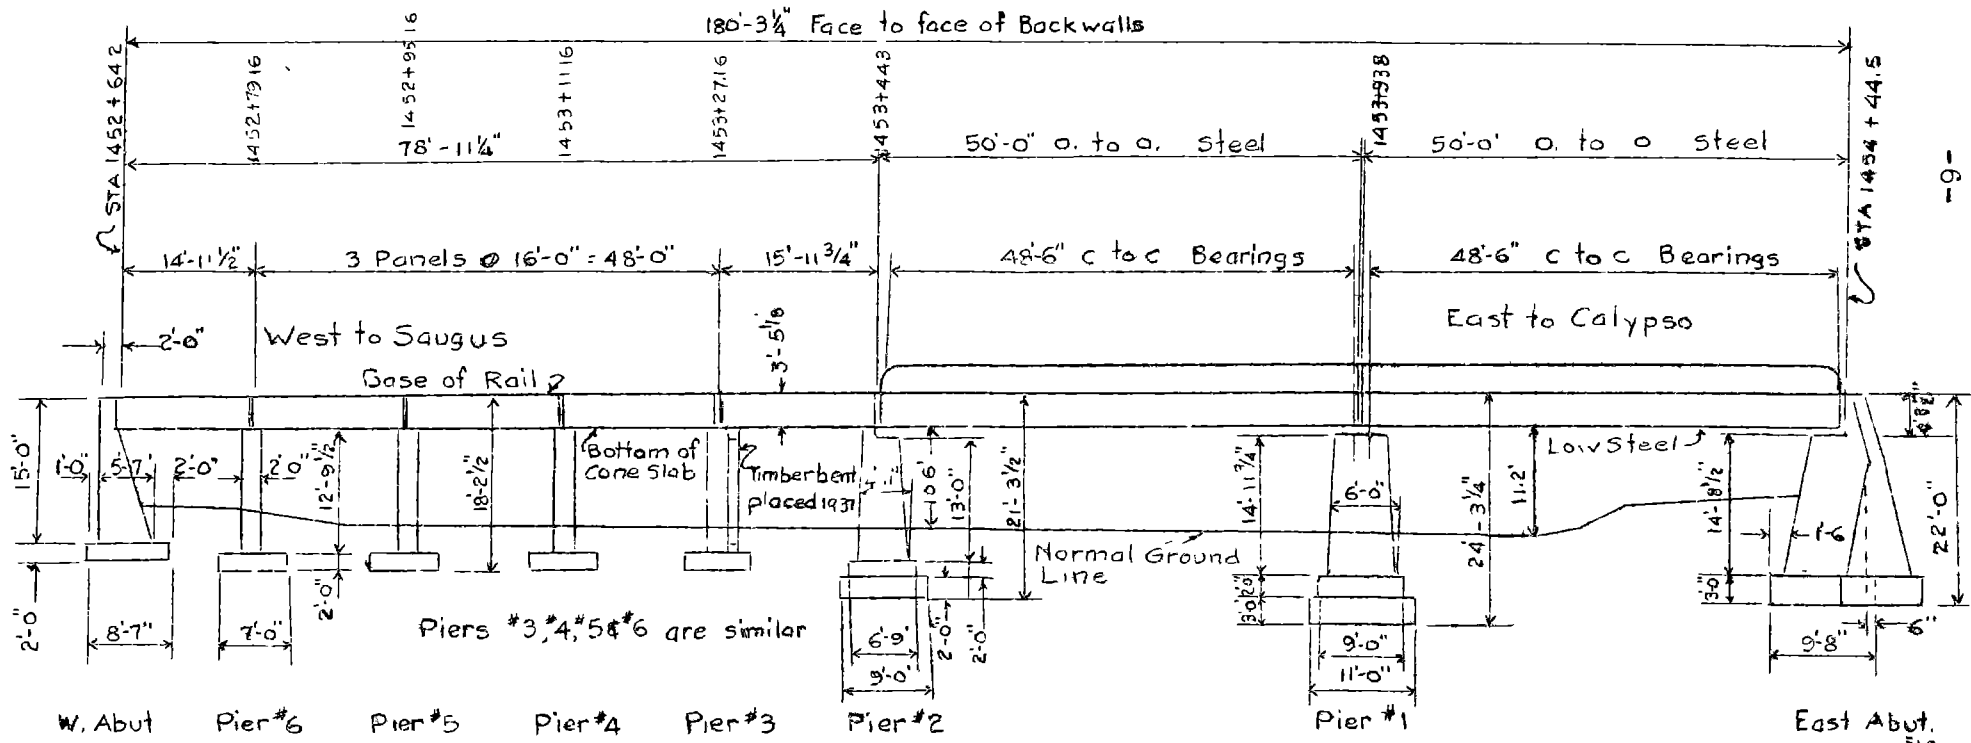
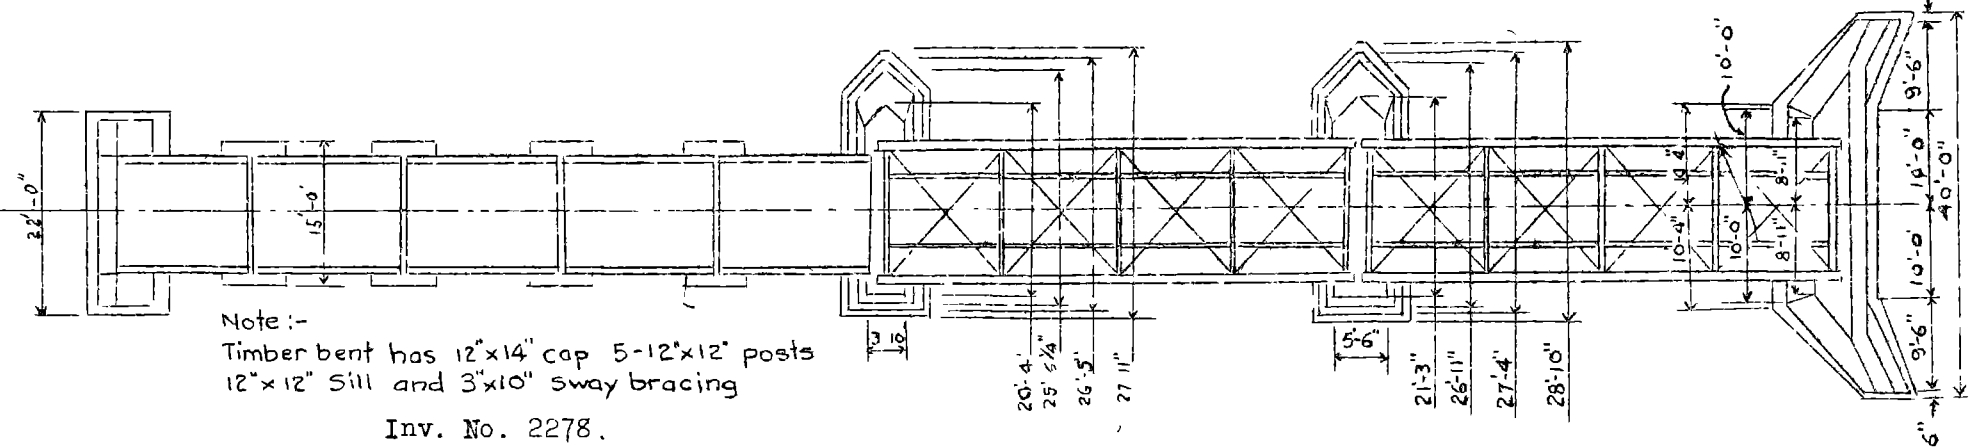
Inv. No. 2278.
 C., M., St. P. & P. R. R.,
 Saugus, Mont.,
 June 19, 1938.

The east abutment of the bridge was practically undamaged. Pier 1 stood at a 45° angle to its normal position; piers 2 and 3 were tipped together, midway between their normal positions; piers 4, 5 and 6, and the west abutment were sheared off. The two girder-spans were in the stream bed about 50 feet south of the bridge.

Division Engineer Johnson stated that he was a member of an inspection party which made a complete inspection of Bridge AA-438 in June, 1937. The rip-rapping was found to be adequate and in good condition. The frame bent at pier 3 had not been erected at that time but as it was listed on the work sheet he gave particular attention to the condition of that pier. Although there was a slight spalling at the top of the pier on the east side and at the end of the slab, he concluded that the reinforcing bent was not necessary for the safety of the bridge and it was not treated as emergency construction but was taken care of in the course of regular work. After the accident the frame bent was gone, and some of the rip-rapping was one-fourth mile south of the bridge. He stated that he is authorized to spend any money that is necessary to correct unsafe conditions as they become apparent. It was his opinion that the accident was caused by the undermining of the north side of pier 2 and the east side of pier 3.

The investigation disclosed that several months prior to the accident a wooden bent was installed at pier 3; it does not appear that the use of this bent had any bearing on this accident. The footing of pier 1 extended $9\frac{1}{2}$ feet below the normal stream bed, while the footings of piers 2 and 3 extended 7 feet and $4\frac{1}{2}$ feet, respectively, below the normal stream bed, and all rested on gravel which provided a bearing surface adequate to support the weight of the bridge and any superimposed load. Since the riprap was displaced and the footings of the piers scoured to such an extent that they were displaced from their normal locations, it is evident that the footings did not extend far enough below the stream bed for such a volume of rapidly moving water as was involved in this instance.

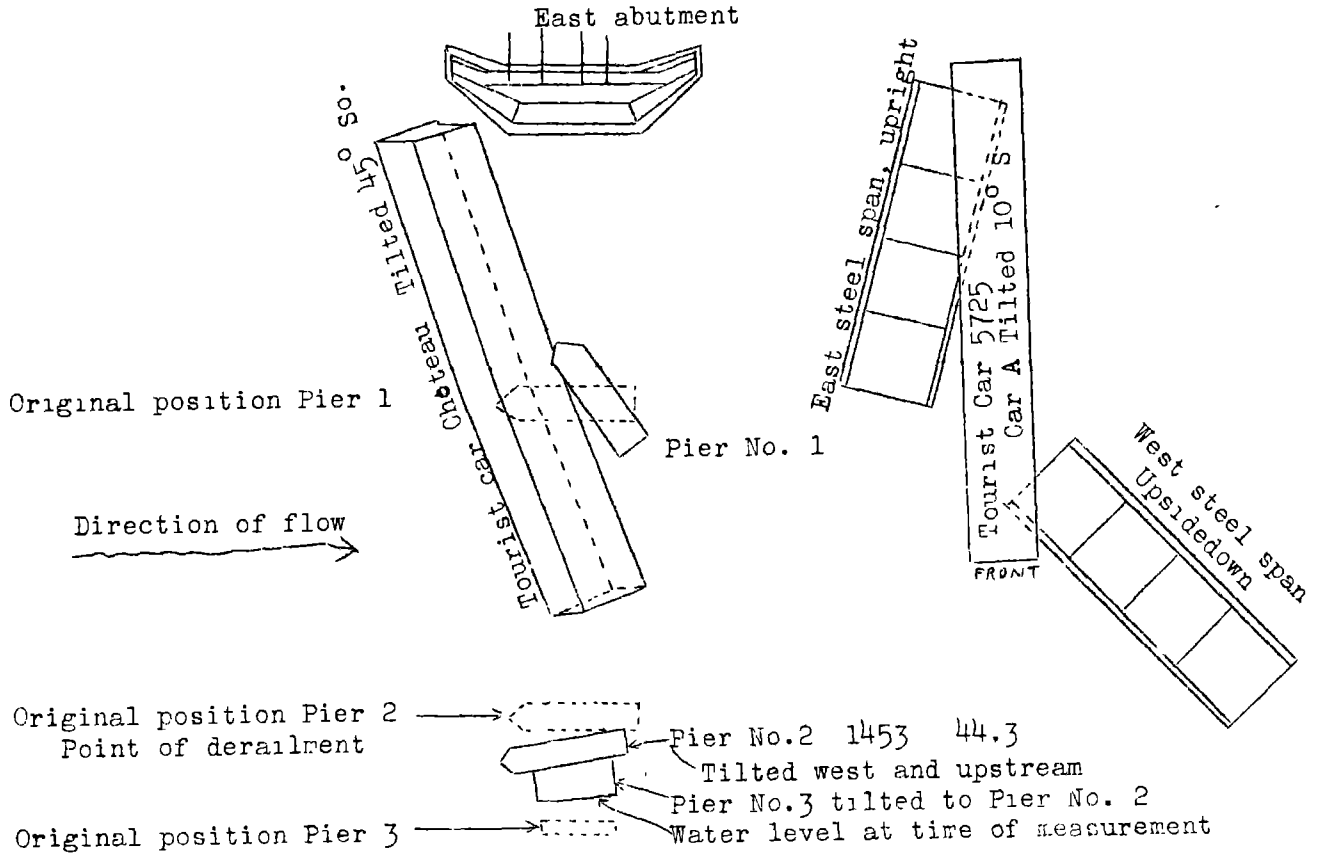
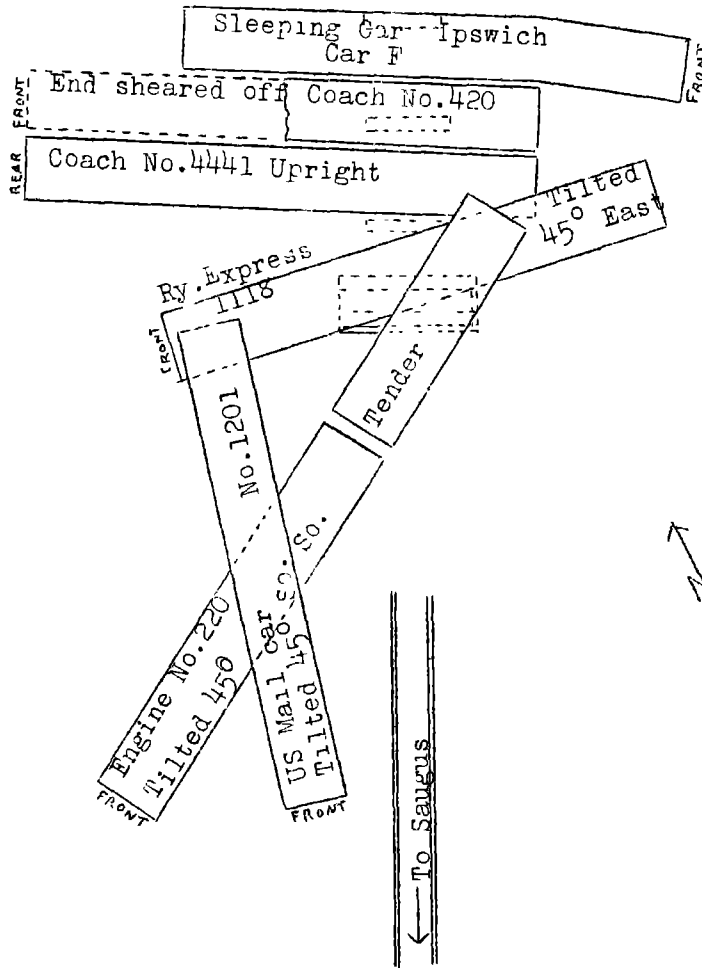
Pier No. 4, sheared off

Pier No. 5, sheared off

Pier No. 6, sheared off

West abutment, sheared off
