INVESTIGATION NO. 3165  
CHICAGO, MILWAUKEE, ST. PAUL AND PACIFIC  
RAILROAD COMPANY  
REPORT IN RE ACCIDENT  
AT STURTEVANT, WIS., ON  
FEBRUARY 11, 1948

Kind of accident: Head-end collision

March 26, 1948

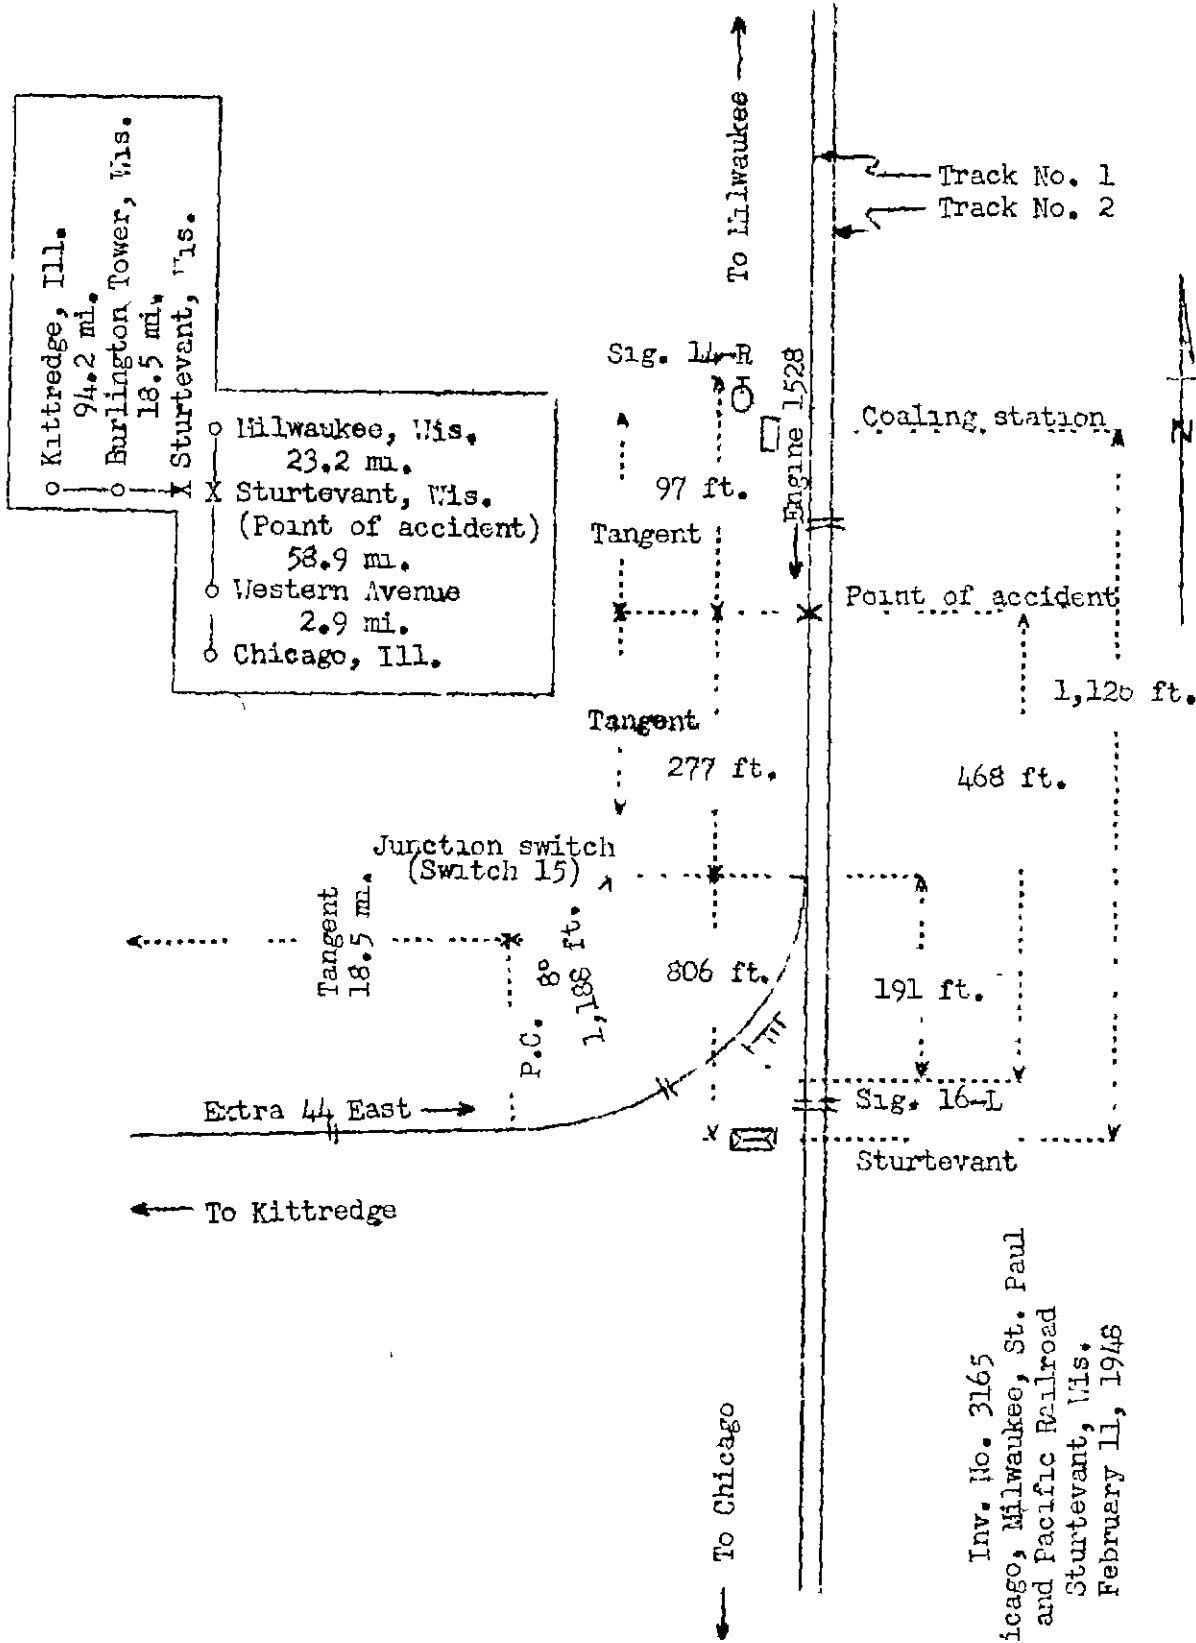
Inv. No. 3165  
 Chicago, Milwaukee, St. Paul  
 and Pacific Railroad  
 Sturtevant, Wis.  
 February 11, 1948

Location of Accident and Method of Operation

Home signal 14-R, governing east-bound movements on track No. 1, is 97 feet west of the point of accident. Home signal 16-L, governing movements from the single-track line through switch 15 to track No. 1, is 191 feet west of switch 15, and is of the three-arm, upper-quadrant, semaphore type. The involved day aspect and corresponding indication and name of signal 16-L are as follows:

Engine 1528, headed east and en route eastward on track No. 1, stopped about 7:40 a. m. within interlocking limits at the coaling station at Sturtevant. Switch 15 was lined for engine 1528 to proceed eastward on track No. 1. Signal 16-L, governing movements from the single-track line through switch 15 to track No. 1, displayed stop. About 3 minutes after engine 1528 stopped at the coaling station, Extra 44 East passed signal 16-L and ran through switch 15. This train proceeded westward on track No. 1 and was moving at a speed of 33 miles per hour when it struck engine 1528 at a point 468 feet west of signal 16-L and 277 feet west of switch 15.
