INTERSTATE COMMERCE COMMISSION

REPORT OF THE DIRECTOR OF THE BUREAU OF SAFETY CONCERNING
INVESTIGATION OF AN ACCIDENT WHICH OCCURRED ON THE
CHICAGO, MILWAUKEE, ST. PAUL & PACIFIC RAILROAD AT
TOMAH, WIS., ON JANUARY 30, 1932.

March 30, 1932

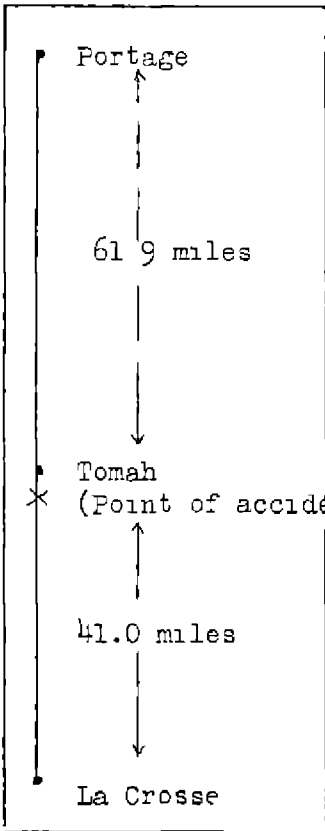
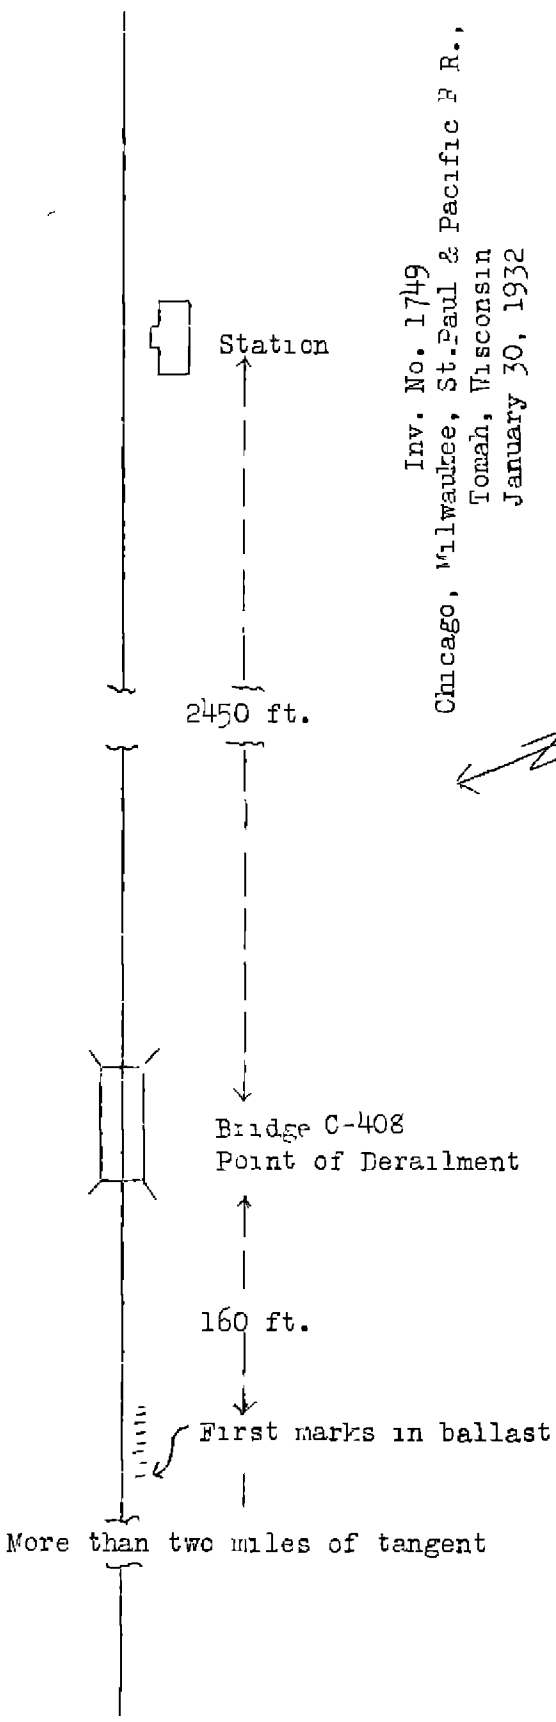
Inv. No. 1749
 Chicago, Milwaukee, St. Paul & Pacific F. R.,
 Tomah, Wisconsin
 January 30, 1932

This accident was caused by a broken main rod.

was found and that when the engine reached the bridge and a section of the broken rod encountered the frozen rock ballast it caused the engine to be lifted up, breaking the frame, and when it dropped back on the track it broke the rails, resulting in the derailment of the train.
