INVESTIGATION NO. 2528
THE CHICAGO, MILWAUKEE, ST. PAUL AND
PACIFIC RAILROAD COMPANY
REPORT IN RE ACCIDENT
NEAR ZANE, IDAHO, ON
SEPTEMBER 20, 1941

Accident near Zane, Idaho, on September 20, 1941, caused
by rock slide.

Inv-2528
 C. M. St. P. & P. R. R.
 Zane, Idaho
 September 20, 1941

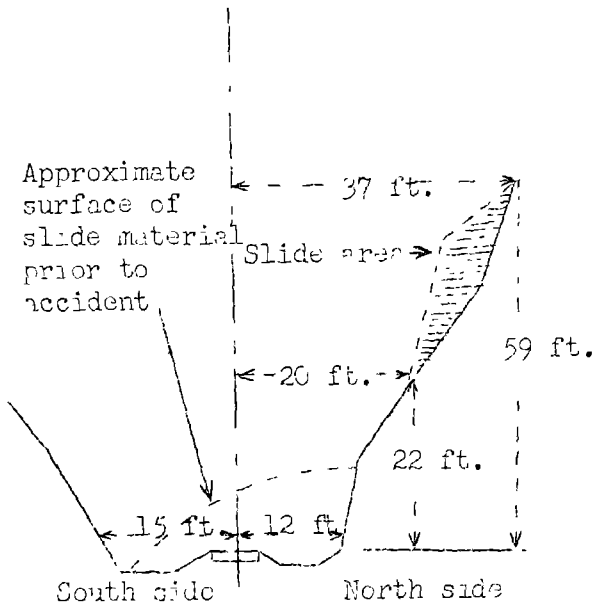
PROFILE AT POINT OF DERAILMENT

This accident occurred on that part of the Coast Division designated as the First Subdivision, which extends between Malden, Wash., and Avery, Idaho, a distance of 108.8 miles. In the vicinity of the point of accident this is a single-track line over which trains are operated by timetable, train orders and an automatic block-signal system. The accident occurred at a point 1.46 miles east of Zane. As the point of accident is approached from the west there are, in succession, a tangent 1,397 feet in length, a 3° curve to the right 1,856 feet, a tangent 683 feet, and a 10° curve to the left 330 feet to the point of accident and 514 feet beyond. The grade for east-bound trains is, successively, 0.127 percent ascending a distance of 3,877 feet and level 330 feet to the point of accident and 514 feet beyond.

A slide consisting of about 230 cubic yards of limestone fell from the north slope and covered the track a distance of approximately 50 feet. The greatest depth on the north rail was approximately 8 feet, and on the south rail, about 6 feet. The maximum height, width and depth of the area from which the slide fell were, respectively, 37, 32 and 8 feet. The base of this area was about 22 feet above the track. There was no indication that the track had been damaged as a result of the slide. After the accident occurred, the rail bonds were intact at the point of derailment and the automatic signals functioned properly.
