**RAILROAD ACCIDENT INVESTIGATION**

**Report No 3844**

CHICAGO, MILWAUKEE, ST PAUL AND PACIFIC RAILROAD COMPANY

ATKINS YARD, IOWA

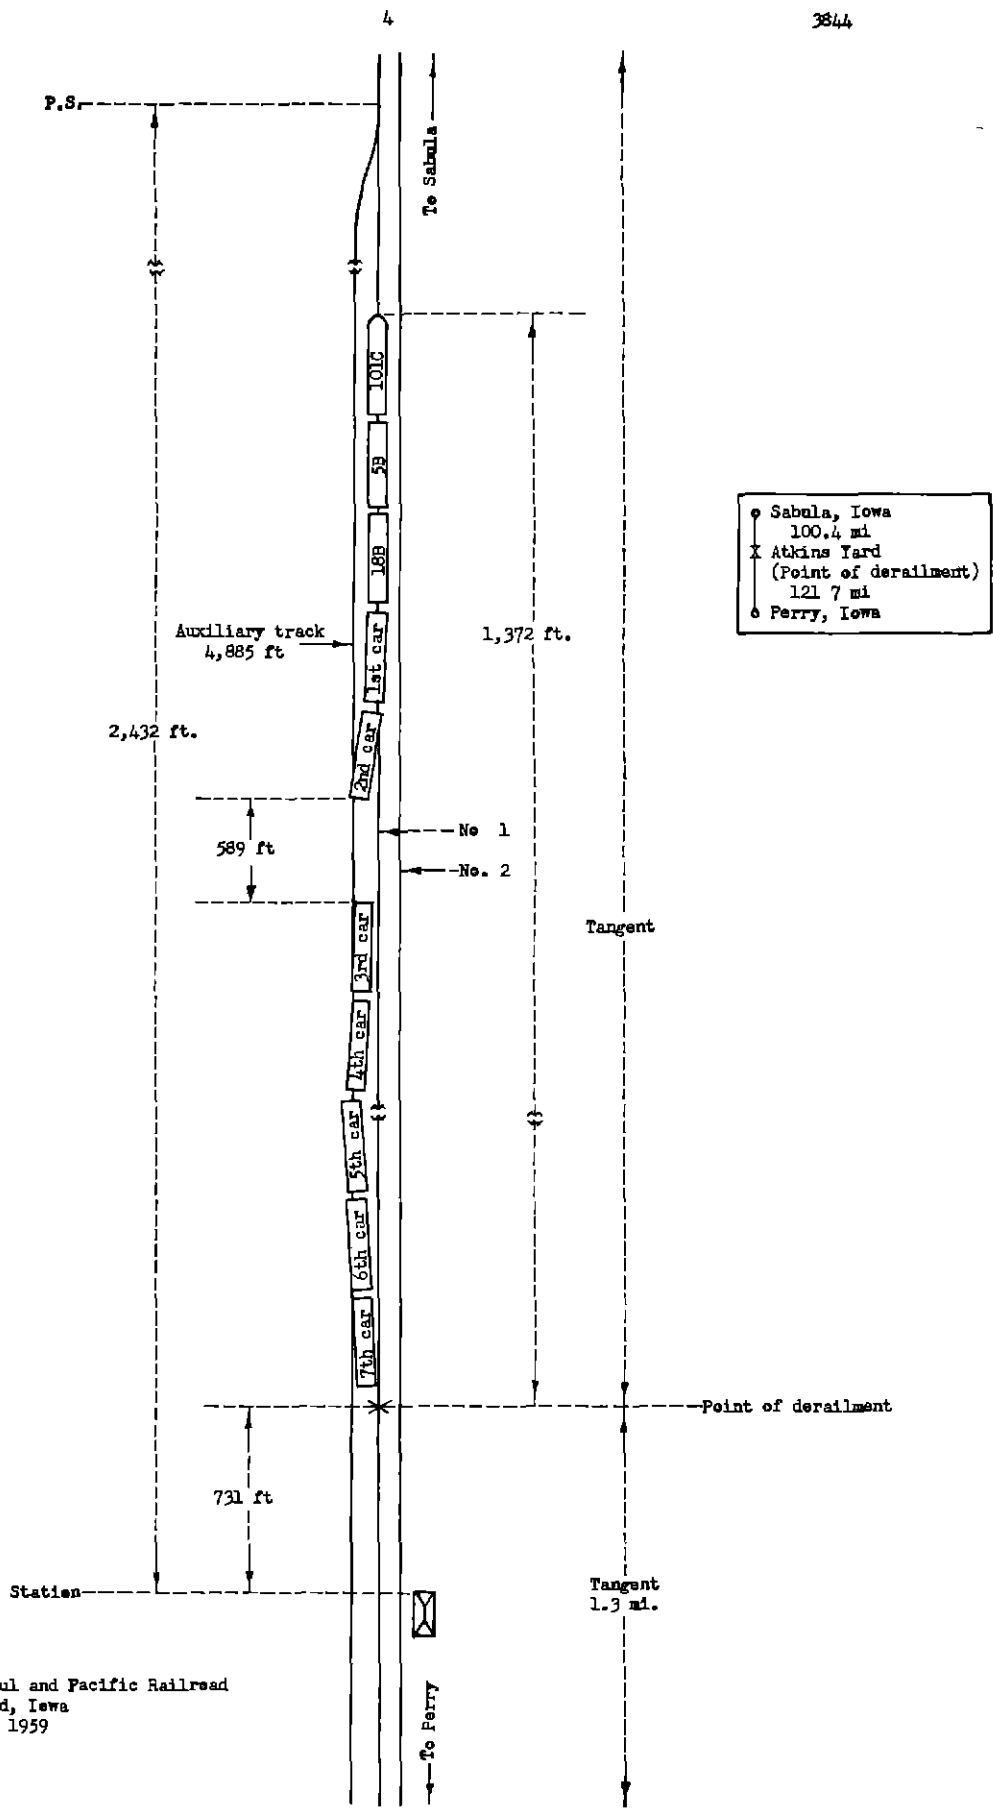
Chicago, Milwaukee, St Paul and Pacific Railroad  
Atkins Yard, Iowa  
April 2, 1959

The train stopped with the locomotive 1,372 feet east of the point of derailment. The derailed equipment stopped upright on or near the structures of track No. 1 and the auxiliary track as shown in the sketch. Separations occurred between the 2nd and 3rd cars and between the 4th and 5th cars. The 2nd and 3rd diesel-electric units were slightly damaged, and the derailed cars were somewhat damaged.
