REPORT NO. 3756

CHICAGO, MILWAUKEE, ST. PAUL AND PACIFIC
RAILROAD COMPANY

IN RE ACCIDENT

Accident near Montevideo, Minn., on June 17, 1957, caused by
a washout.

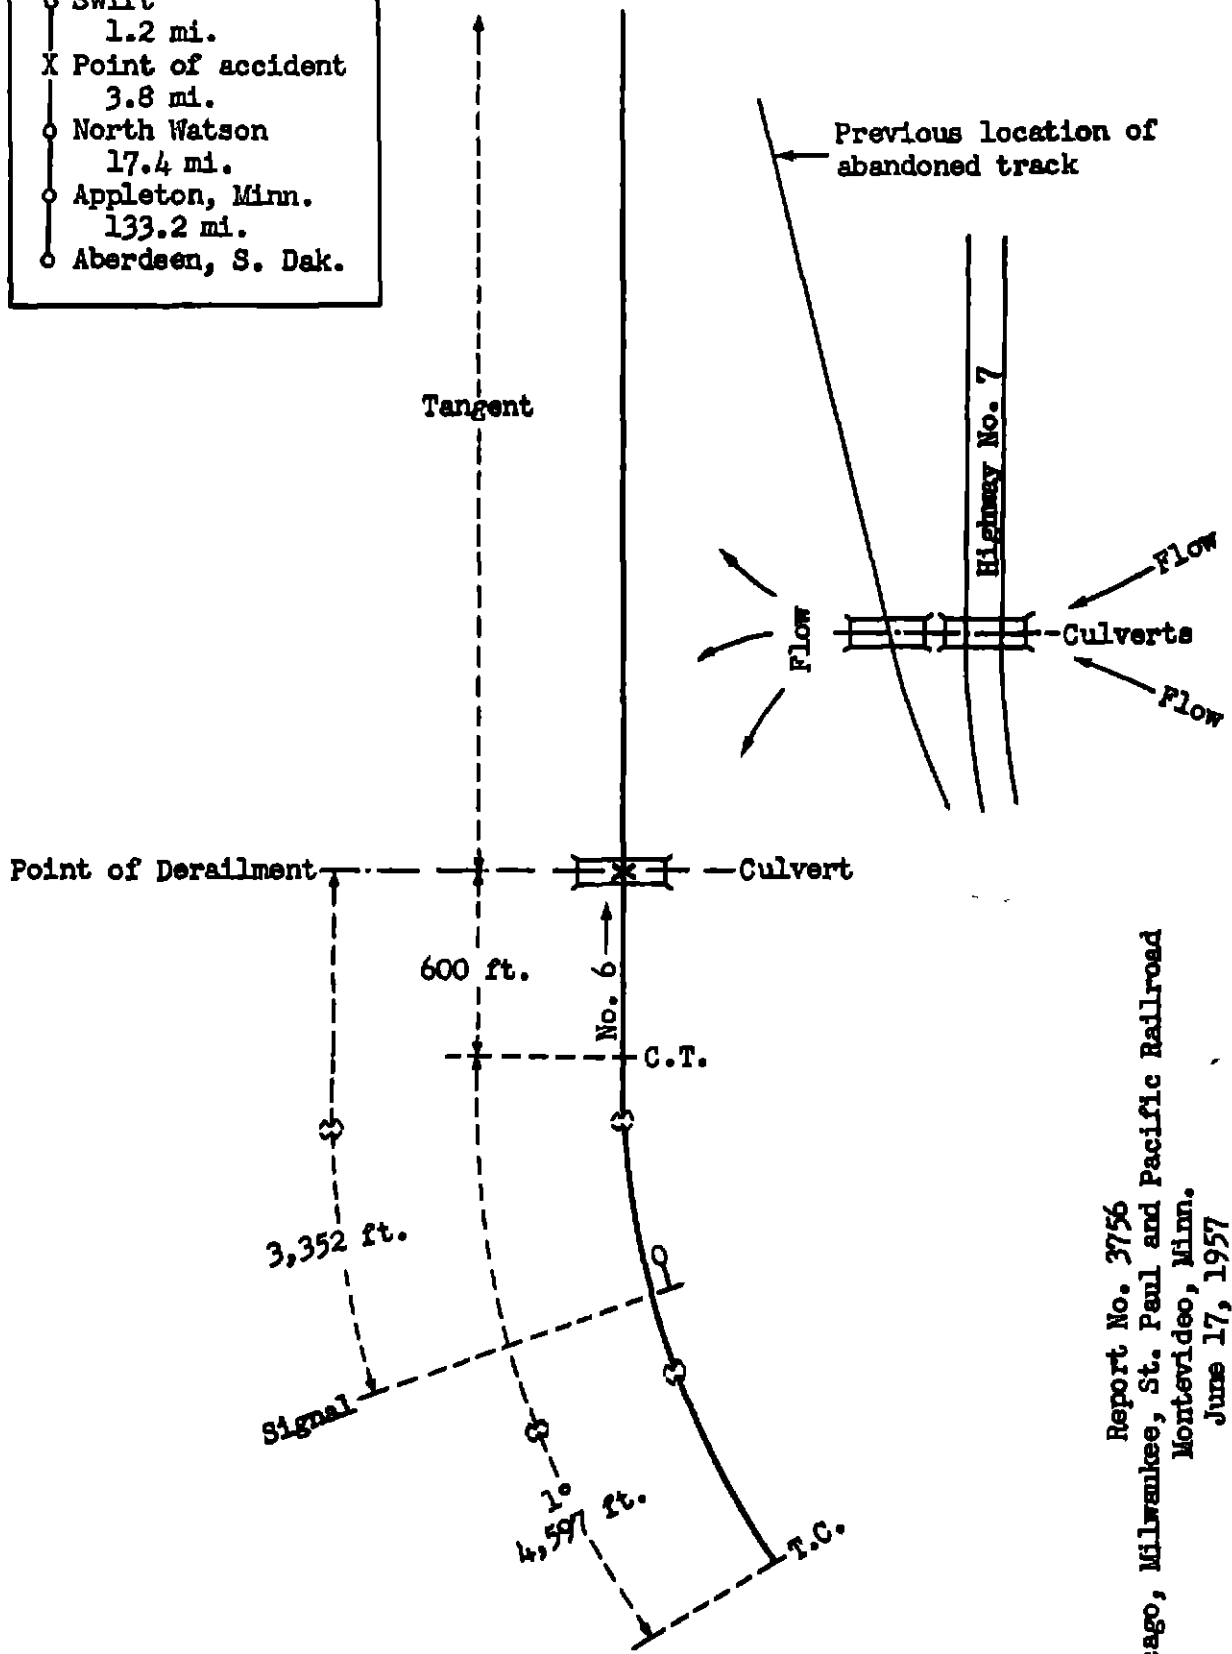
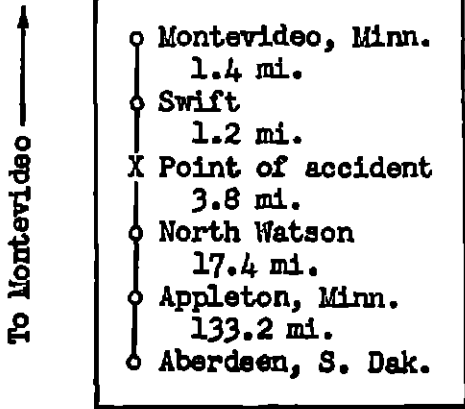
Report No. 3756
 Chicago, Milwaukee, St. Paul and Pacific Railroad
 Montevideo, Minn.
 June 17, 1957

Location of Accident and Method of Operation
