RAILROAD ACCIDENT INVESTIGATION

Report No 3815

CHICAGO, MILWAUKEE, ST PAUL AND PACIFIC RAILROAD COMPANY

JULY 31, 1958

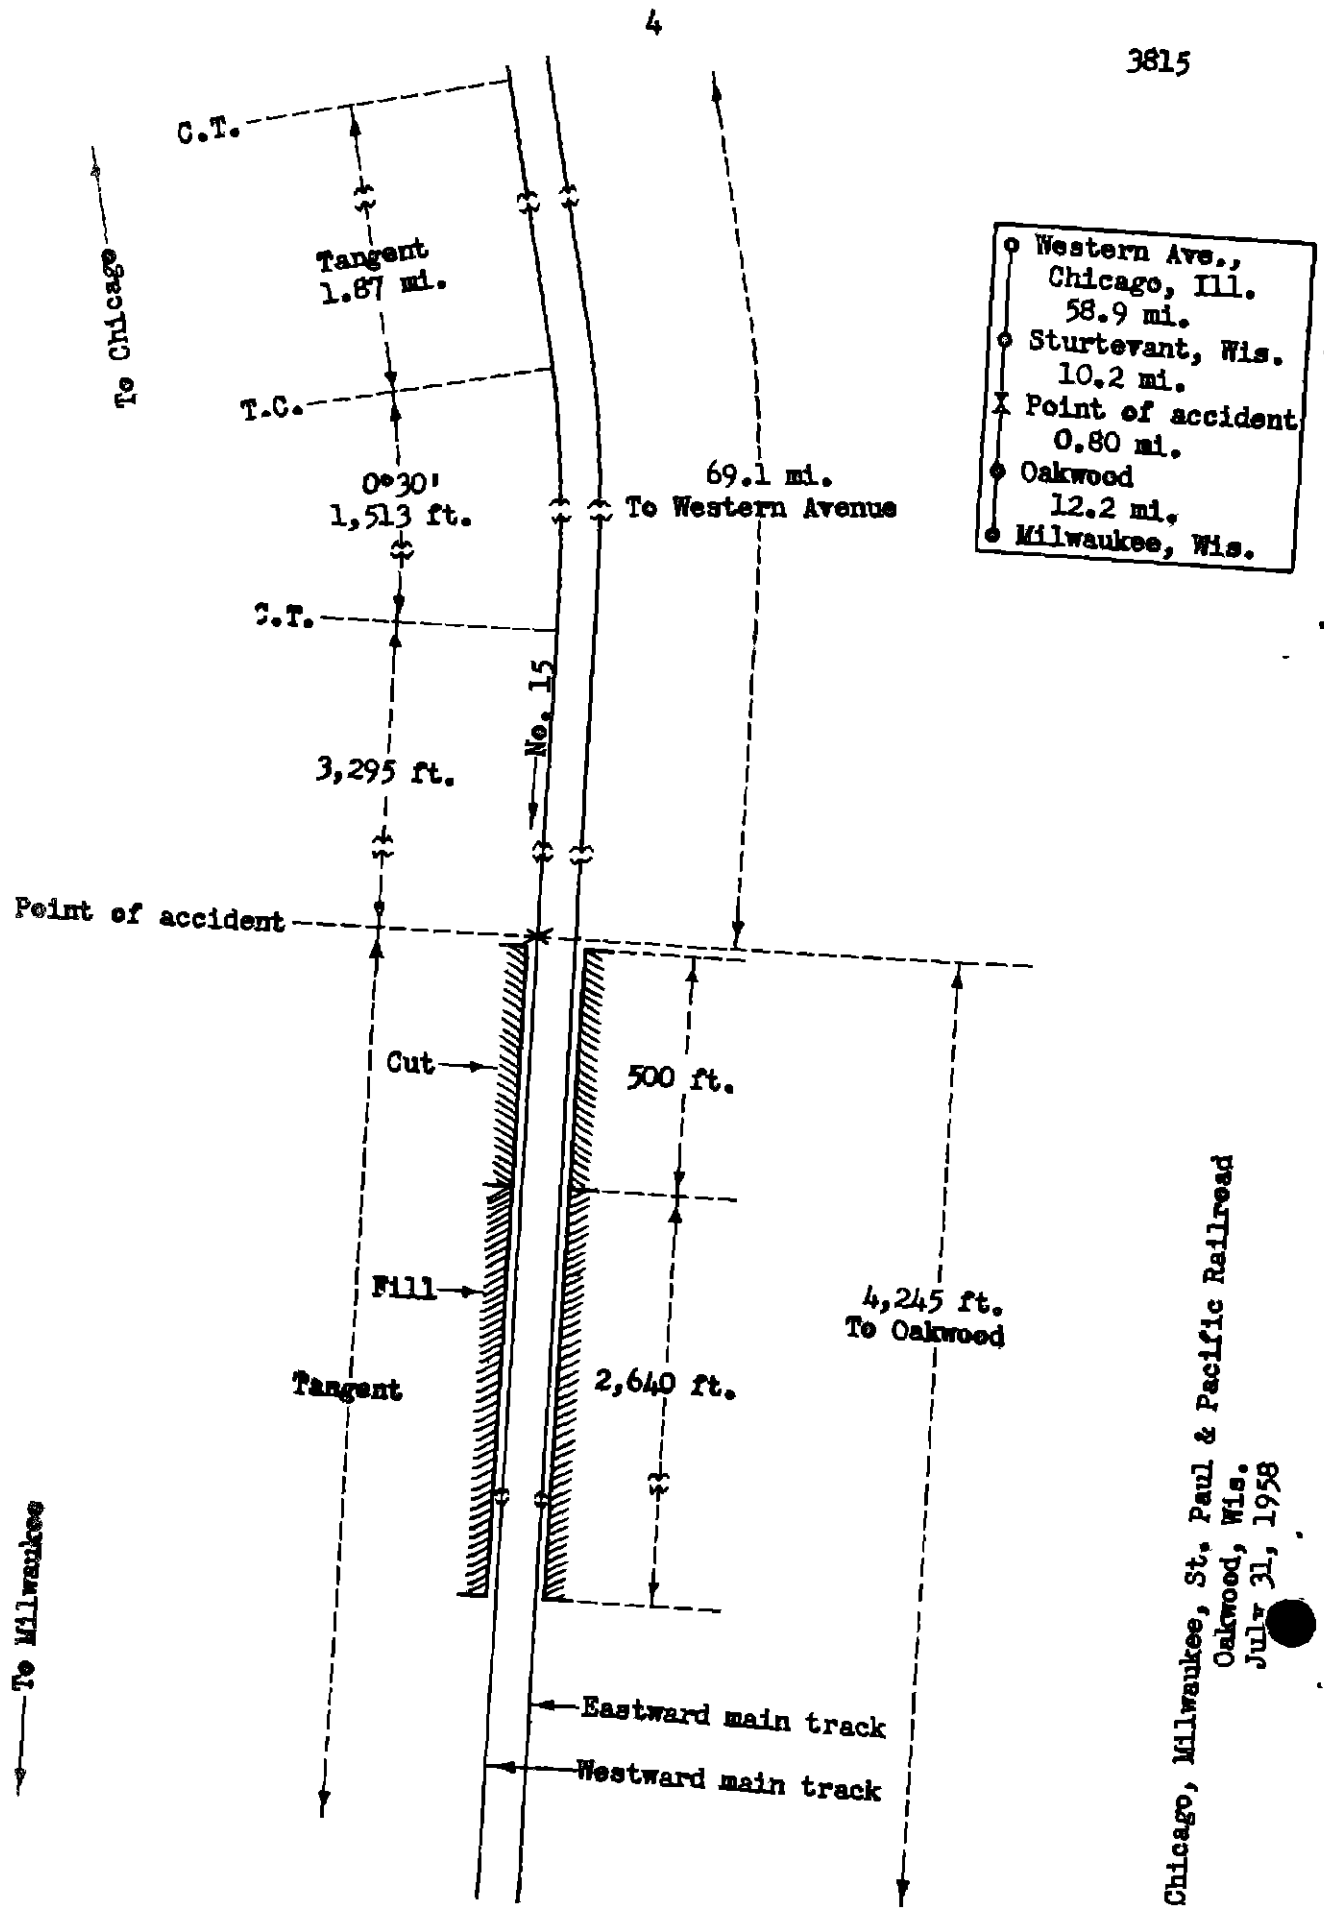
Chicago, Milwaukee, St. Paul & Pacific Railroad
 Oakwood, Wis.
 July 31, 1958
