RAILROAD ACCIDENT INVESTIGATION

Report No 3795

CHICAGO, MILWAUKEE, ST PAUL AND PACIFIC RAILROAD COMPANY

JANUARY 8 1958

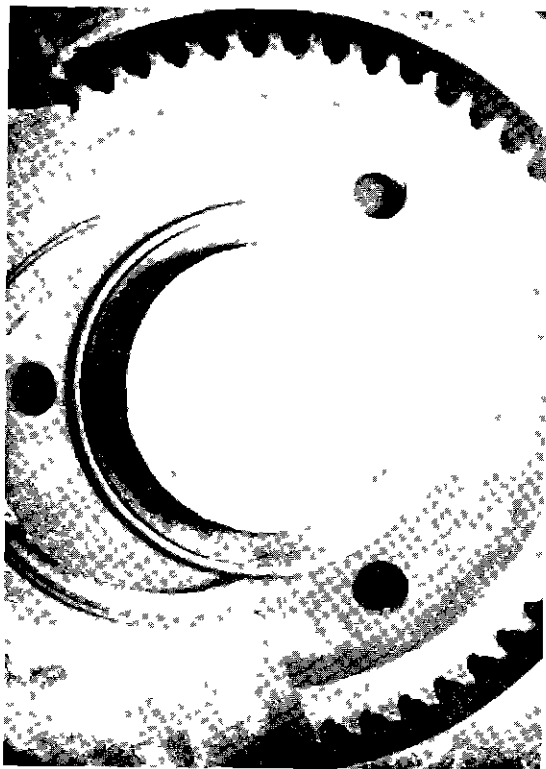
The broken surfaces of the axle were damaged to the extent that the cause of the fracture could not be determined (See Plates 2 and 3)

Figure 2. Traction motor gear
