RAILROAD ACCIDENT INVESTIGATION

REPORT NO 4091

**CHICAGO, MILWAUKEE, ST PAUL AND PACIFIC
RAILROAD COMPANY**

MAY 23, 1966

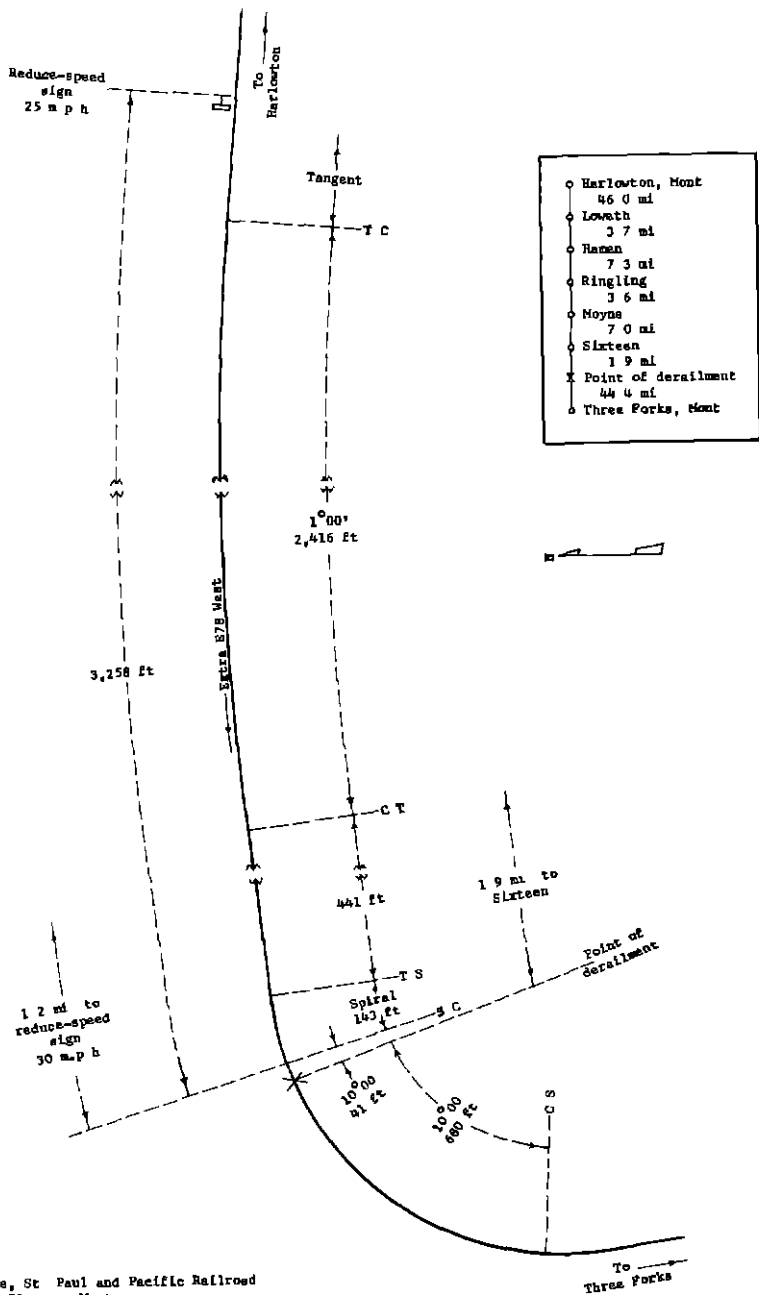
Chicago, Milwaukee, St. Paul and Pacific Railroad
 Sixteen, Mont
 May 23, 1966

The derailment occurred on the main track, 69.5 miles west of Harlowton and 1.9 miles west of Sixteen.

In the derailment area, the main track is laid in a 10-degree curve in a deep cut. Reduce speed signs for westbound trains

The train stopped with the front end 352 feet west of the derailment point. The three locomotive units, the 1st to 23rd cars and the 47th to 72nd cars, inclusive, were derailed. The locomotive units overturned to the north and stopped in line, on their right sides, against and parallel to the north side of the track structure. The derailed cars stopped in various positions on or near the track structure.
