RAILROAD/HIGHWAY ACCIDENT REPORT

**COLLISION OF A CHICAGO,
ROCK ISLAND AND PACIFIC RAILROAD COMPANY
FREIGHT TRAIN WITH AN AUTOMOBILE**

DES MOINES, IOWA

JULY 1, 1976

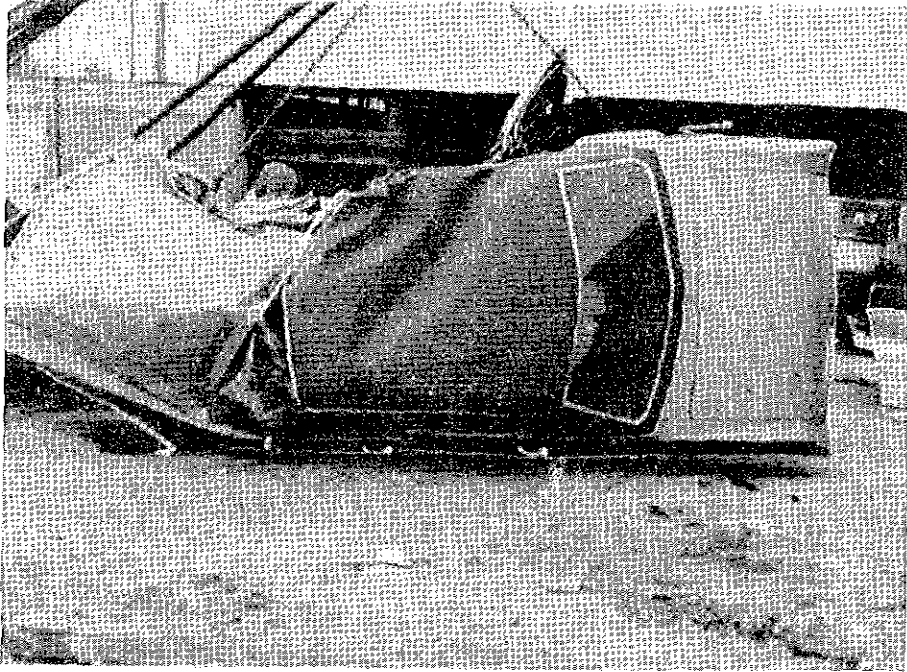
The automobile was a 1970 four-door Chevrolet. The passenger compartment was severely damaged in the collision. The roof and floor pan were crushed inward about one-third the width of the passenger compartment with deformation of these areas extending into the driver's area. (See figure 1.) The fan was on low, the radio was on at low volume, and the windows on the driver's side were almost fully lowered. The windows on the right side were closed.

Figure 1. Damage to automobile.

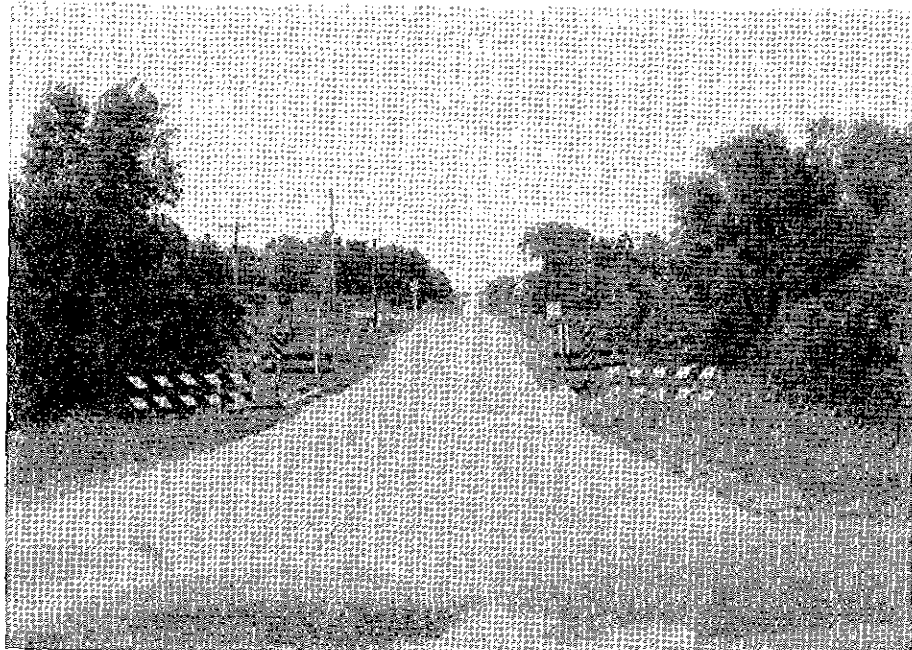
The posted highway speed limit was 45 mph. The presence of the crossing was indicated by an advance warning sign 750 feet before the crossing and an "RxR" symbol painted on the pavement 400 feet before the crossing. Two standard railroad crossing signals-- two horizontal red lights flashing alternately for each signal -- faced each direction of traffic. (See figure 2.)

Figure 2. View of East 56th Street and Chicago, Rock Island, and Pacific railroad/highway grade crossing as seen by approaching northbound traffic. Advance railroad warning sign is not shown in this photograph.

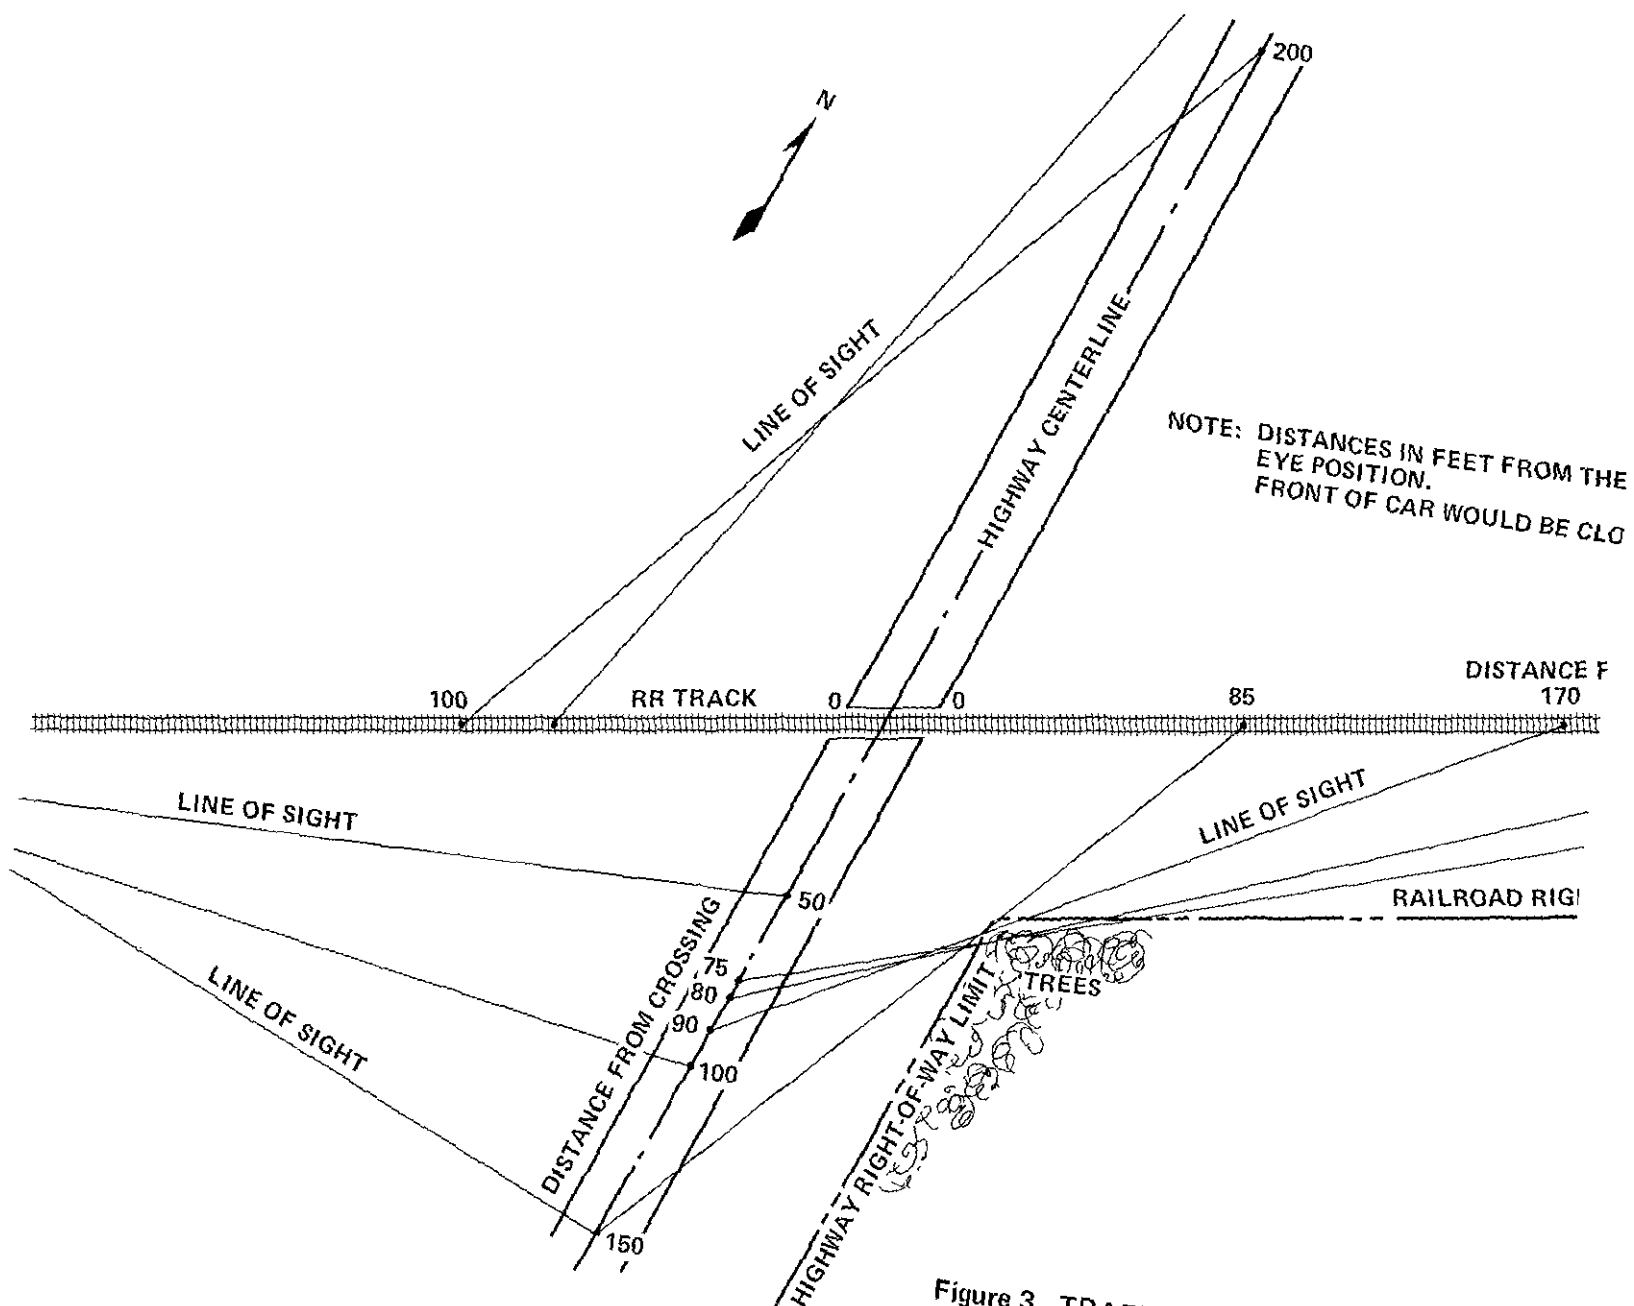
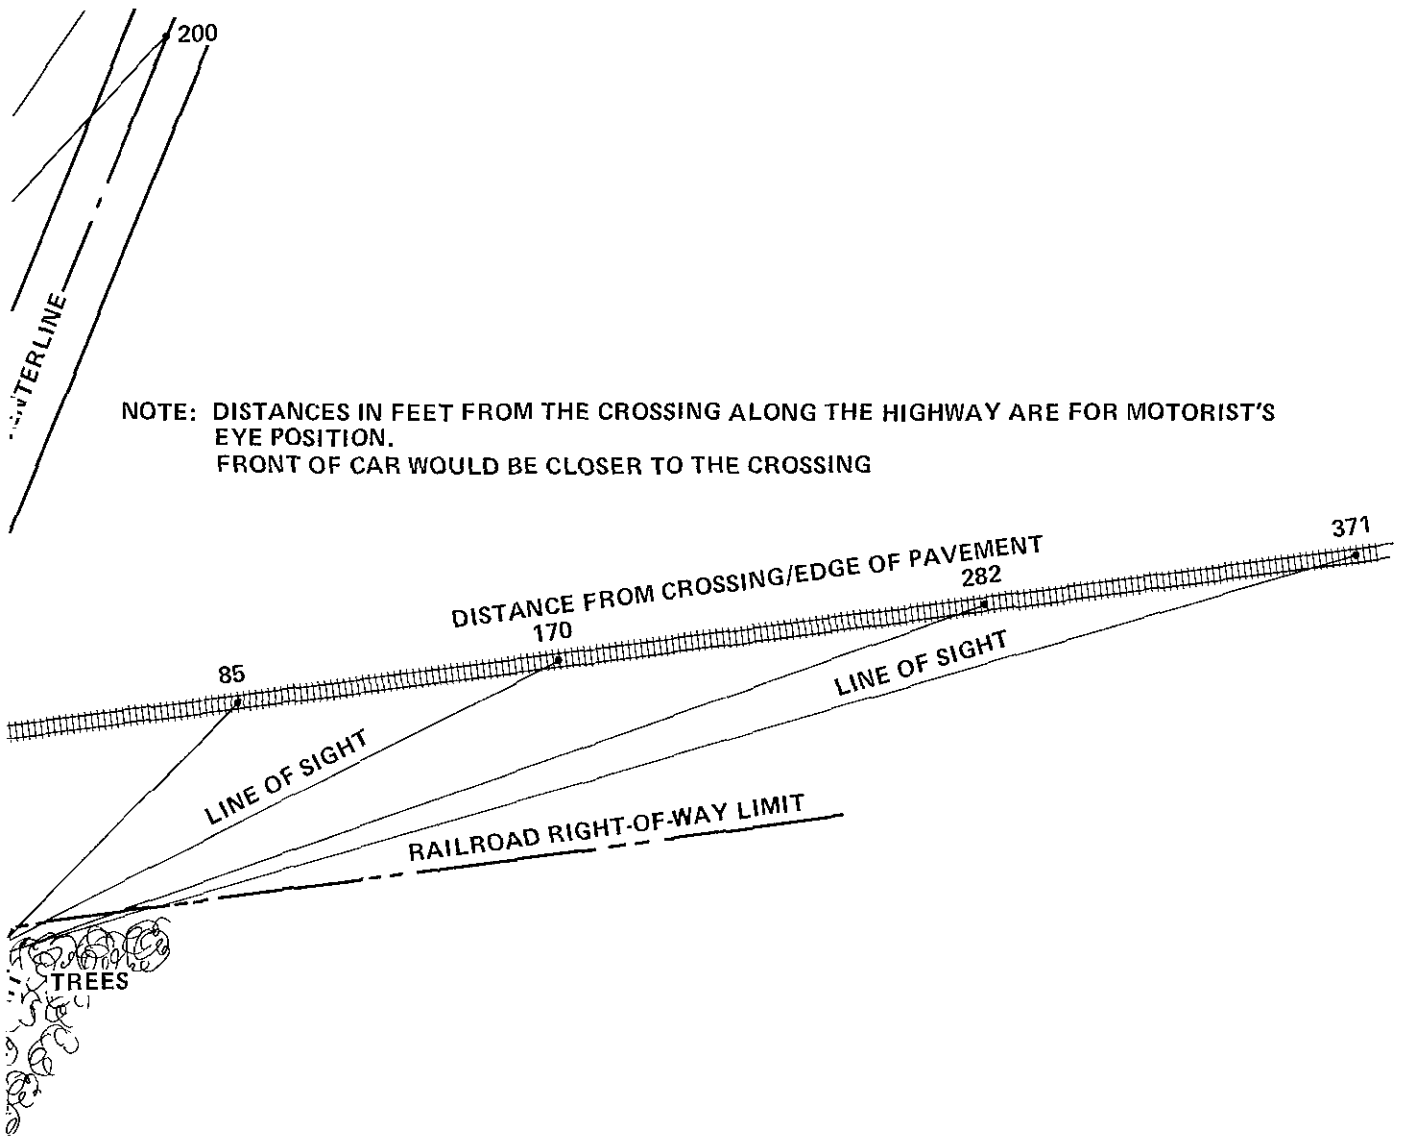
Figure 3. TRAFFIC SIGHT DISTANCE FOR OBSERVING TRAINS

An eastbound train that is within 280 feet of the crossing can be seen by a northbound driver when that driver is at a point 150 feet from the crossing. A westbound train can be seen from this point if it is within 85 feet of the crossing. (See figure 3.) The distance within which approaching westbound trains can be seen gradually increases to about 170 feet at a point 90 feet before the crossing. From this point, the distance within which approaching westbound trains can be seen increases rapidly until there is unlimited visibility when northbound traffic is 50 feet before the crossing. Up to this point, a driver's view of westbound trains is limited by a line of trees on private property next to the highway. The trees are just beyond the 50-foot rights-of-way of the highway and railroad.

For southbound highway traffic, a driver's view of eastbound trains is initially limited by a hill. At a point 200 feet before the crossing, an approaching eastbound train can be seen if it is within 100 feet of the crossing. Southbound motorists have unlimited visibility of westbound trains.

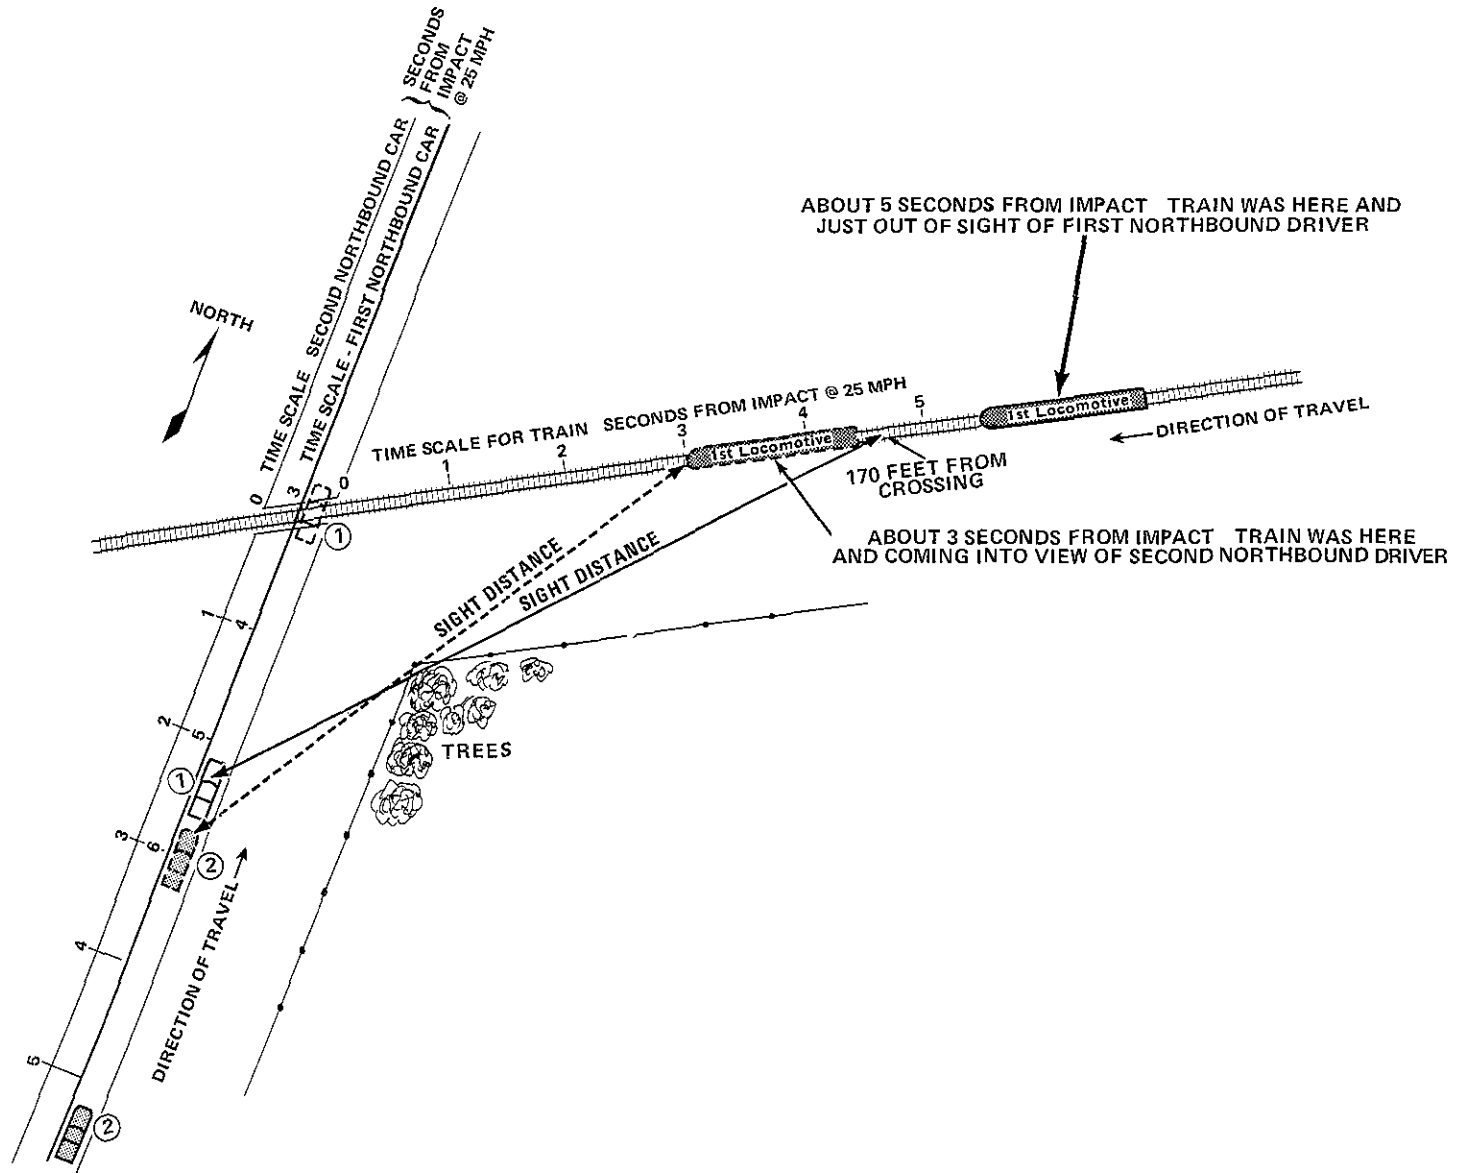
Reconstruction of the accident sequence (see figure 4) indicates that when the first northbound automobile was about 80 feet from the track, the driver could have seen about 170 feet down the track to the east; the train would have been just out of sight at this point. Since the driver was traveling at 25 to 30 mph when she arrived at this point, she had already lost any opportunity to make a normal stop at the crossing, and she also was beyond the point from which it would have been possible to detect the train and skid to a stop short of the crossing from a speed of 30 mph. Therefore, the driver had little or no opportunity to see the train before she had to commit to a decision to cross the track, and she would not have been able to stop once she did see the train.

Figure 4. Reconstruction of relative positions of train and two northbound automobiles as they approached the crossing at equal approach speeds.

About 3 seconds before impact, the train had approached to within about 110 feet of the crossing and was just in position to be seen by the second northbound driver. (See figure 4.) The second northbound driver may have detected and reacted to the presence of the train as evidenced by the dipping motion of her car. If, as the train brakeman estimated, she was 60 feet from the track when this dipping motion occurred and the dipping motion resulted from a brake application, she had detected and reacted to the train about 1.1 to 1.3 seconds after the train was visible, and she could have skidded to a stop, but just short of the track. Even though she may have detected the train, reacted about as quickly as could be expected, and began to stop, she may have considered her chances of avoiding a collision through braking to be very marginal and stopped braking.
