REPORT NO. 3714

CHICAGO, ROCK ISLAND AND PACIFIC
RAILROAD COMPANY

IN RE ACCIDENT

AT DURANT, IOWA, ON

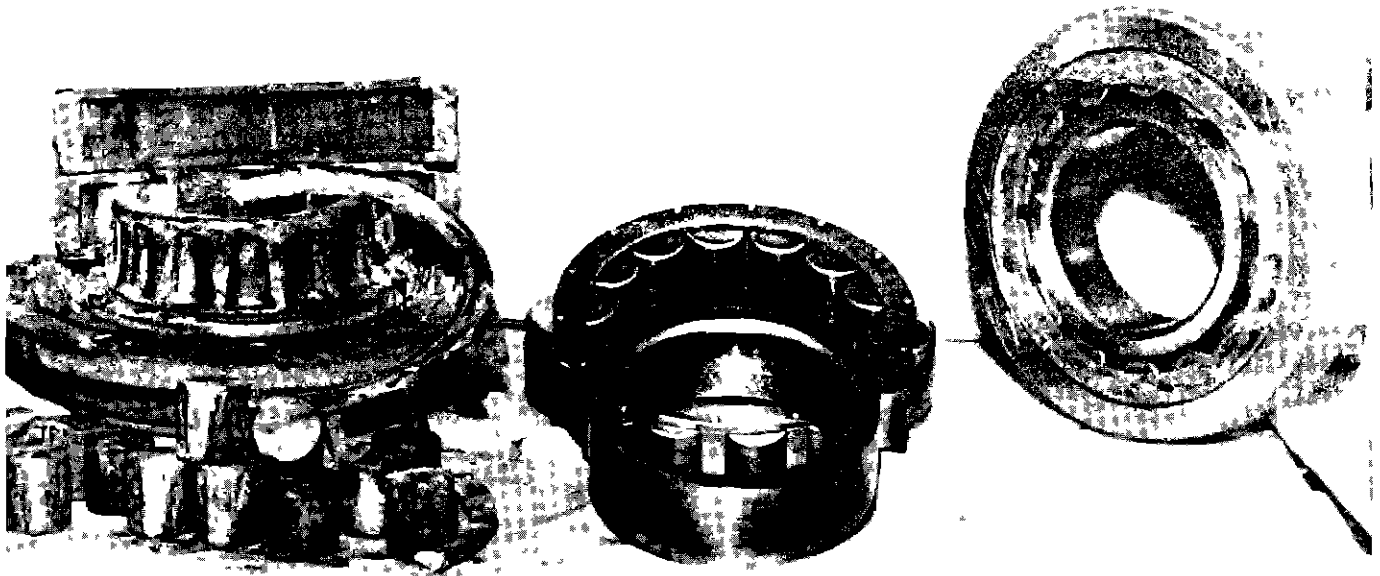
The roller-bearing cage was broken, discolored and distorted. The bearing rollers were dark blue in color and embedded in the surface of the bore of the inner bearing race. Flat spots having maximum width of 1/2 inch extended the entire length of each roller. Some rollers were slightly elongated at the flattened area.

PLATE II: Condition of bearing races, rollers, and cage removed from seized traction motor on locomotive unit 656 as compared with new bearings of the same type.
