RAILROAD ACCIDENT INVESTIGATION

Report No 3885

THE CHICAGO, ROCK ISLAND AND PACIFIC RAILROAD COMPANY

JUNE 23, 1960

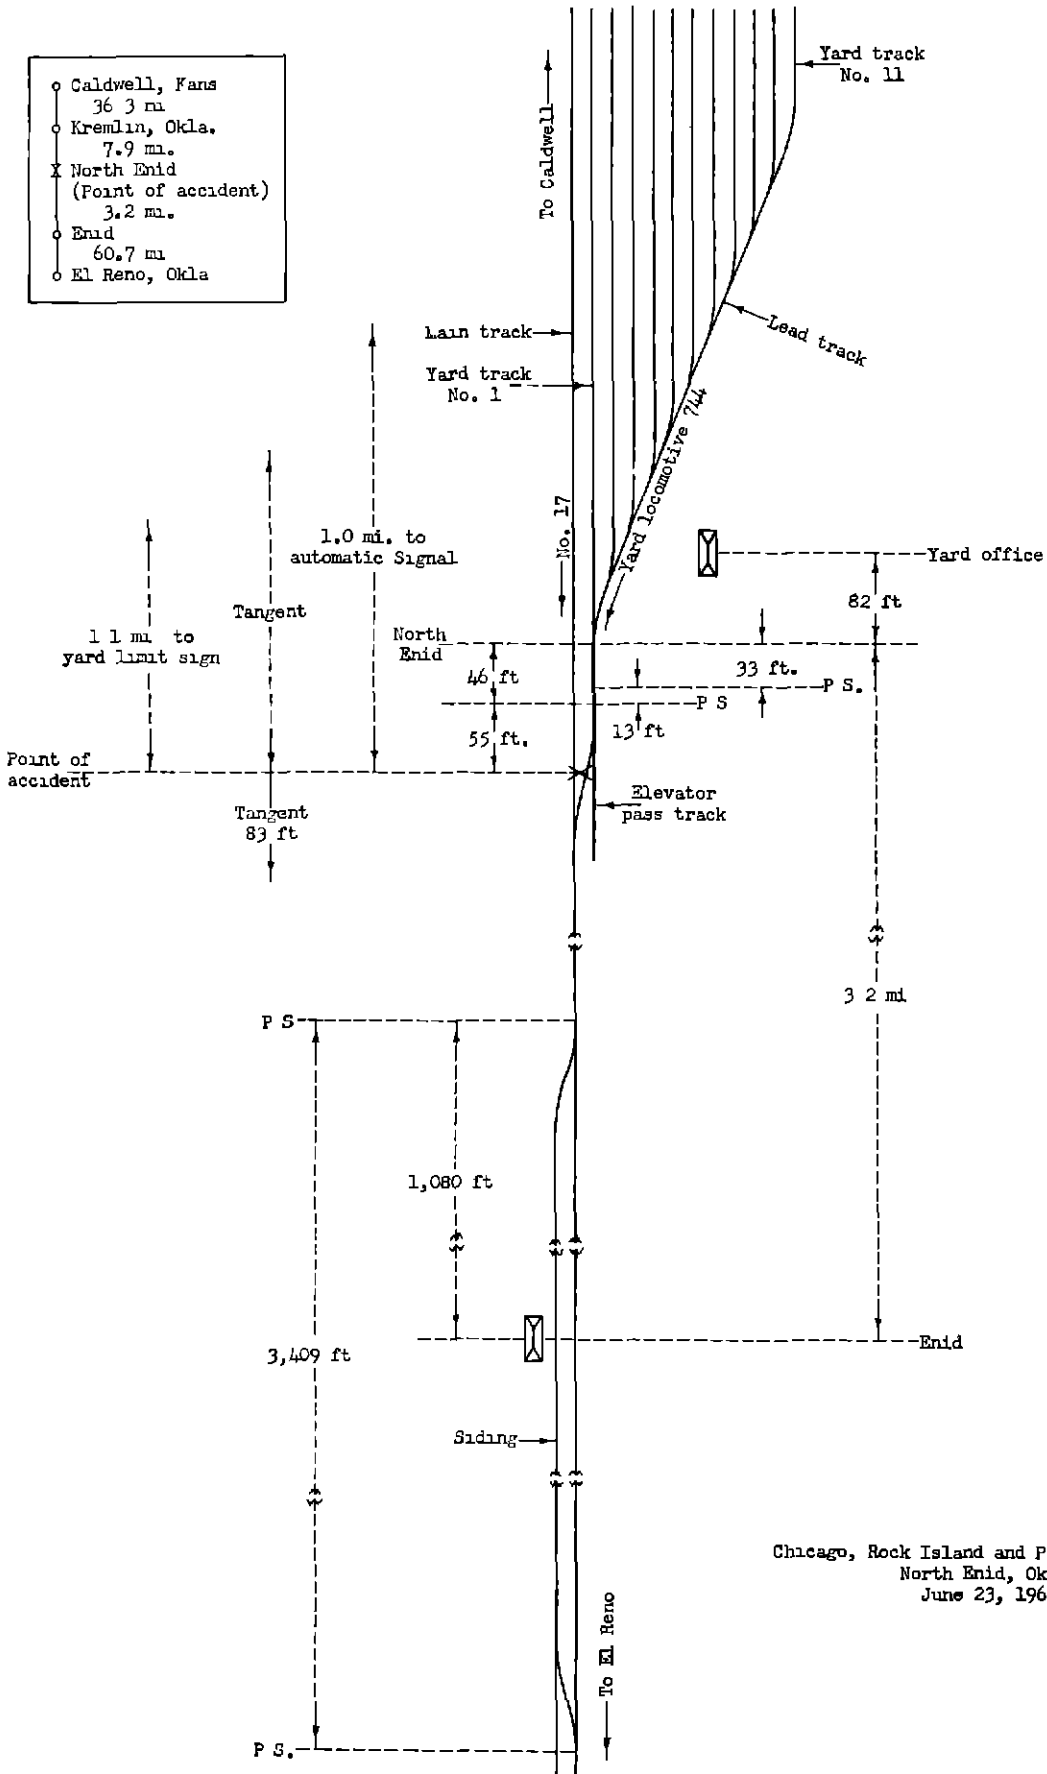
- Caldwell, Kans
36.3 mi.
- Kremlin, Okla.
7.9 mi.
- X North Enid
(Point of accident)
3.2 mi.
- Enid
60.7 mi
- El Reno, Okla

Chicago, Rock Island and Pacific Railroad
 North Enid, Okla.
 June 23, 1960

Location of Accident and Method of Operation

The accident occurred within yard limits at the fouling point of the main track and the crossover at North Enid, 55 feet south of the north switch of the crossover. From the north the main track is tangent for a considerable distance north of the point of accident and 83 feet southward. The grade for southbound trains in the vicinity of the point of accident is 0.30 percent descending.
