**RAILROAD ACCIDENT INVESTIGATION**

**Report No 3830**

CHICAGO, ROCK ISLAND AND PACIFIC RAILROAD COMPANY

JANUARY 16, 1959

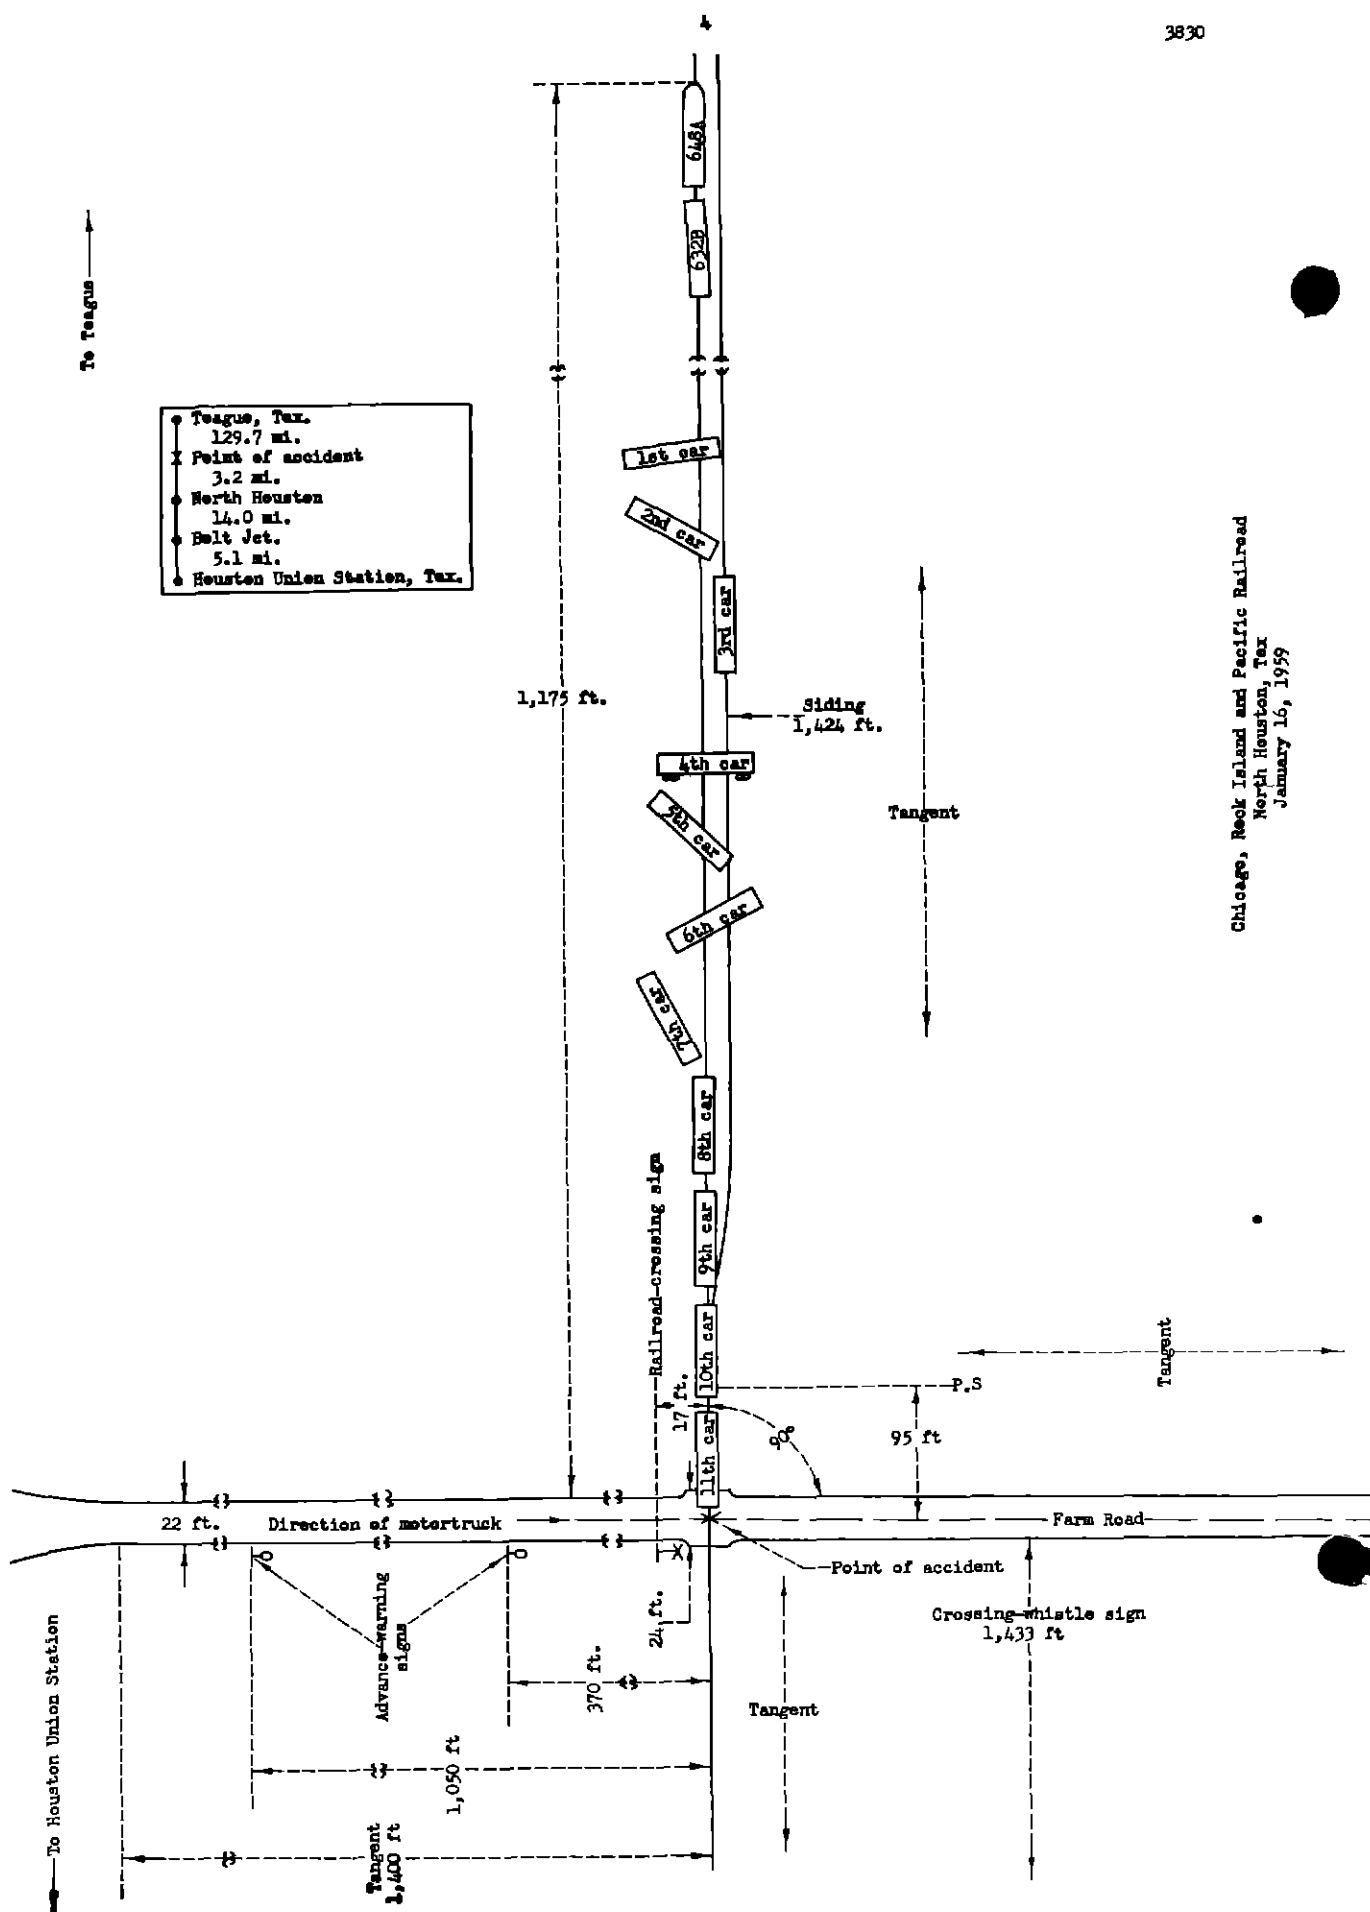
Chicago, Rock Island and Pacific Railroad  
 North Houston, Tex  
 January 16, 1959

equipment of No 508 stopped in various positions on or near the track structure as shown in the sketch of this report. Four freight cars standing on the siding north of the crossing were struck by equipment of No 508 and were derailed. The diesel-electric units, the 4th to 9th cars, inclusive, of No 508, and 3 of the freight cars were heavily damaged. The 1st to 3rd cars, inclusive, of No 508, and a freight car, were slightly damaged.

The tractor and the semi-trailer stopped in the northwest angle of the intersection. The tractor was separated from the semi-trailer and was destroyed. The semi-trailer was heavily damaged.
