RAILROAD ACCIDENT INVESTIGATION

Report No 3780

CHICAGO, ROCK ISLAND AND PACIFIC RAILROAD COMPANY

PEABODY, KAN

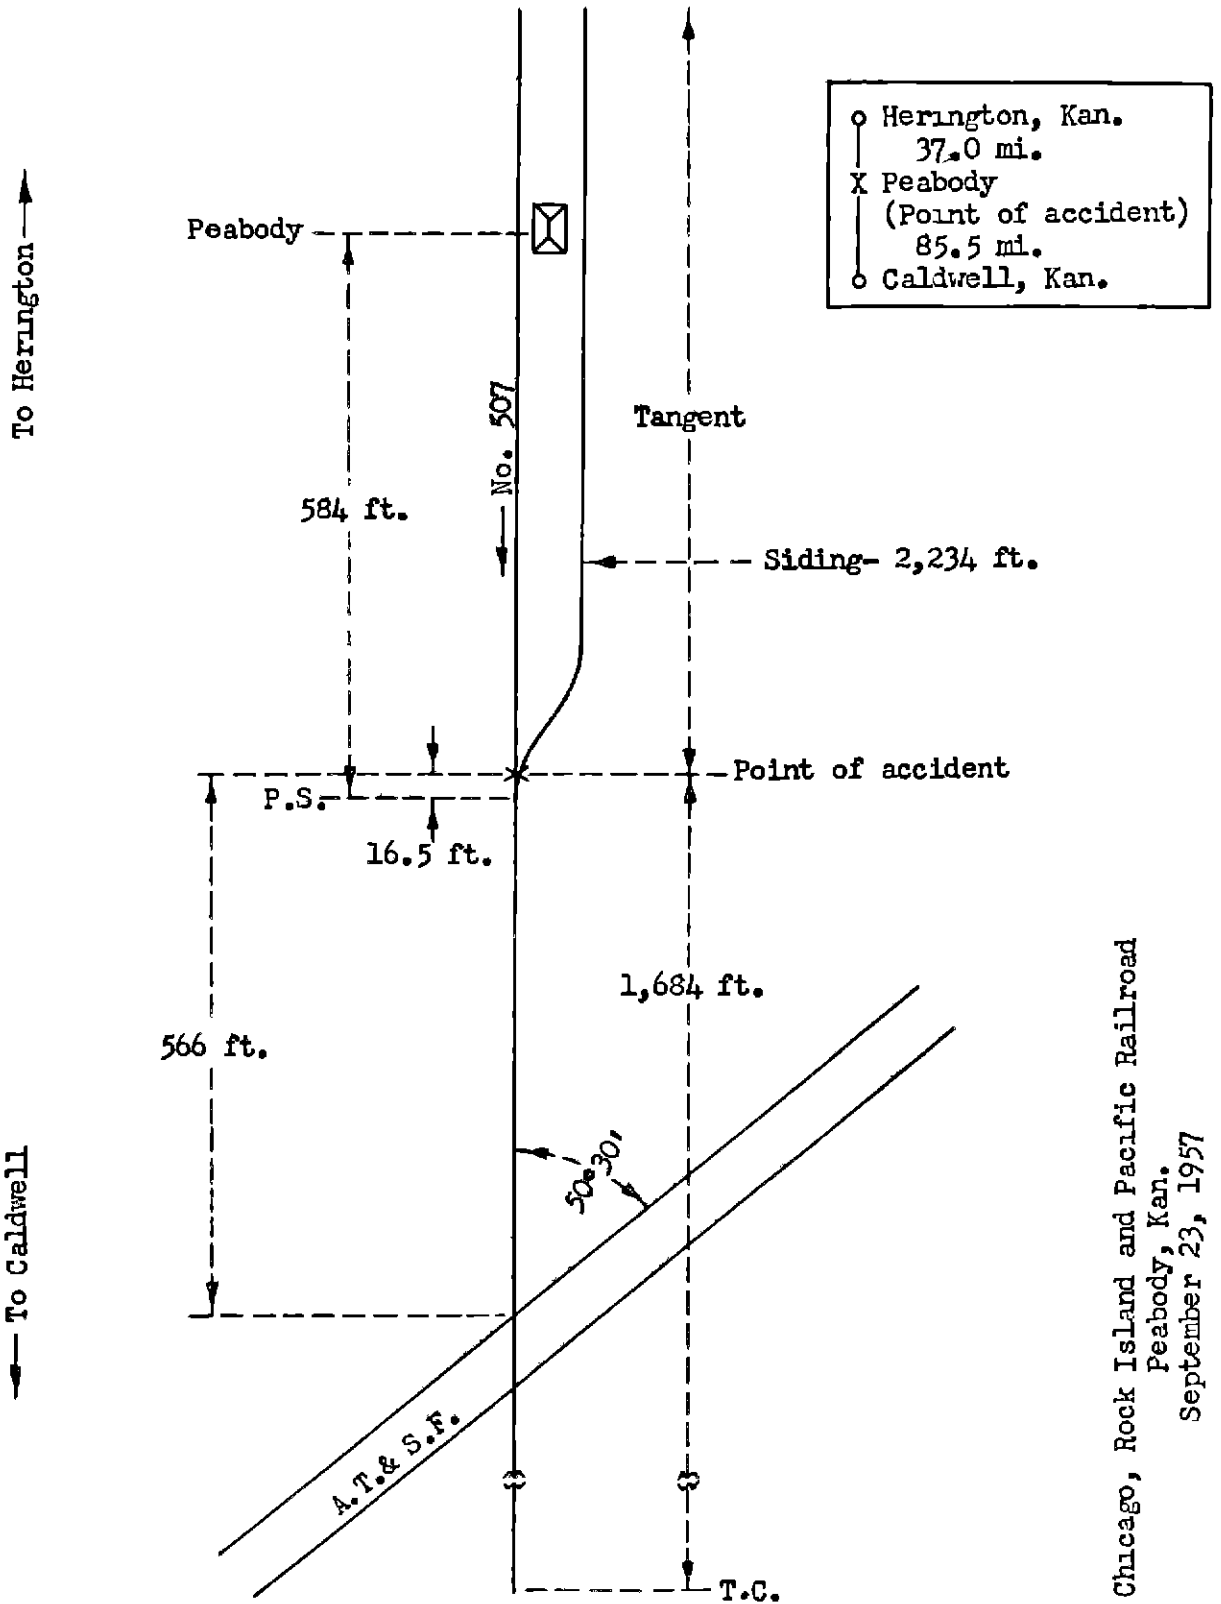
Chicago, Rock Island and Pacific Railroad
 Peabody, Kan.
 September 23, 1957

Location of Accident and Method of Operation
