RAILROAD ACCIDENT INVESTIGATION.

REPORT NO. 4168 LIBRARY

CHICAGO, ROCK ISLAND AND PACIFIC RAILROAD COMPANY

MARCH 25, 1970

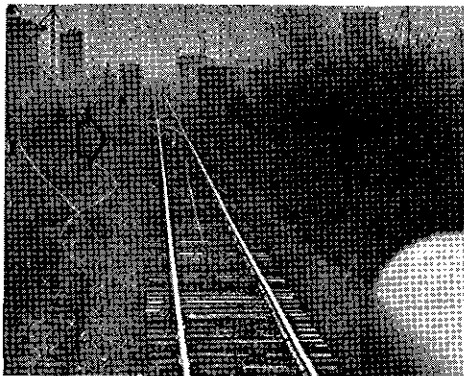
A circular non-reflectorized target, approximately 15 inches in diameter, was attached to the top of the switch stand. It was displayed when the switch was in reverse position, lined for movement from the main track to the siding or vice versa The switch stand had no lamp See photo below for west siding-switch, in reverse position, with switch target displayed

West siding-switch at Union, from distance of 310 feet.

At the time of the collision, the switch stand for the west switch of the siding at Union had neither a switch lamp nor a reflectorized target. This condition was brought to the attention of the Missouri Public Service Commission. Two days after the accident, the State agency initiated action to ensure the CRI&P's compliance with the order of September 10, 1968.

8 The absence of a switch lamp or a reflectorized target on the switch stand for the west siding-switch at Union appears to have been a causal factor in the accident. Had such lamp or target been provided, there is a possibility the engineer of No. 74 would have been alerted to the fact that the switch was not properly lined in sufficient time to avert the collision.

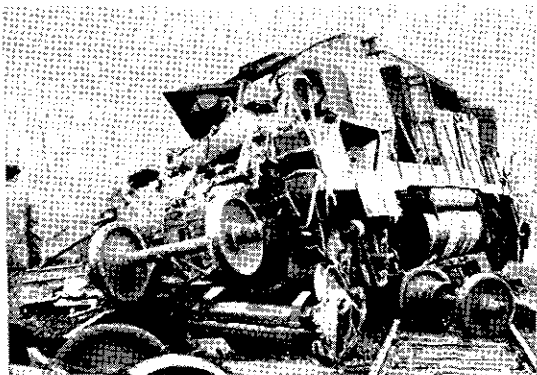
This train stopped with the front end 40 feet east of the collision point. Both trucks of the first diesel-electric unit derailed. This unit stopped upright with its rear truck on the siding structure, and with the front end on the north side of the main track structure and against the overturned caboose of the preceding train. Its control compartment was demolished by the caboose (see photo below) and other appurtenances were heavily damaged. The second unit was slightly damaged.

Leading, or control compartment, end of first locomotive unit of No. 74.

9 The incident at Union was another slow-speed collision resulting in fatal injury to a crew member in the control compartment at the front of a road-switcher type diesel-electric unit, due to a struck caboose or other car overriding the underframe of the unit and telescoping the

control compartment The aforesaid fatal injury and casualties from similar slow-speed collisions investigated by the FRA appear to have been caused by control compartments lacking the structural strength to withstand impacts of overriding equipment, and/or being insufficiently protected by structural components of that part of diesel-electric units in front of the control compartments
