INTERSTATE COMMERCE COMMISSION

Ex Parte No. 183

ACCIDENT NEAR UTICA, ILL.

Accident near Utica, Ill., on July 7, 1951, caused by a defective spring-rail-frog assembly.

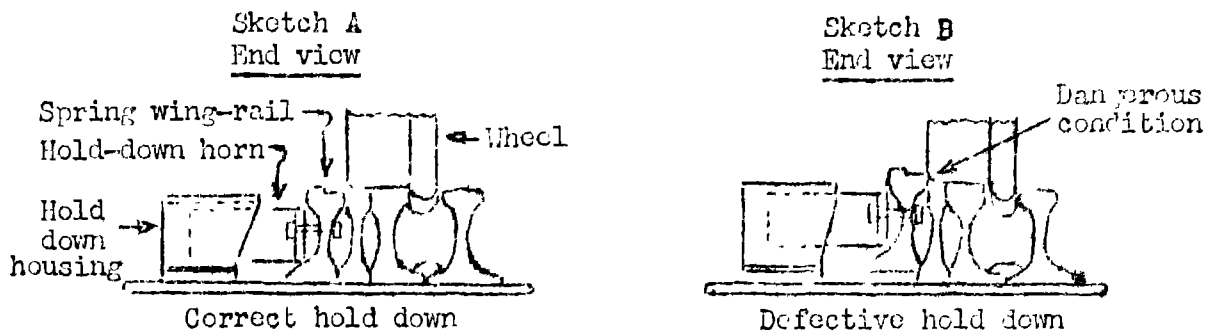
Examination of the frog assembly disclosed that at a point in the channeling of the spring wing-rail where the rim of a wheel moving in a trailing direction on the main track normally would first pass over the inside of the rail, the top of the rail was battered in a manner which indicated that it had been struck by wheels during a considerable period of time. The battering continued westward on top of the rail and parallel to the main track and increased in depth toward the inside of the rail until at a point opposite the spring housing it was $3/4$ inch deep. At a point between the spring housing and the point of frog, the inside of the spring wing-rail was marked throughout a distance of about $1/2$ inch from the top of the rail. This mark continued westward on the gage side of the rail a distance of about 9 feet. The surface of the mark was smooth and indicated a heavy rubbing action which diminished in intensity west of the point of frog. The welds on the flanges of the west hold-down housing were broken, and the heads of both bolts had been pulled through the holes in the base plate. The fractures of the welds were worn smooth which indicated that they had been broken for some time. The weld on the west flange of the east hold-down housing was recently broken, and the bolt was missing from this flange. The weld on the east flange was cracked, but the bolt was in place. The east leg of the east

The worn condition of the top of the spring wing-rail indicated that the top of the rail had been rising sufficiently above the frog point-rails to come in contact with the rims of wheels. Sketch A below illustrates the correct position of the spring wing-rail when the channeling is below the tops of the frog point-rails. Sketch B illustrates a defective condition of the frog assembly when the spring wing-rail is raised sufficiently to permit a wheel rim to engage the inside of the rail.

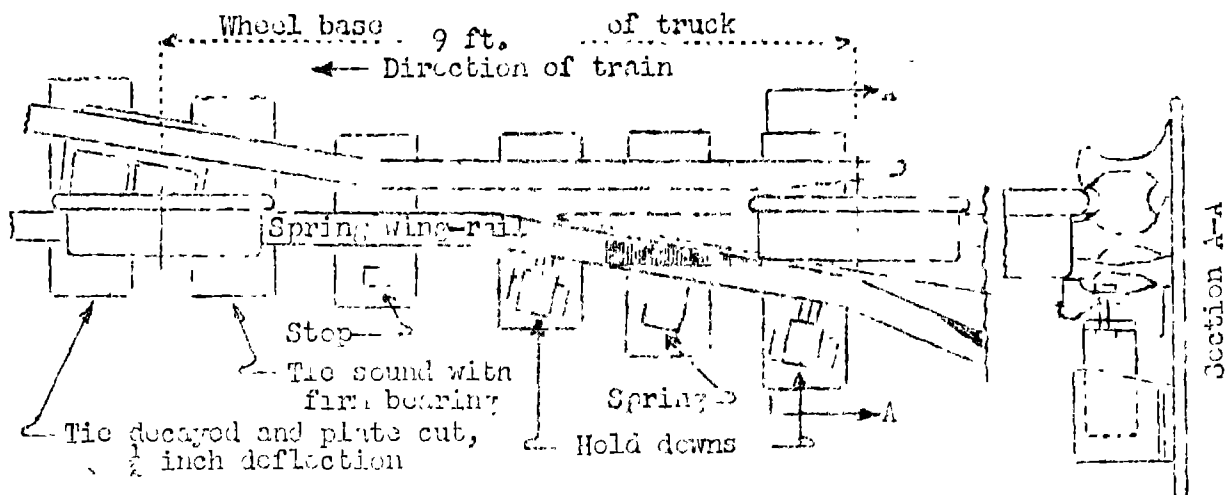
wing-rail and the worn location of the rail was approximately 9 feet. When the Diesel-electric units of Second 505 passed over the frog there was sufficient deflection at the leaving end of the spring wing-rail, combined with excessive vertical clearance in the east hold-down and the defective condition of the west hold-down, to permit the flared end of the rail to rise high enough for the outer edge of the rim of the left rear wheel of the rear truck of the fourth Diesel-electric unit to engage the inside surface of the rail as shown in the following sketch.

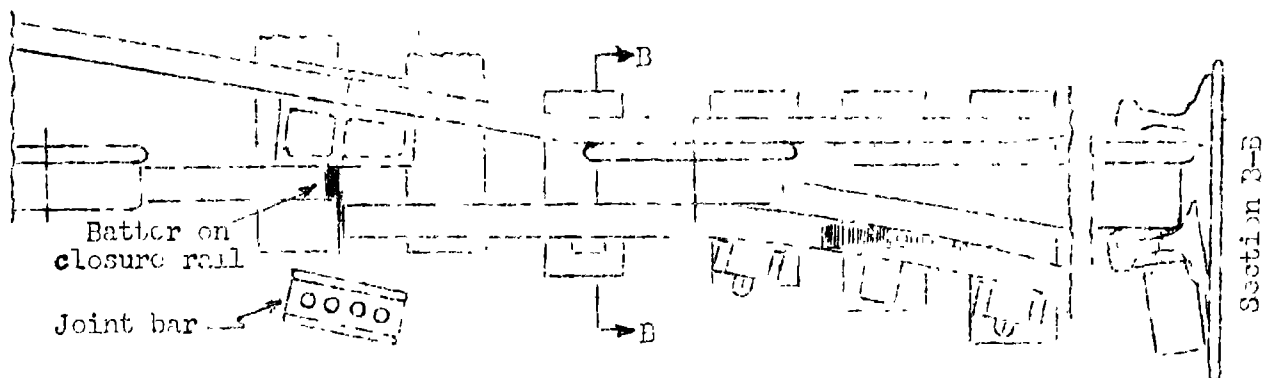
The rail was then forced outward and canted, and the wheel dropped inside the rail immediately west of the frog point as shown in the following sketch.
