ACCIDENT ON THE
CHICAGO, ROCK ISLAND & PACIFIC RAILWAY

ALTOONA, IOWA

AUGUST 3, 1938

INVESTIGATION NO. 2286

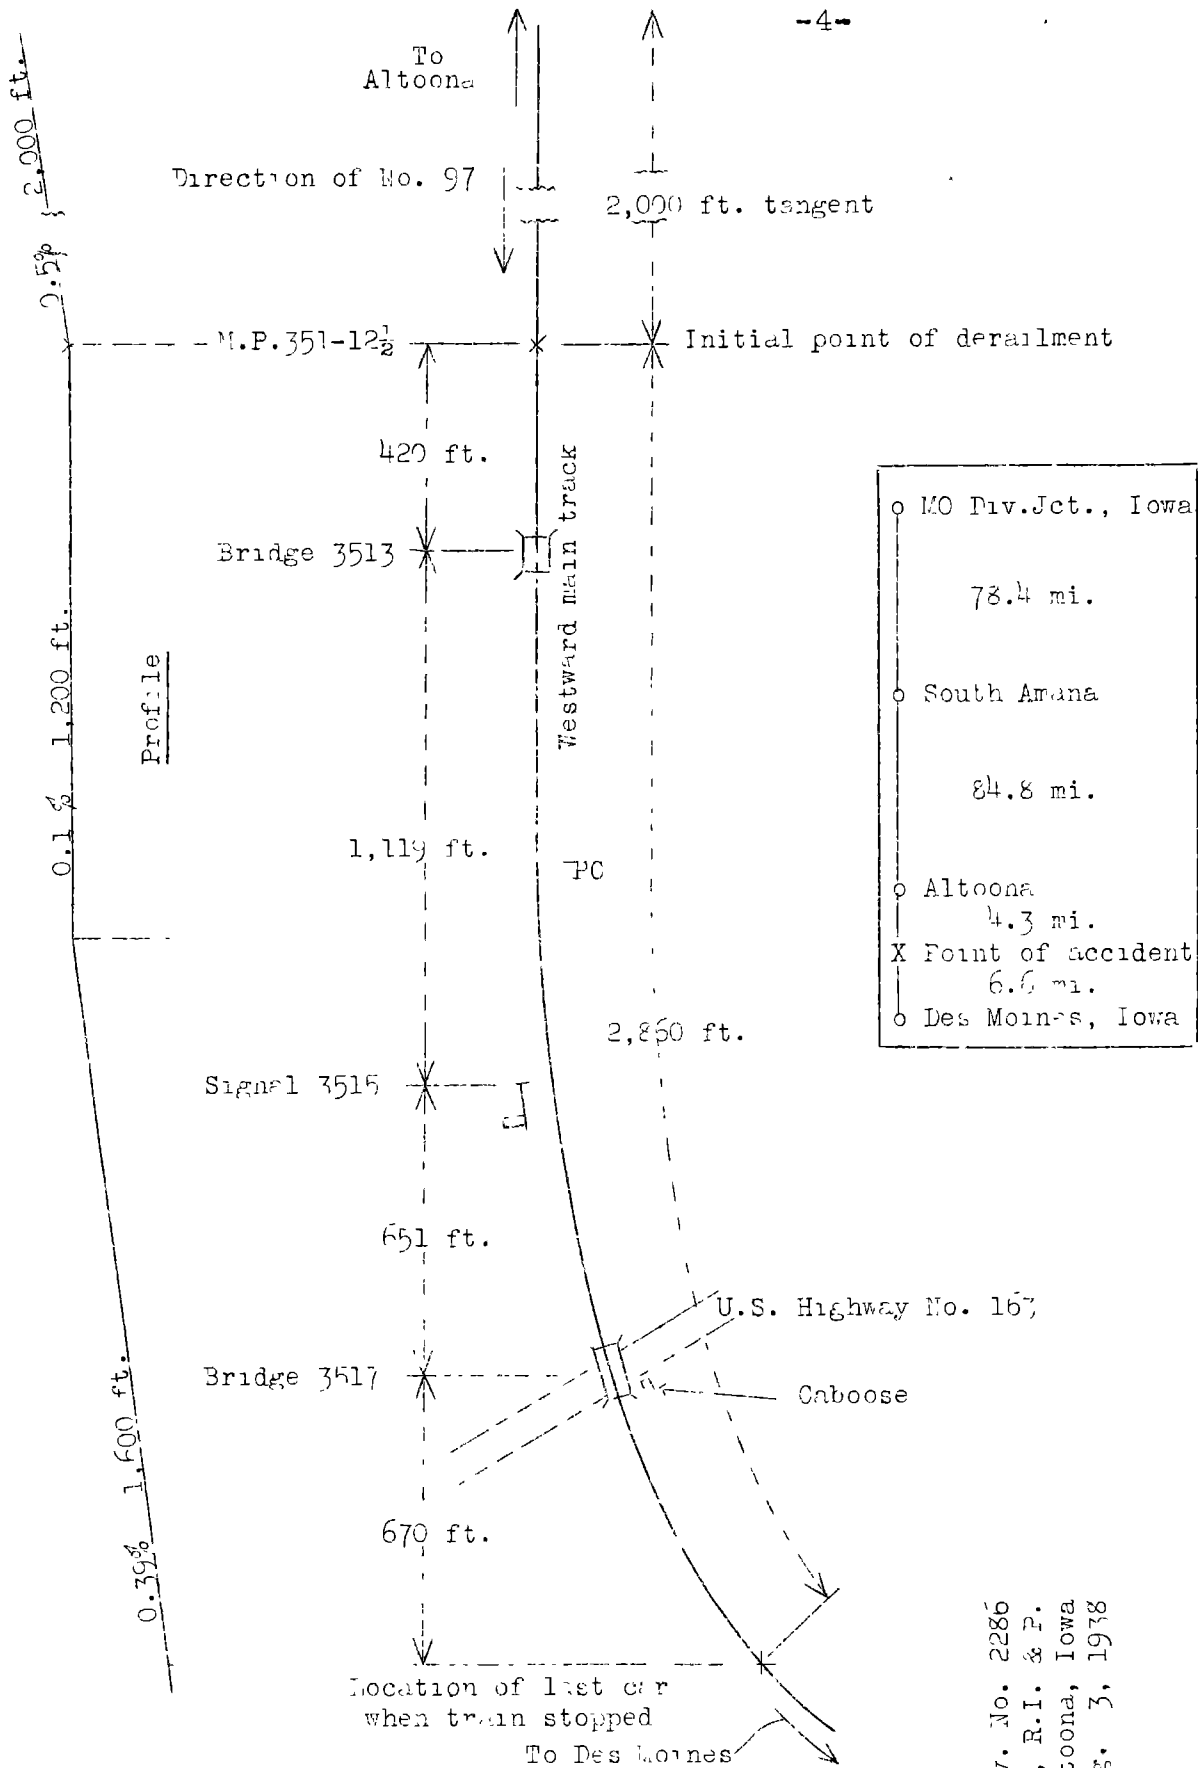
Inv. No. 2286
 C., R.I. & P.
 Altoona, Iowa
 Aug. 3, 1938

Bridge #3513, automatic block signal 3515 and Bridge #3517 are located 420 feet, 1,539 feet and 2,190 feet, respectively, west of the initial point of derailment. The final derailment occurred at Bridge #3517 which is composed of one 45-foot deck-plate girder span and a four-panel pile trestle at each end; this bridge is 18 feet above U. S. Highway No. 163.

No. 97 was proceeding at a speed of about 45 miles per hour when the rear car and the caboose became partially derailed. According to the evidence a west-bound passenger train had passed over this track about 30 minutes before No. 97 and the members of the crew who were on the head end of the latter train found nothing abnormal in the condition of the track; however, after the train involved in the accident had stopped, it was found that at a point about 2,800 feet to the rear of the train, within a distance of three or four rail lengths, the track at one point was out of alignment 9 inches to the south and at another point 6 inches to the north. After disconnecting the track to re-align it, the north and south rails overlapped 2-1/2 and 3 inches, respectively.

The accident occurred at a point where the gradient changed from 0.5 percent descending to 0.1 percent descending. Apparently the recently disturbed track and the high temperature created a condition making the track susceptible to creeping down the 0.5 percent descending grade; this condition combined with the force exerted as No. 97 passed in a westward direction caused the track to creep in the same direction to a point on the lesser grade where the track was more firmly anchored, resulting in a greater resistance to the creeping movement, which caused the track to deflect both to the north and to the south.

This accident was caused by kinked track.
