## INTERSTATE COMMERCE COMMISSION

REPORT OF THE DIRECTOR OF THE BUREAU OF SAFETY CONCERNING AN  
ACCIDENT ON THE CHICAGO, ROCK ISLAND & PACIFIC RAILWAY  
NEAR BLAND, MO., ON AUGUST 12, 1935.

October 15, 1935.

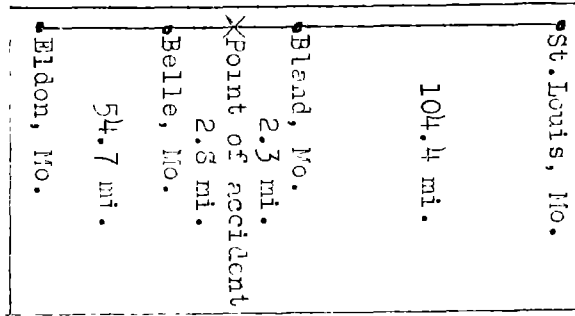
Inv. No. 2004  
Chicago, Rock Island & Pacific Ry.,  
Bland, Mo.  
August 12, 1935

X  
Point of  
accident
