INVESTIGATION NO. 2863
THE CHICAGO, ROCK ISLAND & PACIFIC
RAILWAY COMPANY

REPORT IN RE ACCIDENT

AT FLAGLER, COLO., ON

JANUARY 20, 1945

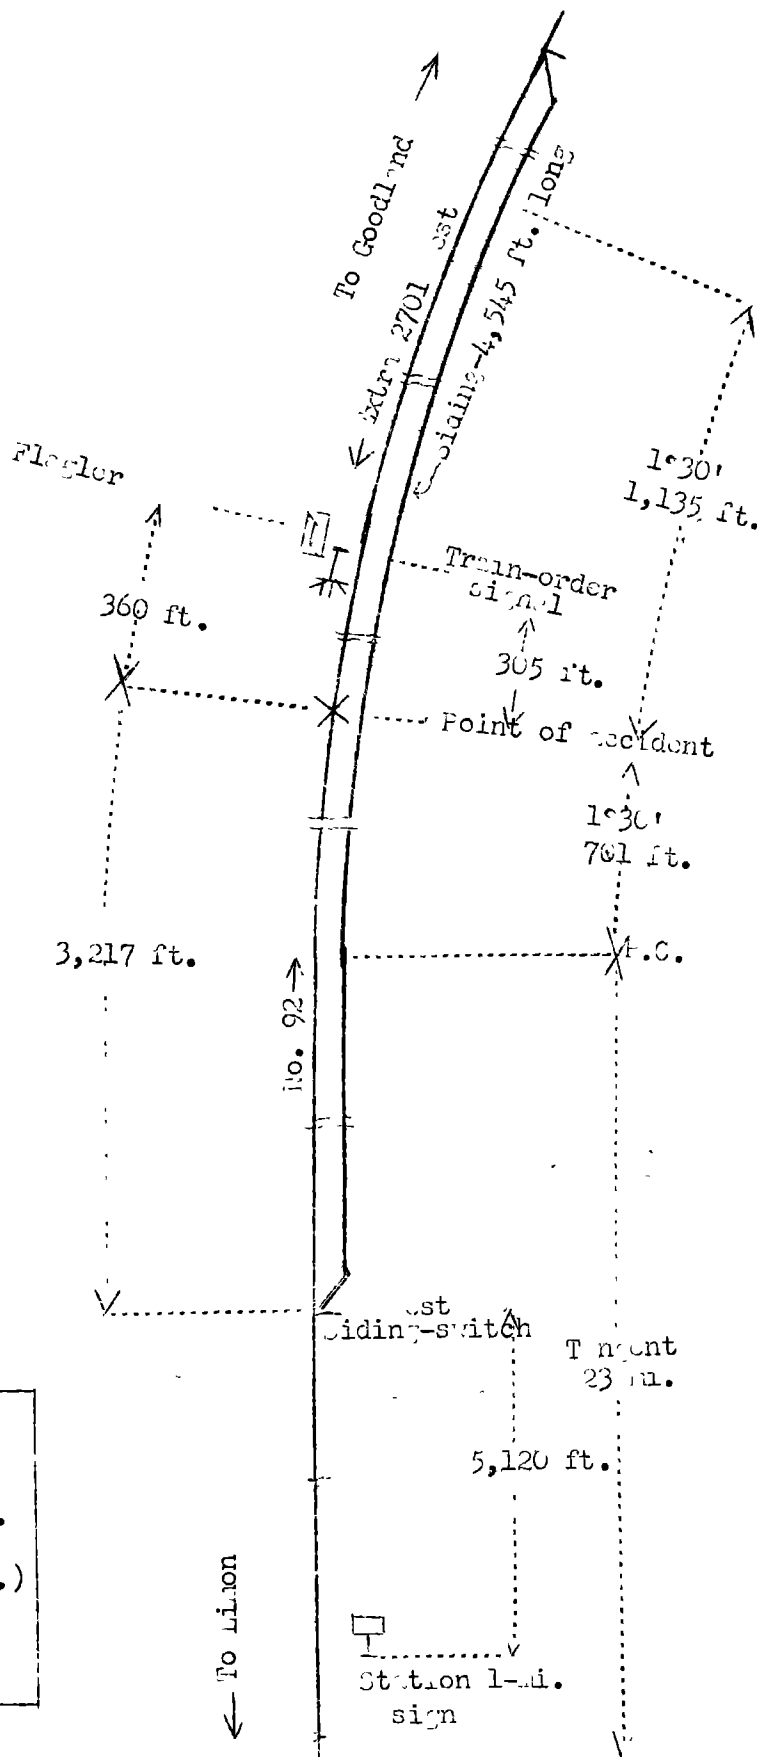
Inv. No. 2363
 Chicago, Rock Island & Pacific
 Railway
 Flagler, Colo.
 January 20, 1945

Location of Accident and Method of Operation

Extra 2701 West, consisting of engine 2701, 45 cars and a caboose, stopped on the main track at Flagler at 1:10 a. m., with the engine standing 3,217 feet east of the west siding-switch. About 17 minutes later the engine was struck by No. 92.

Extra 2701 West stopped on the main track at Flagler about 1:10 a. m., with the engine standing 305 feet west of the train-order signal and 3,217 feet east of the west siding-switch. All the surviving employees concerned understood that, under the rules, train order No. 282 required No. 92 to enter the siding at the west switch to clear for Extra 2701 West. About 17 minutes after Extra 2701 West stopped at Flagler the engine was struck by No. 92.
