ACCIDENT ON THE
CHICAGO, ROCK ISLAND & PACIFIC RAILWAY

FLORIS, IA

FEBRUARY 16, 1936

INVESTIGATION NO. 2044

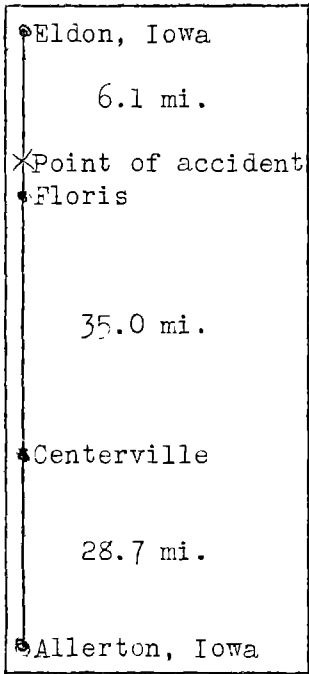
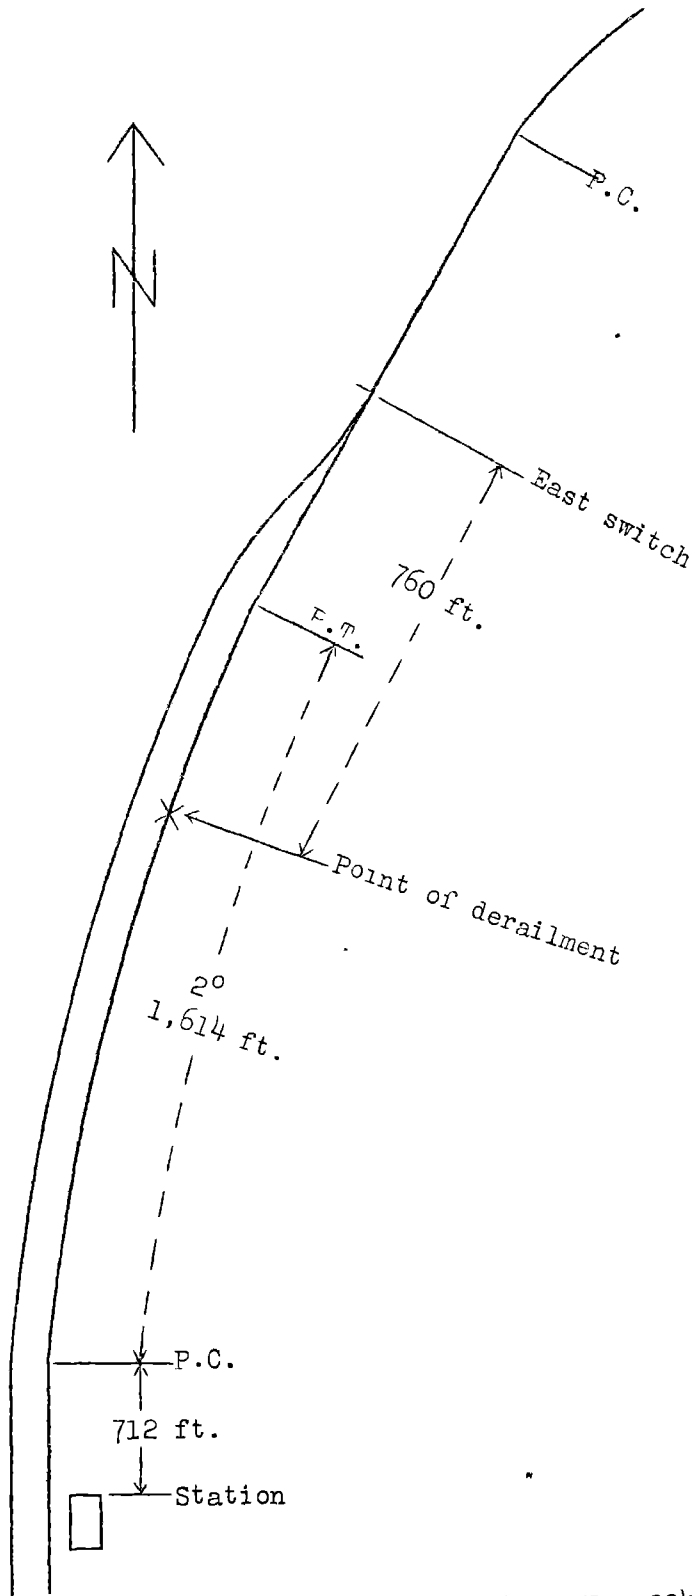
Inv. No. 2044
Chicago, Rock Island & Pacific Ry.
Floris, Iowa
Feb. 16, 1936

An inspection of the derailed equipment by the Commission's inspectors showed that the journal on the south side of the forward axle of the leading truck of R. I. gondola 185444 had been broken off, apparently due to being overheated. The stub of the journal was about 3 3/8 inches in length from the dust guard seat and 5 1/2 inches in diameter near the back fillet, but had been cut and ground down until it was conical in shape, tapering toward the outer end, and this reduced section at the end was somewhat ragged

in appearance, showing a distinct twist. The detached portion of this same journal was $5\frac{1}{4}$ inches in diameter, and was broken off approximately 6 inches from the collar, the break being somewhat irregular. The cross-section of the broken end disclosed a fracture extending between $1\frac{1}{2}$ and $1\frac{3}{8}$ inches inward from the surface of the journal toward the center; the remainder of the metal, especially near the center, indicated that this end of the journal had been torn and twisted off, the twist in the fibre of the metal corresponding with the central section of the stub end of the axle. The packing in the three other journal boxes of this same truck was of sufficient quantity and in good condition.
