INVESTIGATION NO. 3162  
CHICAGO; ROCK ISLAND AND PACIFIC  
RAILROAD COMPANY  
REPORT IN RE ACCIDENT  
AT IOWA CITY, IOWA, ON  
FEBRUARY 1, 1948

Railroad: Chicago, Rock Island and Pacific  
Date: February 1, 1948  
Location: Iowa City, Iowa  
Kind of accident: Rear-end collision  
Trains involved: Freight : Passenger  
Train numbers: Extra 5014 West : 7  
Engine numbers: 5014 : Diesel-electric  
units 635 and  
621  
Consists: 40 cars, caboose : 10 cars  
Estimated speeds: 10 m. p. h. : 20 m. p. h.  
Operation: Timetable, train orders and  
automatic block-signal system  
Tracks: Double; 1°30' curve; 0.33 percent  
descending grade westward  
Weather: Clear and dusk  
Time: 5:58 p. m.  
Casualties: 1 killed; 20 injured  
Cause: Freight train without authority  
backing into block occupied by  
following passenger train

Accident at Iowa City, Iowa, on February 1, 1948, caused  
by a freight train without authority backing into  
a block occupied by a following passenger train.

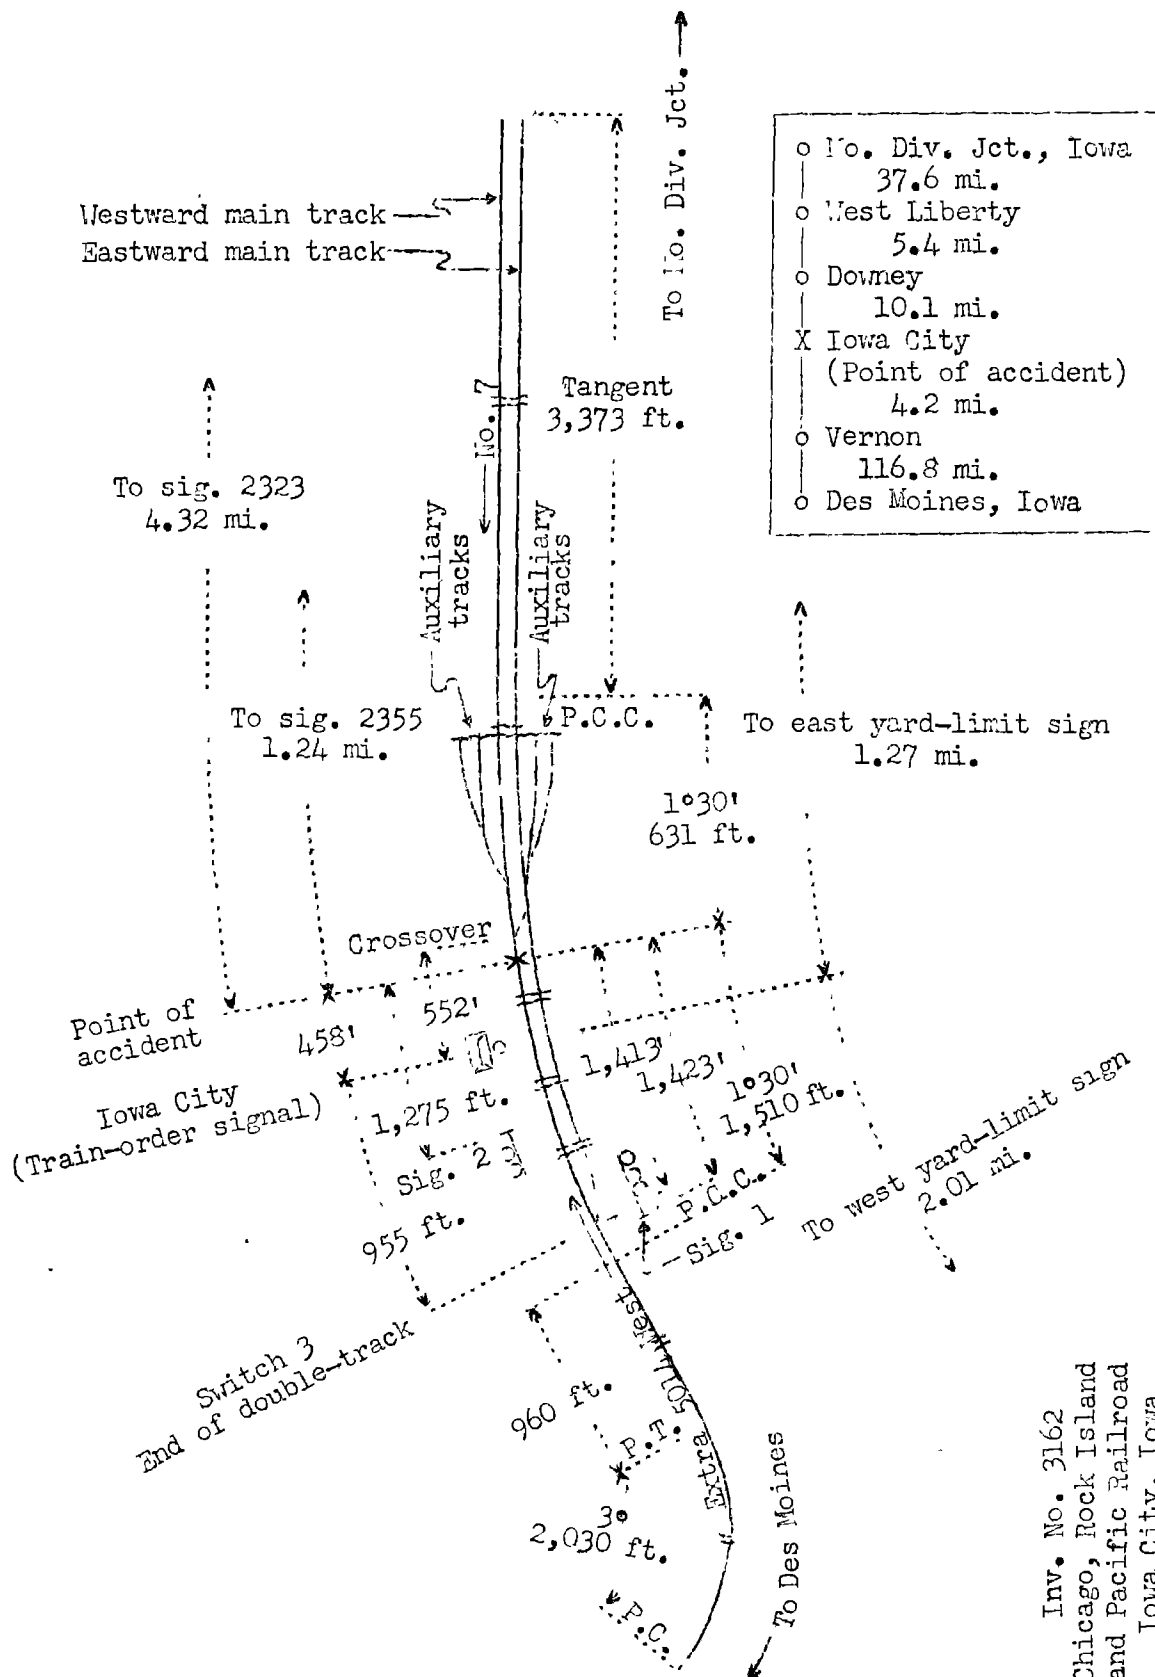
Inv. No. 3162  
Chicago, Rock Island  
and Pacific Railroad  
Iowa City, Iowa  
February 1, 1948

This accident occurred on that part of the Des Moines Division extending between Mo. Div. Jct., Davenport, and Des Moines, Iowa, 174.1 miles. Between Mo. Div. Jct. and Iowa City, 53.1 miles, this is a double-track line over which trains moving with the current of traffic are operated by timetable, train orders and an automatic block-signal system, and between Iowa City and Altoona, 110.1 miles west of Iowa City, a single-track line over which trains are operated by timetable, train orders and an automatic block-signal system. The switch at the west end of the double-track at Iowa City, designated as switch 3, is within yard and interlocking limits. Switch 3 is 955 feet west of the station, and is controlled from an interlocking machine in the station. A hand-operated trailing-point crossover 200 feet long connects the eastward and the westward main tracks. The west switch of this crossover is 552 feet east of the station. Between points 2,793 and 803 feet east of the station, auxiliary tracks parallel the main tracks on the north and the south. The accident occurred on the westward main track at a point 458 feet east of the station and 1,413 feet east of switch 3. From the east there are, in succession, a tangent 3,373 feet in length and a compound curve to the left, having a maximum curvature of  $1^{\circ}30'$ , 631 feet to the point of accident and 1,510 feet westward. From the west there are, in succession, a  $3^{\circ}$  curve to the left 2,030 feet in length, a tangent 960 feet and the curve on which the accident occurred. The grade is 0.33 percent descending westward.
