ACCIDENT ON THE  
CHICAGO, ROCK ISLAND & PACIFIC RAILWAY

JEFFERSON, OKLA.

DECEMBER 30, 1935

INVESTIGATION NO. 2029

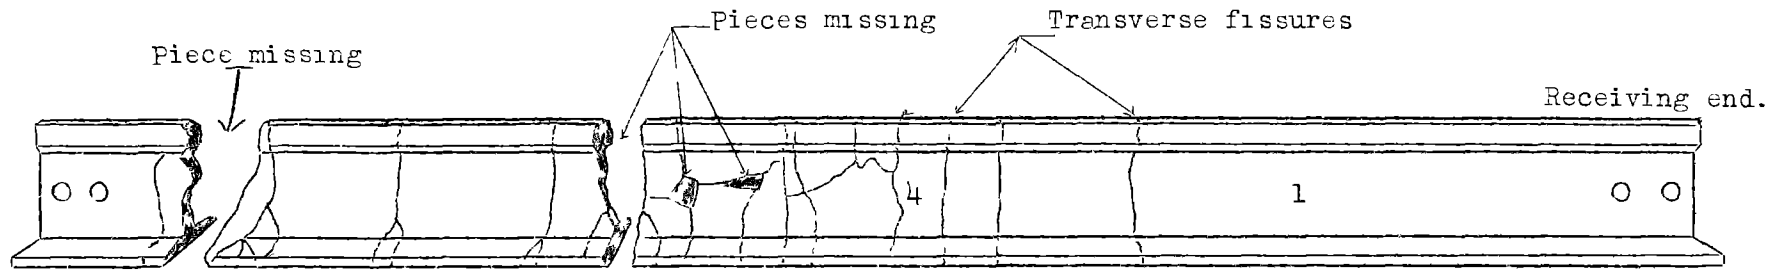
Illinois Steel Co. 9020 A.R.A. section - Rolled 1926 Heat #50588 "D Rail

The rail involved was in the left or south side of the track; it was a 90-pound rail, 39 feet in length, rolled in November, 1926, by the Illinois Steel Company at the Gary Plant,

heat No. 50588-5-D, ARA section 9020, and was laid in the track in 1927. The first break occurred 13 feet 1/2 inch from the receiving end and disclosed a transverse fissure covering an area of 80 percent of the head of the rail, extending to within 1/16 inch of the top surface; there also were smaller fissures at three other locations. The first marks on the ties were at a point 14 feet west of the first break, near the gauge side of the right rail, and on the outside of the left rail at a point 18 feet from the point of break; these marks continued diagonally across the track for a distance of approximately 66 feet, the right mark being entirely between the rails and ending near the inside of the left rail, while the left mark ended near the outside of the right rail of the passing track. There were no other wheel marks on the ties, although there were flange marks on the various pieces of broken rail, while the track itself was torn up to such an extent as to make the identification of marks exceedingly difficult. There were no marks of any kind east of the broken rail.

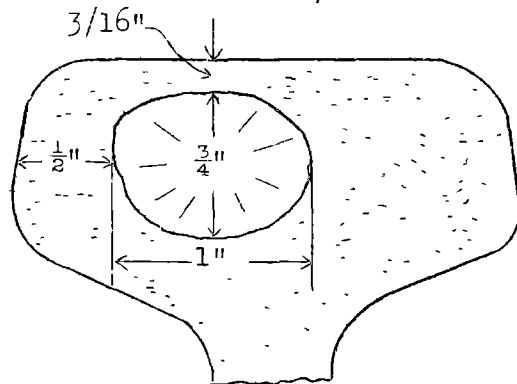
Receiving end piece # 4

Examination of the track after the accident disclosed that the rail had been broken into numerous pieces, approximately 30 of which were recovered, and that four of the fractures were due to the presence of transverse fissures. The largest of these fissures was at the first break, approximately 13 feet from the receiving end of the rail, covering an area of about 80 percent of the head and extending to a point 1/16 inch from the top surface of the rail; another fissure covered an area of about 20 percent of the head of the rail, while the others covered about 10 percent.

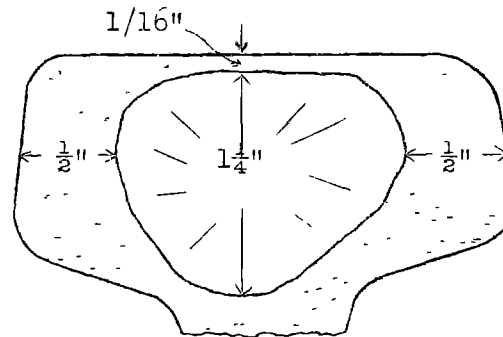
Leaving end piece # 1

Section Foreman Schadd, in charge of the section on which this accident occurred, stated that he arrived at the scene about 5:15 a.m., and on examining the track he found that the first break in the rail was at the leaving end of a 13-foot section, this fracture disclosing a transverse fissure which covered about 75 percent of the area of the head. The balance of the rail was broken into pieces varying in length from 2 inches to 4 feet, which in his opinion was the result of the accident; there were no marks of any kind on the track east of the first break. Section Foreman Schadd stated that he worked on this track on December 26, tightening bolts and inspecting the rails as he went along, and last patrolled the track prior to the accident on December 28, at which time he noticed nothing wrong.

Roadmaster Sturdevant stated that on his arrival at the scene of the accident he found that in addition to the transverse fissure in the leaving end of the 13-foot section, which was the receiving end of the rail, there also was a transverse fissure at another point, covering an area of about 20 percent of the head of the rail. The initial fissure, in his opinion, covered an area of from 80 to 85 percent; it had not reached the outer surface of the rail, and therefore could not have been detected by visual inspection. The rail was broken into 31 or more pieces, with several pieces missing. There were no marks on the track east of the broken rail and it was his opinion that the rail failed under the train. Roadmaster Sturdevant stated that about once each year a Sperry detector car is operated over this track, and that the last trip prior to the accident was on March 22, 1935, at which time no defects were found in the immediate vicinity of the point of accident, although a transverse fissure was found at a point about 9/10 mile east thereof and another one about 10 miles east thereof. The track had been worked on at various times during the months between April and September and was in good condition. On November 11, a split web was found in a 110-pound rail, and Roadmaster Sturdevant stated that he immediately told the section foreman to reissue the instructions to watch the rails at all times for defects, as at that time they expected to tighten bolts and could examine each rail as they went along.
