REPORT NO. 3328
CHICAGO, ROCK ISLAND AND PACIFIC
RAILROAD COMPANY
IN RE ACCIDENT
NEAR KREMLIN, OKLA., ON
MAY 9, 1950

Accident near Kremlin, Okla., on May 9, 1950, caused by
the sinking of a fill.

Report No. 3328
 Chicago, Rock Island
 and Pacific Railroad
 Kremlin, Okla.
 May 9, 1950

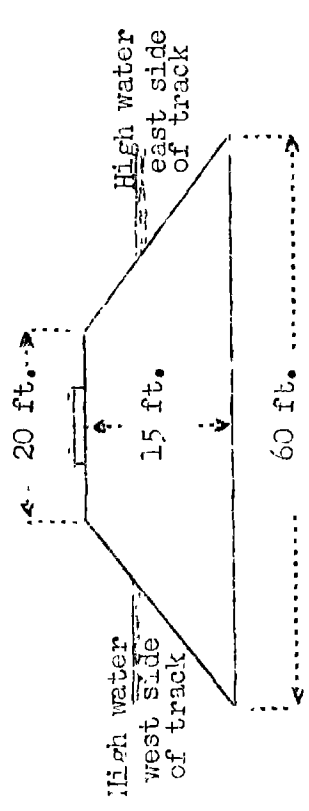
Cross section of fill at point of accident

Examination after the accident disclosed that a section of the fill about 50 feet in length had sunk. At the point of accident the fill had sunk about 10 feet throughout its full width. There was no displaced material at the base of the fill, and there was no indication that any portion of the fill had washed away. Except at the location where the thirty-eighth to the forty-third cars, inclusive, were derailed, the track south of the point of accident was in normal alignment and surface. There was no indication of dragging equipment.

The fill on which the accident occurred was constructed in 1889. Borings made after the accident occurred disclosed that a bed of quick sand, 5 to 7 feet thick, underlay the fill at a depth of about 17 feet. Apparently the quick sand underlying the fill was displaced by the material of the fill.
