REPORT OF THE DIRECTOR

ACCIDENT ON THE

CHICAGO, ROCK ISLAND & PACIFIC RAILWAY

INVESTIGATION NO. 2142

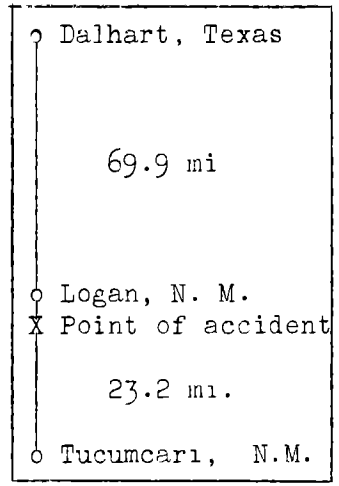
Inv. No. 2142
C., R. I. & P. Ry.
Logan, New Mexico
February 9, 1937

POINT OF ACCIDENT
