ACCIDENT OF THE
CHICAGO, ROCK ISLAND & PACIFIC RAILWAY

OAK FOREST, ILL.

APRIL 20, 1938.

INVESTIGATION NO. 2269

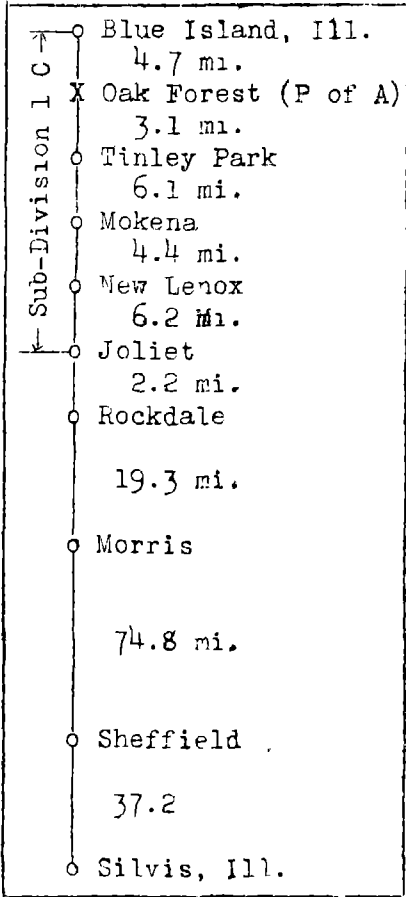
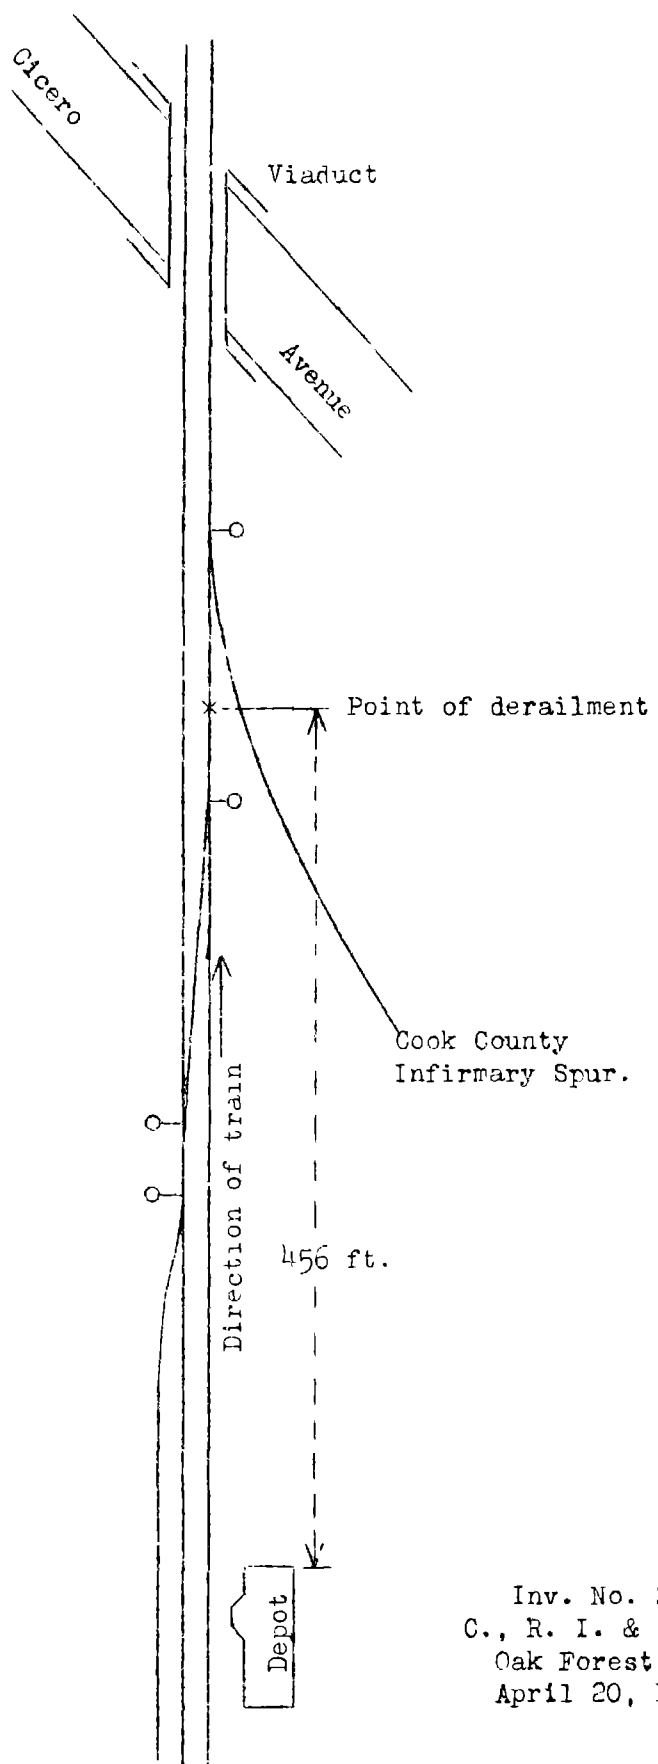
Inv. No. 2269
 C., R. I. & P. Ry.,
 Oak Forest, Ill.,
 April 20, 1938

The engine and first six cars were not derailed. The rear truck of the seventh car and the following 19 cars were derailed. The seventh to tenth cars, inclusive, stopped east of Cicero Avenue; the next 11 cars went over the viaduct and 9 of them were piled up on the street; the following 5 cars were derailed west of the viaduct. The L-3 journal of the seventh car in the train, R.I. 157356, was broken off; this journal was on the right side of the train.
