ACCIDENT ON THE
CHICAGO, SPRINGFIELD & ST. LOUIS RAILWAY

SPRINGFIELD, ILL.

JANUARY 11, 1937

INVESTIGATION NO. 2137

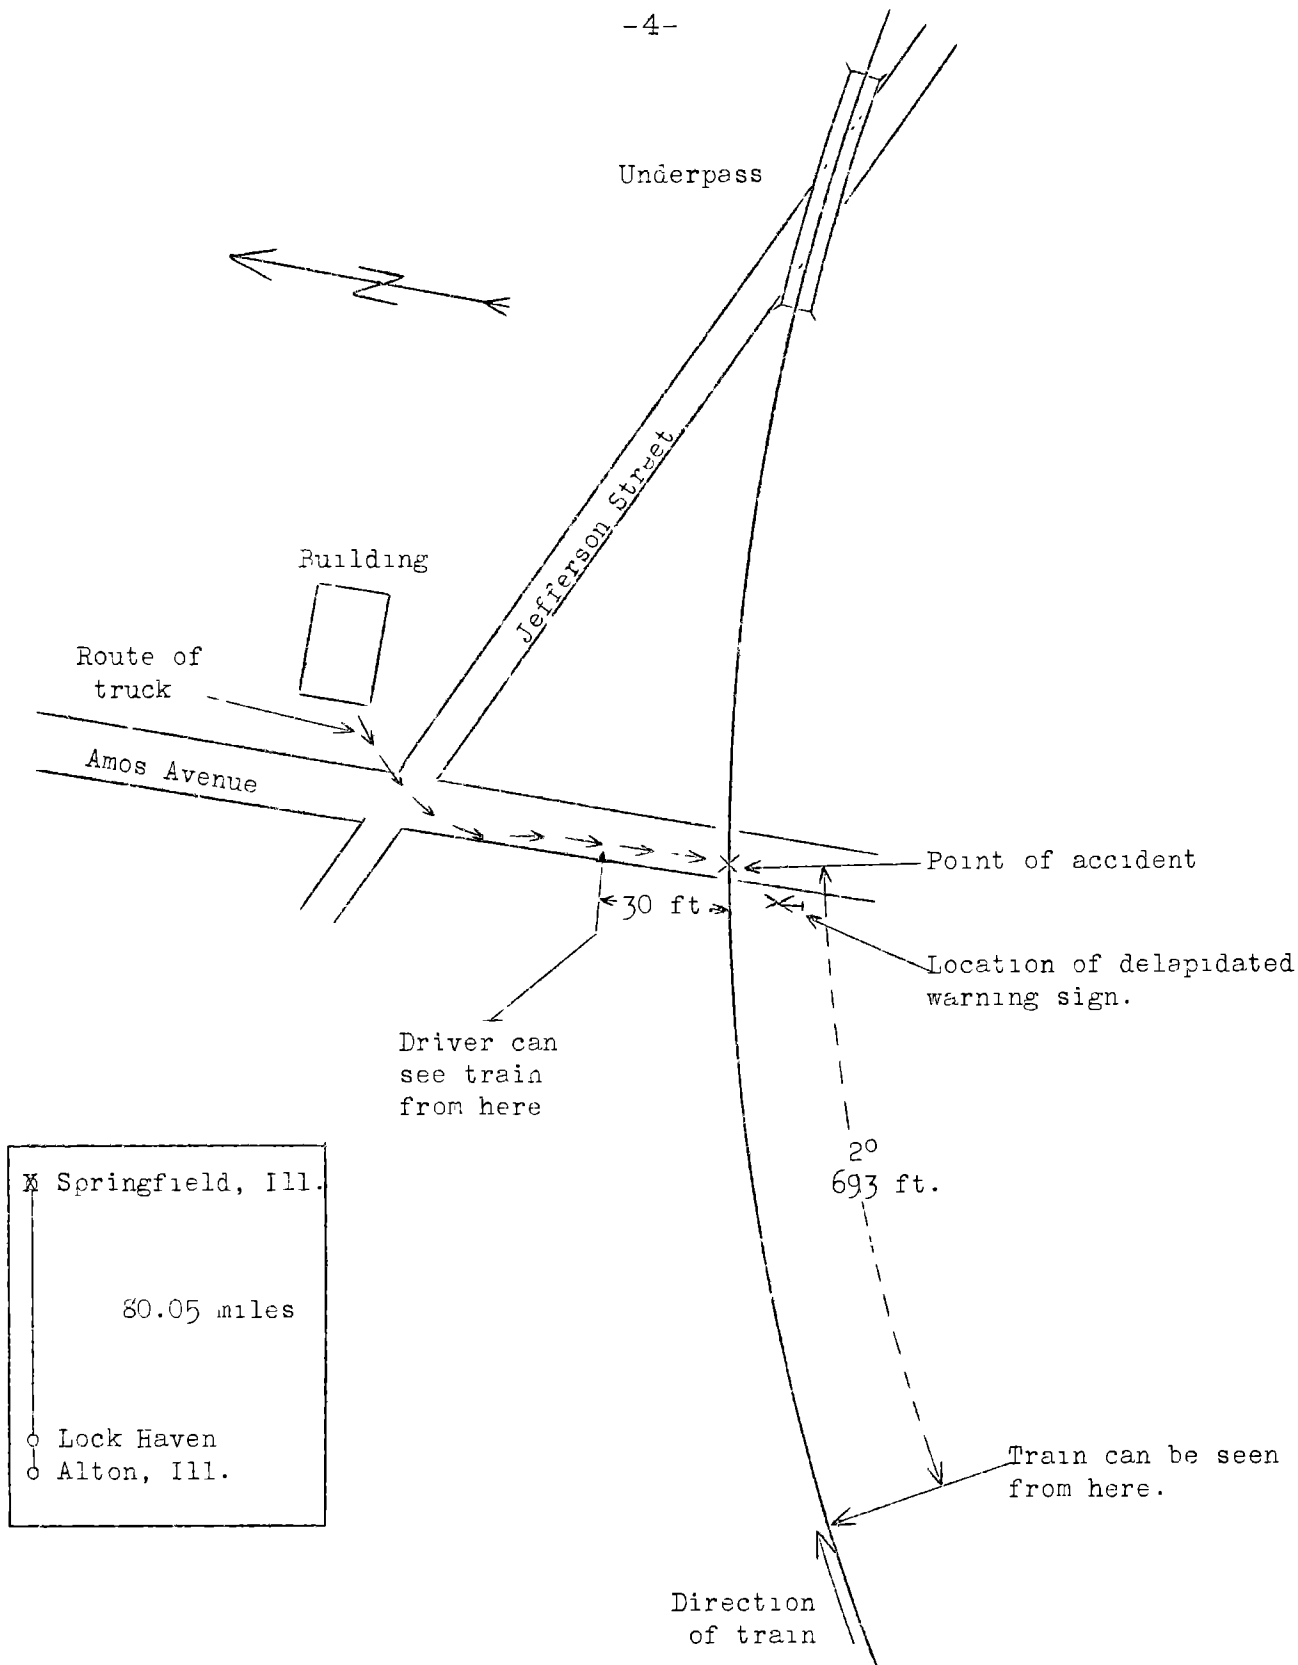
Inv No. 217
 Chicago, Springfield & St. Louis Ry.
 Springfield, Ill.
 January 11, 1937

The view of the crossing to be had by the engineman of a north-bound passenger motor car similar to the one involved in this accident is restricted by the curvature of the track to a distance of 693 feet, while such a north-bound train can be seen a distance of 726 feet by the driver of an east-bound vehicle from a point on the highway 85 feet west of the west rail. After the driver has reached a point 30 feet from the track he can see the train clearly for a distance of 693

feet south of the crossing and this view continues until he reaches the crossing.

A crossing-warning sign of the cross-bar type is located in the southeast angle of the intersection at a point 18 feet from the center of the track, on the edge of the highway. At the time of the accident one of the cross bars was missing and the words "RAIL ROAD" which appeared on the remaining bar were scarcely visible; in fact, it is doubtful whether one not familiar with the conditions would know that this was intended as a warning sign.

It is recommended that immediate steps be taken to erect suitable crossing warning signs on each side of the track and to maintain them in proper condition to serve the purpose for which intended.
