INVESTIGATION NO. 3115  
CHICAGO, SAINT PAUL, MINNEAPOLIS AND OMAHA  
RAILWAY COMPANY

REPORT IN RE ACCIDENT  
NEAR HUBBARD, NEBR., ON

JULY 8, 1947

Accident near Hubbard, Nebr., on July 8, 1947, caused  
by a broken rail.

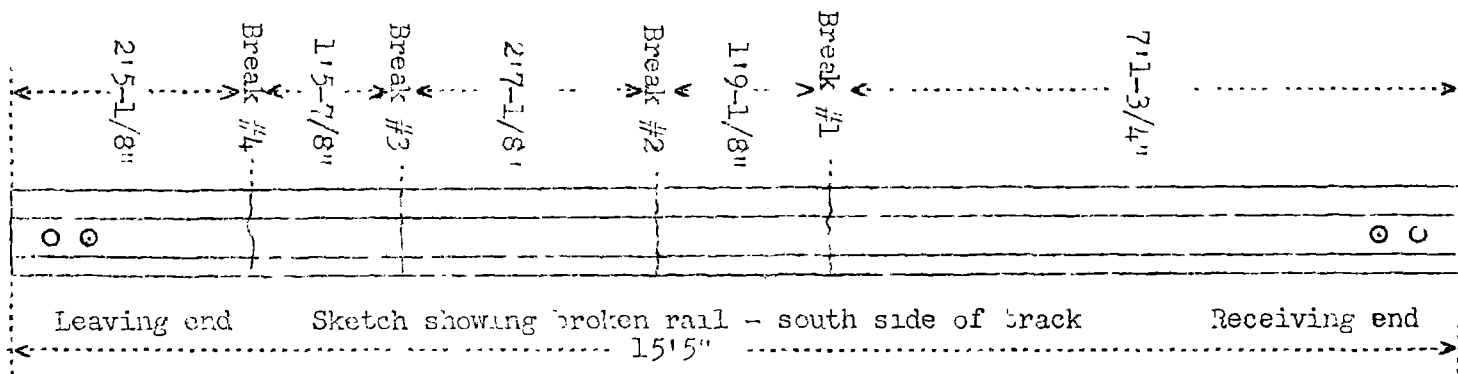
Sketch of end views showing locations of transverse fissures

Soon after the accident occurred a broken rail was found on the south side of the track. This rail was broken at four locations. Break No. 1 occurred 7 feet 1-3/4 inches west of the receiving end of the rail, and breaks Nos. 2, 3 and 4 occurred at points, respectively, 1 foot 9-1/8 inches, 4 feet 4-1/4 inches and 5 feet 10-1/8 inches west of break No. 1. At breaks Nos. 1, 2, 3 and 4, there were transverse fissures which covered, respectively, 25 percent, 80 percent, 80 percent and 5 percent of the cross-sectional area of the head of the rail. None of these fissures extended to the surface of the rail. Break No. 2 occurred between two ties, and the other three breaks occurred over ties. The receiving ends at breaks Nos. 2

and 4 were considerably battered. The piece of rail immediately west of break No. 4 remained attached to the adjoining rail. Apparently the failure of the rail at breaks Nos. 2 and 4 occurred when the front portion of the train passed over it, then the other breaks occurred, and the broken pieces became displaced.
