INVESTIGATION NO. 3171
CHICAGO, SAINT PAUL, MINNEAPOLIS AND OMAHA
RAILWAY COMPANY
REPORT IN RE ACCIDENT
AT LEVIS, WIS., ON
MARCH 7, 1948

Accident at Levis, Wis., on March 7, 1948, caused by
failure to provide adequate protection for a
crossover movement.

Inv. No. 3171
 Chicago, Saint Paul, Minneapolis
 and Omaha Railway
 Levis, Wis.
 March 7, 1948

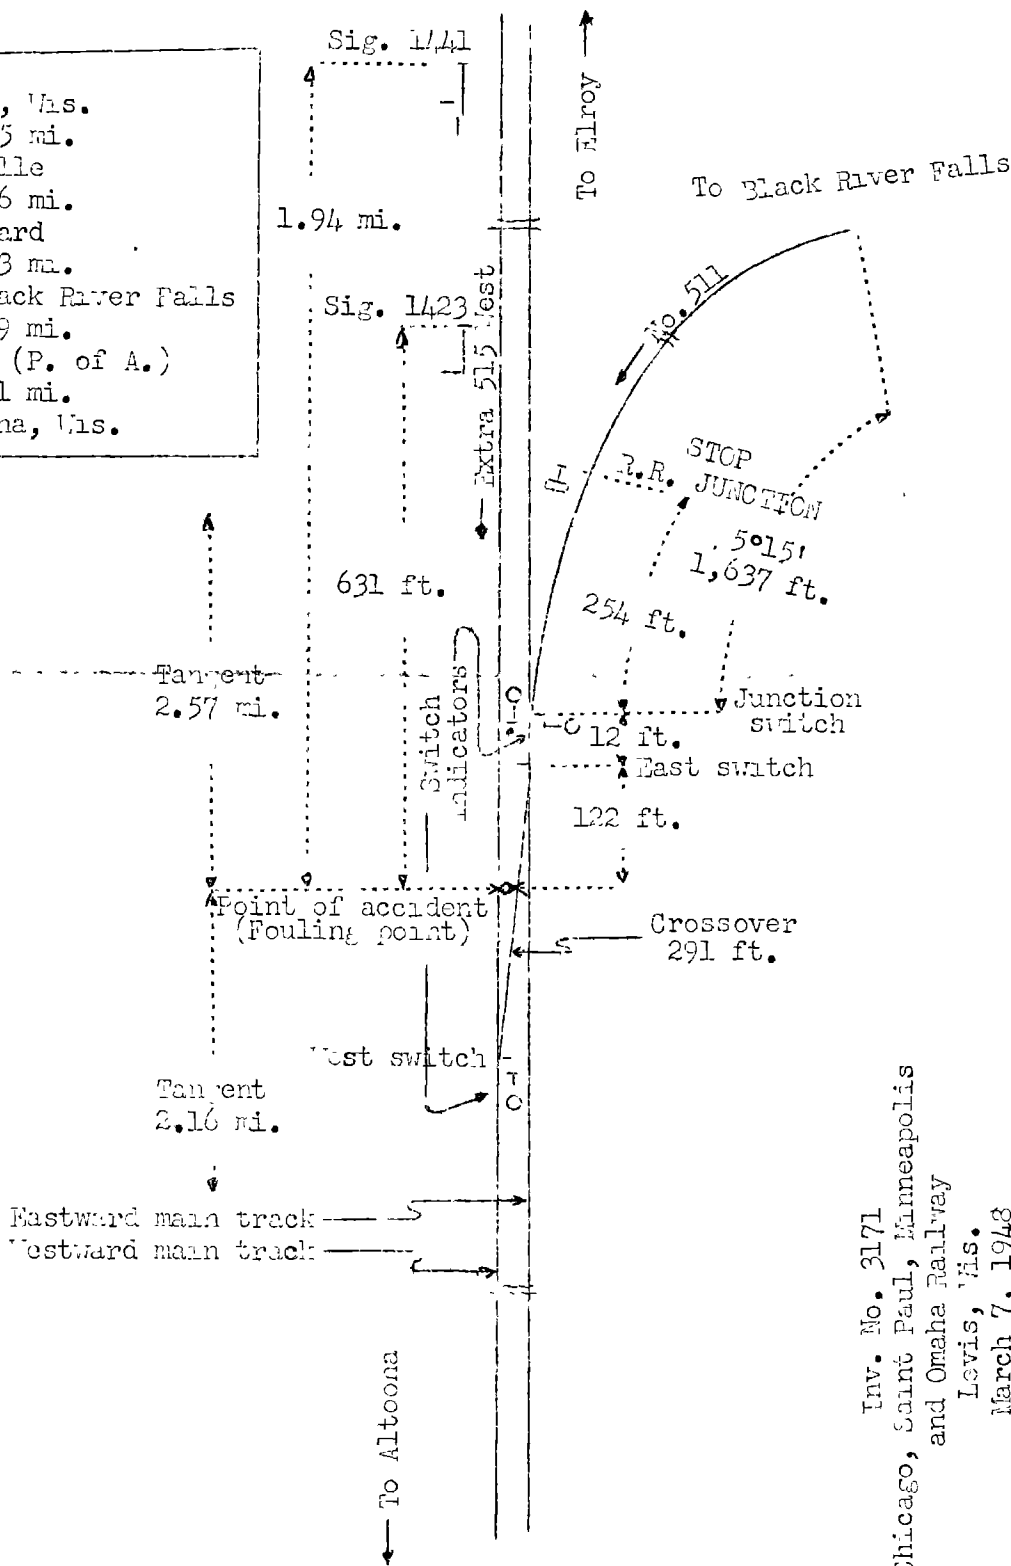
This accident occurred on that part of the Eastern Division extending between Elroy and Altoona, Wis., 105.4 miles. In the vicinity of the point of accident this is a double-track line over which trains are operated by timetable, train orders and an automatic block-signal system. At Sheppard and at Levis, respectively, 49.1 and 54.3 miles west of Elroy, a single-track line 5.2 miles long connects with the eastward main track of the double-track line. The single-track line extends through Black River Falls, located 3.3 miles southwest of Sheppard and 1.9 miles southeast of Levis. Trains are operated over this line by timetable and train orders. There is no station at Levis. The junction switch at Levis is hand-operated, and is opposite a telephone booth. A hand-operated trailing-point crossover 291 feet in length connects the eastward and the westward main tracks at Levis. The east and west switches of the crossover are, respectively, 12 feet and 303 feet west of the junction switch. The accident occurred at the fouling point of the westward main track and the crossover, at a point 122 feet west of the east crossover-switch. The double-track line is tangent throughout a distance of 2.57 miles immediately east of the point of accident and 2.16 miles westward. The grade is 0.308 percent descending westward. From the southeast on the single-track line there is a 5°15' curve to the left extending 1,637 feet to the junction switch.

Automatic signals 1441 and 1423, governing west-bound movements on the westward main track, are, respectively, 1.94 miles and 631 feet east of the point of accident. Signal 1441 is of the two-arm, four-indication, semaphore type, and is continuously lighted. Signal 1423 is of the one-arm, three-indication, semaphore type, and is approach lighted. Switch indicators of the semaphore type are located adjacent to the switchstands of the junction switch and both switches of the crossover. The involved aspects and the corresponding indications and names of the signals and indicators are as follows:

The controlling circuits of the block signals are so arranged that when a train is occupying the westward main track in the block extending between signal 1423 and the next signal westward, or when either switch of the crossover is lined for movement through the crossover, signal 1441 displays prepare-to-stop-at-next-signal, and signal 1423 displays stop-and-proceed. The controlling circuit of the switch indicator at the east crossover-switch is so arranged that when a train is occupying the westward main track within a distance of 3.19 miles immediately east of the crossover the semaphore arm of the switch indicator is displayed in horizontal position. If the westward main track is unoccupied within the limits of the controlling circuit the semaphore arm of the switch indicator is displayed at an angle of 45 degrees in the upper quadrant. The switch indicator at the junction switch indicates occupancy of the eastward main track.

No. 511, a west-bound first-class train, backed through the crossover at Levis, entered the single-track line and proceeded to Black River Falls. This train departed from Black River Falls about 1:18 a. m. and stopped at the stop-sign located near the junction switch at Levis about 1:27 a. m. Soon afterward, this train entered the crossover connecting the eastward and the westward main tracks and the engine was struck by Extra 515 West at the fouling point of the westward main track and the crossover.

The controlling circuit of the switch indicator at the east switch of the crossover at Lewis extends to a point 3.19 miles eastward on the westward main track, and is so arranged, that if the westward main track is occupied within that distance, the indicator at the east crossover-switch displays stop. Considering the statements of the crew of No. 511 that the indicator displayed proceed-at-medium speed, that the switches were lined for movement before No. 511 entered the crossover, and that the average speed of Extra 515 West was 60 miles per hour, signal 1441 should have displayed prepare-to-stop-at-next-signal, and signal 1423 should have displayed stop-and-proceed for a period of at least one minute before Extra 515 West passed signal 1441. Tests were made of the signal apparatus, the indicators, and the controlling circuits after the accident, and no defective condition was found. Since signal 1423 changed to display stop when Extra 515 West was a short distance east of this signal, it is apparent that the east crossover-switch was opened at that time, and that the switch indicator should have displayed stop at the time the switch was opened. If the switches involved had been provided with electric switch-locking, it would not have been possible to operate the switches to permit movement from the single-track line and through the crossover when a train was closely approaching, as in this case.

It is recommended that the Chicago, Saint Paul, Minneapolis and Omaha Railway Company install electric switch-locking at main-track hand-operated switches in automatic block-signal territory.
