INTERSTATE COMMERCE COMMISSION

REPORT OF THE DIRECTOR OF THE BUREAU OF SAFETY CONCERNING AN
ACCIDENT ON THE CHICAGO, ST. PAUL, MINNEAPOLIS & OMAHA
RAILROAD AT OMAHA, NEBR., ON JANUARY 1, 1934.

March 6, 1934.

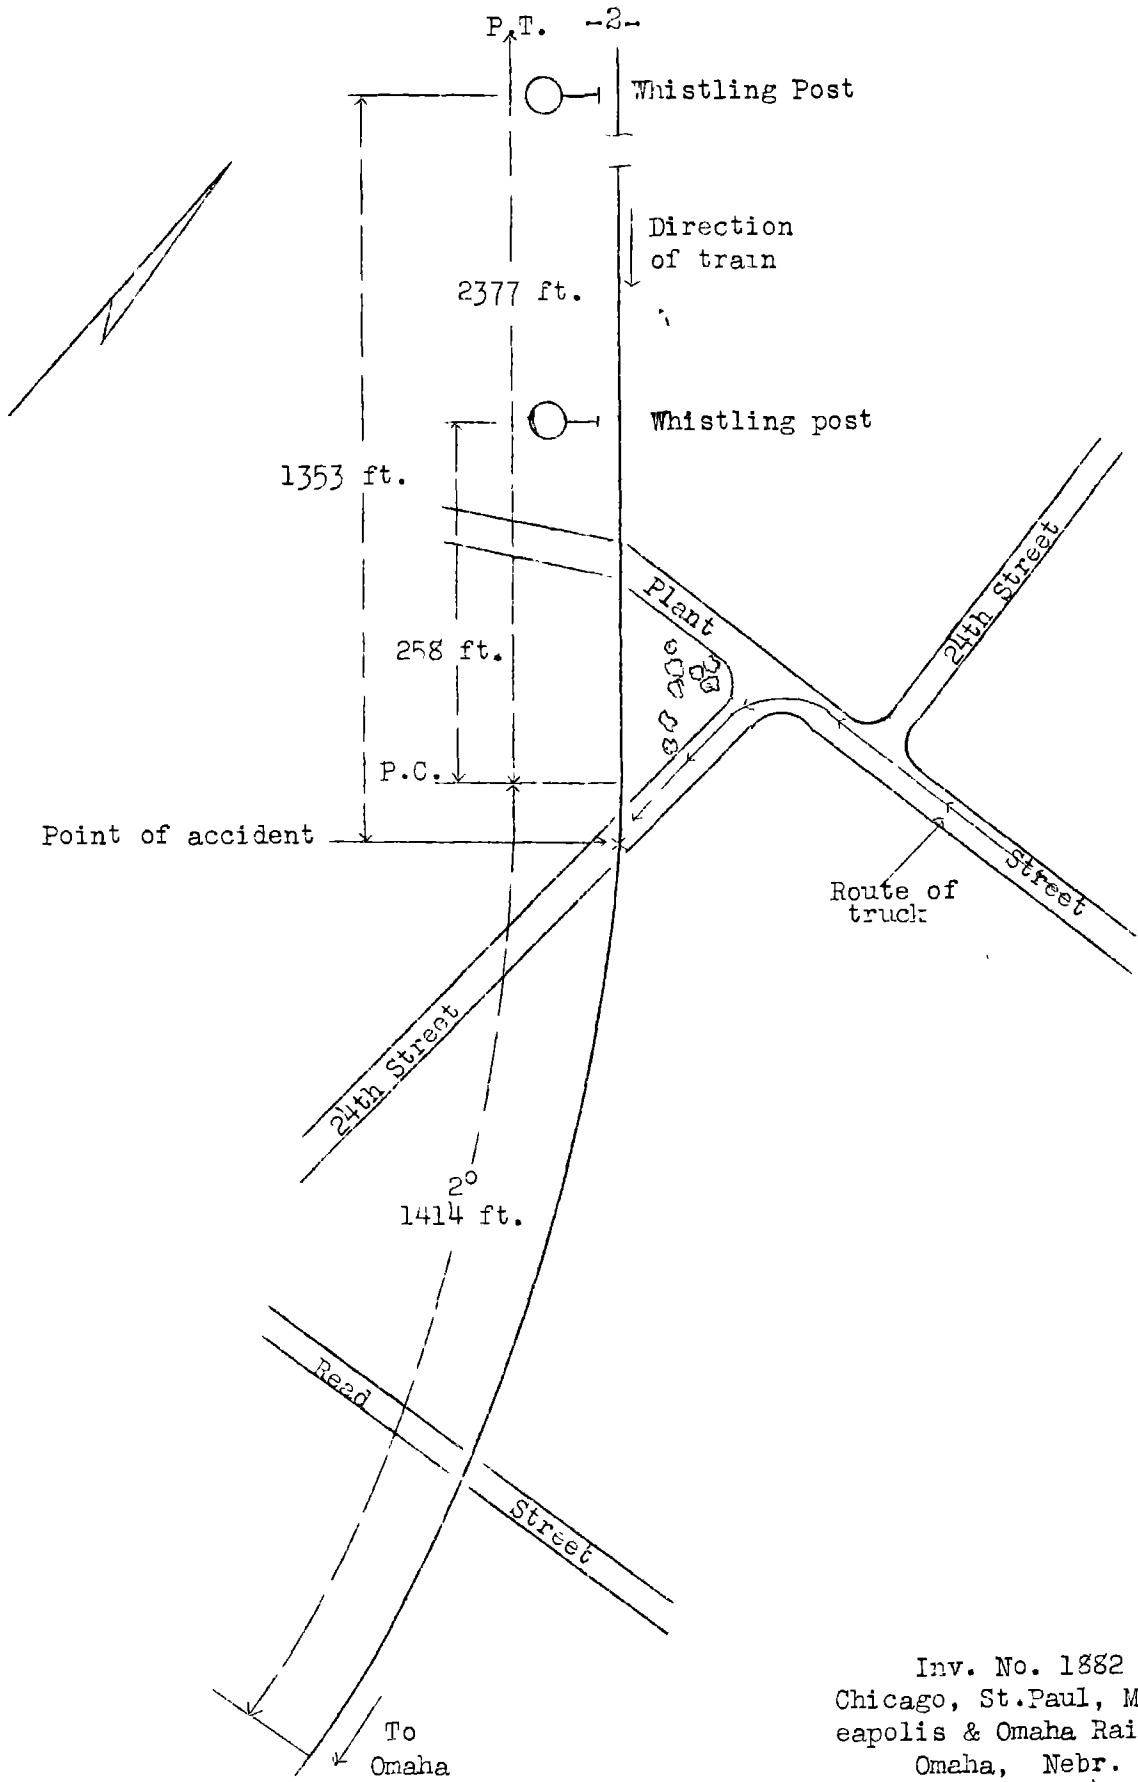
Inv. No. 1882
 Chicago, St. Paul, Minne-
 eapolis & Omaha Railroad
 Omaha, Nebr.
 Jan. 1, 1934

The view had by the driver of a west-bound vehicle approaching the crossing was obscured by trees until a point 50 feet from the track was reached, at which point a train could

have been seen for a distance of 1,500 feet.
