INVESTIGATION NO. 2936
CHICAGO, SAINT PAUL, MINNEAPOLIS AND OMAHA
RAILWAY COMPANY
REPORT IN RE ACCIDENT
AT WORTHINGTON, MINN., ON
SEPTEMBER 27, 1945

Accident at Worthington, Minn., on September 27, 1945,
caused by failure to obey a meet order.

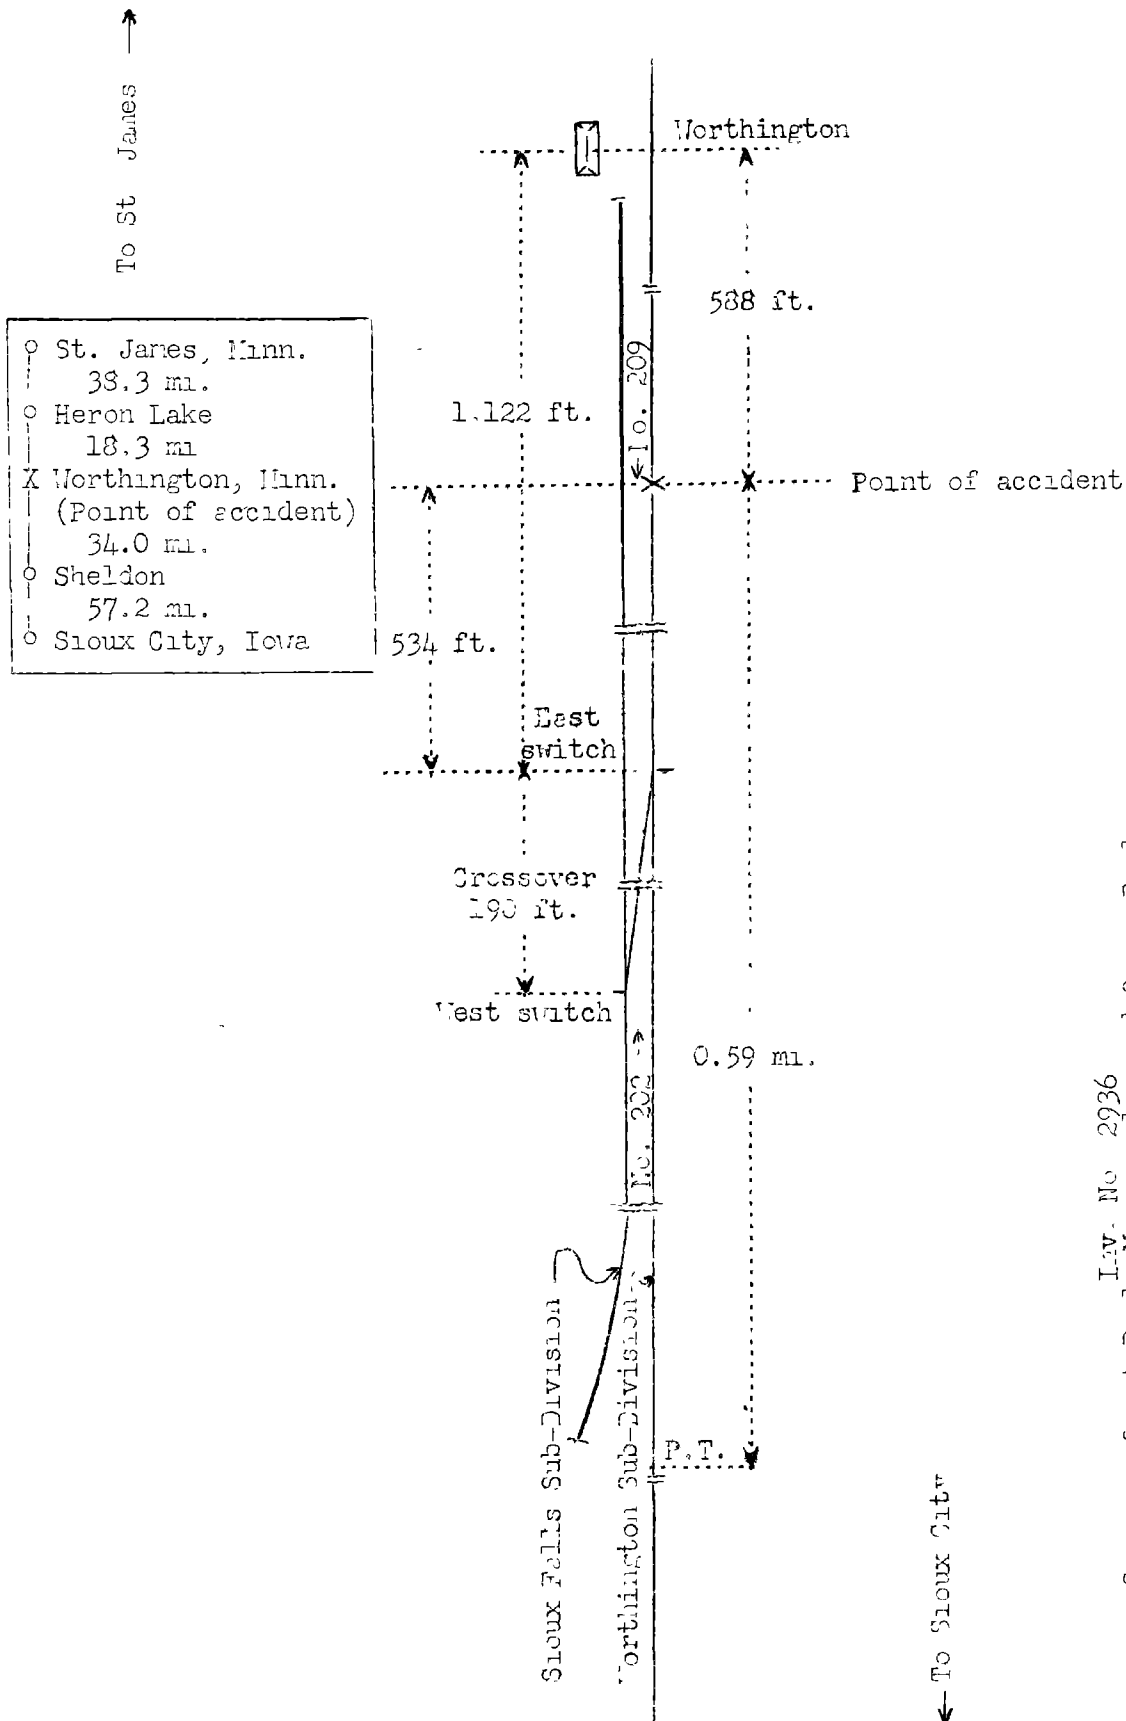
Irv. No. 2936
 Chicago Great Northern Railway
 Minneapolis and Omaha Railway
 Worthington, Minn.
 September 27, 1945

Location of Accident and Method of Operation

This accident occurred on the Worthington Sub-Division, which extends between Sioux City, Iowa, and St. James, Minn., 147.8 miles, a single-track line in the vicinity of the point of accident, over which trains are operated by timetable and train orders. There is no block system in use. Throughout a distance of about 3.5 miles immediately west of the station at Worthington, 91.2 miles east of Sioux City, a single-track line designated as the Sioux Falls Sub-Division parallels the line of the Worthington Sub-Division on the north. The east switch of a crossover 190 feet long, which connects the line of the Worthington Sub-Division and the line of the Sioux Falls Sub-Division, is 1,122 feet west of the station, and is facing-point for west-bound movements on the line of the Worthington Sub-Division. The accident occurred on the Worthington Sub-Division main track, 588 feet west of the station and 534 feet east of the east crossover-switch. The main track is tangent throughout a distance of 0.59 mile west of this point and a considerable distance eastward. The grade is level at the point of accident.

The force of the impact moved No. 209 eastward about 12 feet. None of the equipment of either train was derailed. The front end of the first engine of No. 202 and the front end of the engine of No. 209 were considerably damaged.
