REPORT OF THE DIRECTOR
BUREAU OF SAFETY

ACCIDENT ON THE
CINCINNATI UNION TERMINAL

CINCINNATI, OHIO

INVESTIGATION NO. 2040

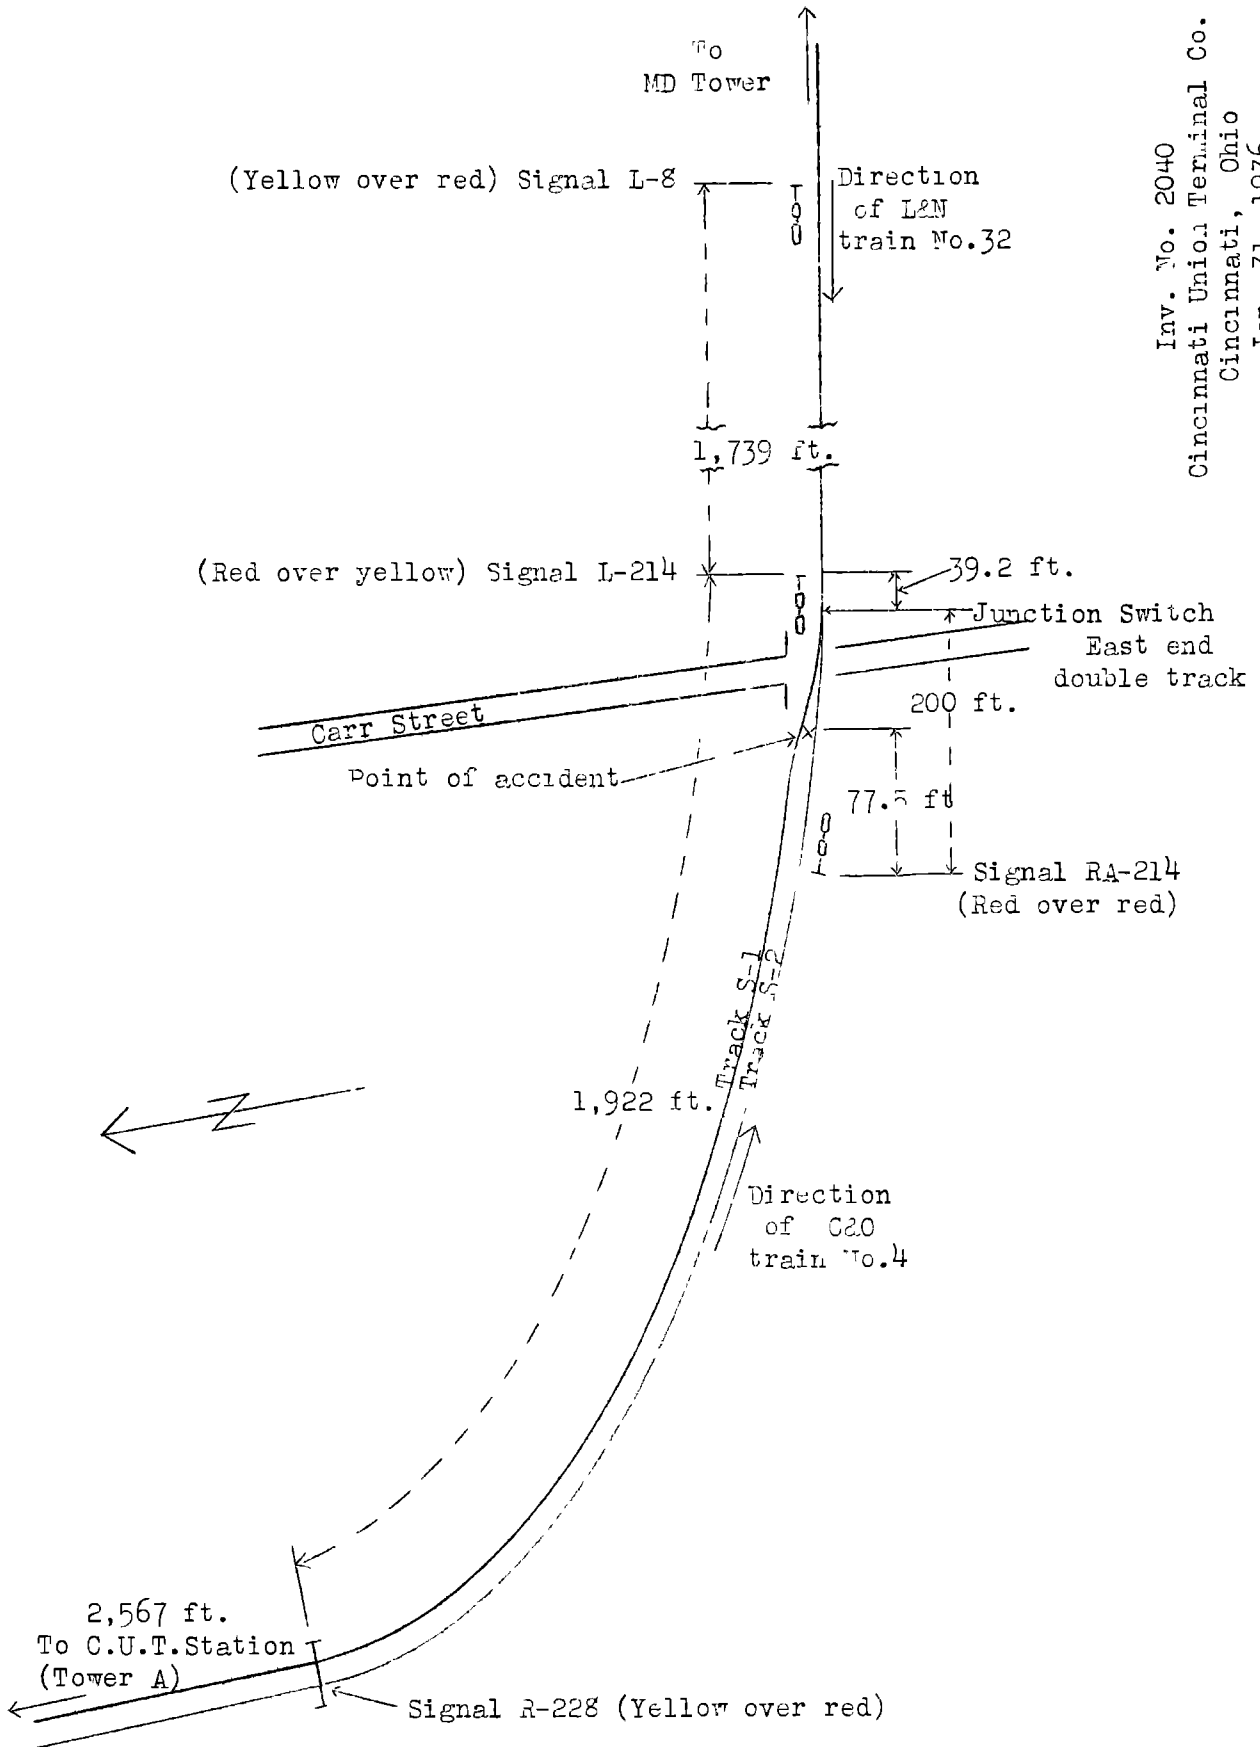
Inv. No. 2040
 Cincinnati Union Terminal Co.
 Cincinnati, Ohio
 Jan. 31, 1936

Signals R-228 and RA-214 govern outbound movements on track S-2; they are located 5,122 feet and 200 feet, respectively, west of the junction switch and are operated from Tower A. Signals L-8 and L-214, governing inbound movements from single-track to double-track, are located 1,778 feet and 39.2 feet, respectively, east of the junction switch. The signals are of the color-light,

Approaching from the west on track S-2 a full view of both units of signal RA-214 is restricted to 260 feet from the engineman's side of the cab; from the fireman's side of the cab a view can be had of this signal from a point 791 feet distant to a point 208 feet from the signal, then it is obscured by the front end of the engine.

The traffic clearance point at the east end of double-track is approximately 50 feet east of signal RA-214, and the front end of the C. & O. engine passed this point approximately 27 feet and stopped 77.5 feet east of the signal.
