REPORT OF THE DIRECTOR
BUREAU OF SAFETY

ACCIDENT ON THE
CINCINNATI UNION TERMINAL

CINCINNATI, OHIO

INVESTIGATION NO. 2046

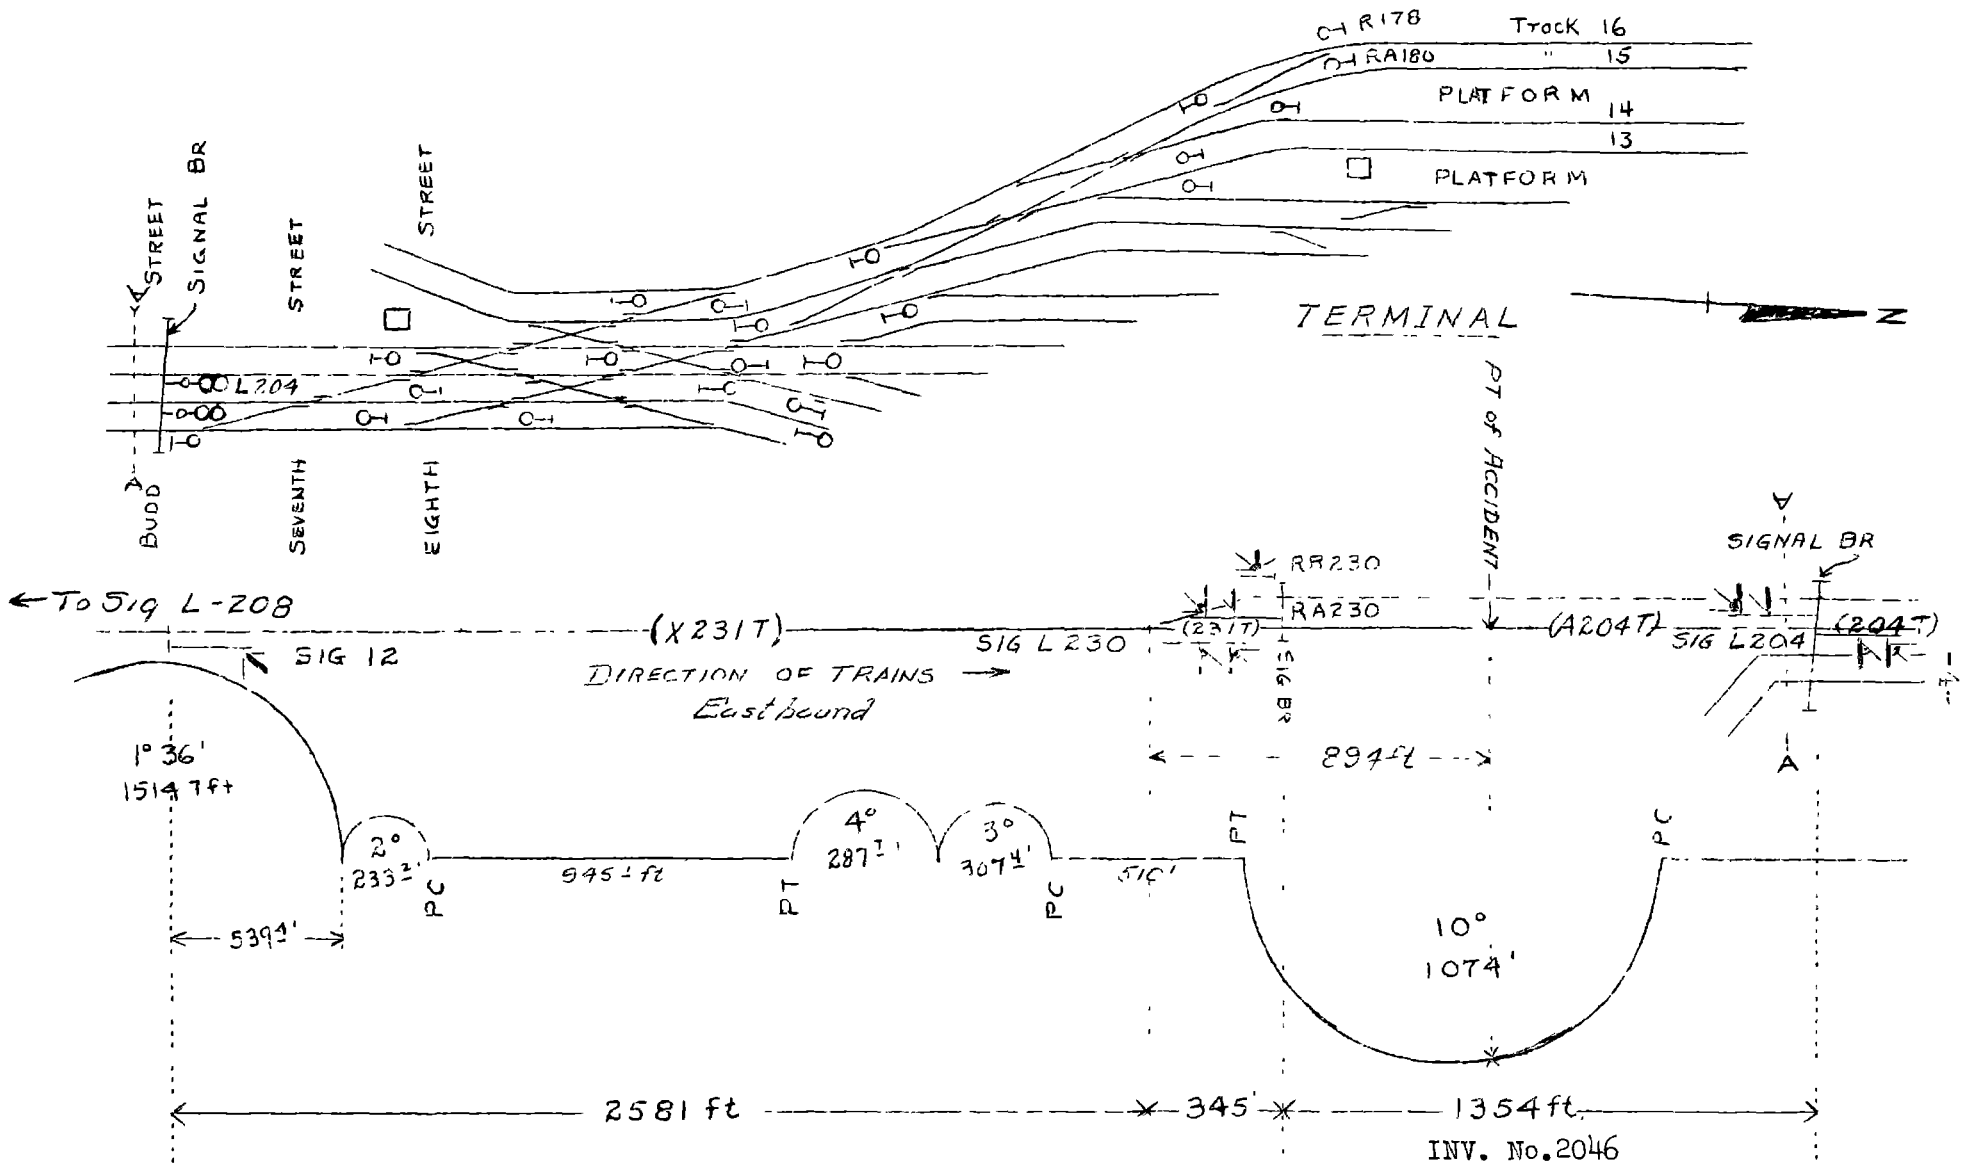
INV. No. 2046
 THE CINCINNATI UNION TERMINAL CO.
 CINCINNATI, O.
 February 23, 1936 .

The signals involved in this accident are home signal L230 and automatic signal 12, both of the color-light type, continuously lighted electrically. Signal L230 governs inbound movements to tracks S3 and S4 and is located on a ground mast at a point 39 feet west of the junction switch, on the south side of the track; this signal displays green over red, indicating proceed; yellow over red, indicating proceed prepared to stop at next signal; red over yellow, indicating proceed at restricted speed, and red over red, indicating stop.

Briefly described, the circuit plans showed the H control of signal L230 through front contacts of relays 231TPS and A204TP, among other selections; and the D control through front contacts of relays L204H and L230H. Relay 231TPS is a track repeating stick relay controlled through track relay 231TR, and relay A204TP is a repeating relay for A204TR relay, both of

these repeating relays being located in Tower A relay room. Track relay 231TR is connected in the track circuit extending from signal L230 to a point 345 feet east, and track relay A204T is connected in the track circuit which adjoins track circuit 231T and extends 1,354 feet east to signal L204, these track relays being located in a housing at signal L230. Signal 12 is operated by a polarized relay which is controlled through L230H relay, acting as a pole-changing relay, and 231TR and X231TR relays, the last-named relay being connected in the track circuit extending between signal L230 and signal 12. With the above-described circuit arrangement, signal L230 should display a red-over-red aspect with the lever normal; a yellow-over-red aspect with the lever moved to the left, track circuits 231T and A204T unoccupied, and signal L204 indicating stop; a green-over-red aspect with the lever moved to the left, track circuits 231T and A204T unoccupied, and signal L204 displaying a yellow-over-red aspect; a red-over-yellow aspect with the lever moved to the left, push button in, and track circuit 231T occupied; and a red-over-yellow aspect with the lever moved to the left, track circuit 231T unoccupied and track circuit A204T occupied. Automatic signal 12 should display a red aspect when either one or both of track circuits X231T and 231T are occupied; a yellow aspect when track circuits X231T and 231T are both unoccupied and signal L230 displays a red-over-red aspect; and a green aspect when track circuits X231T and 231T are both unoccupied and signal L230 displays a yellow-over-red or green-over-red aspect.

This accident was caused by interlocking signal L230 and automatic signal 12 displaying false proceed indications, the false proceed indication displayed by signal L230 was caused by an error in its control circuit, while as a result of this error automatic signal 12 also displayed a false proceed indication through the normal operation of its circuit.
