INVESTIGATION NO. 3907

CINCINNATI UNION TERMINAL COMPANY

REPORT IN RE ACCIDENT

JULY 1, 1945

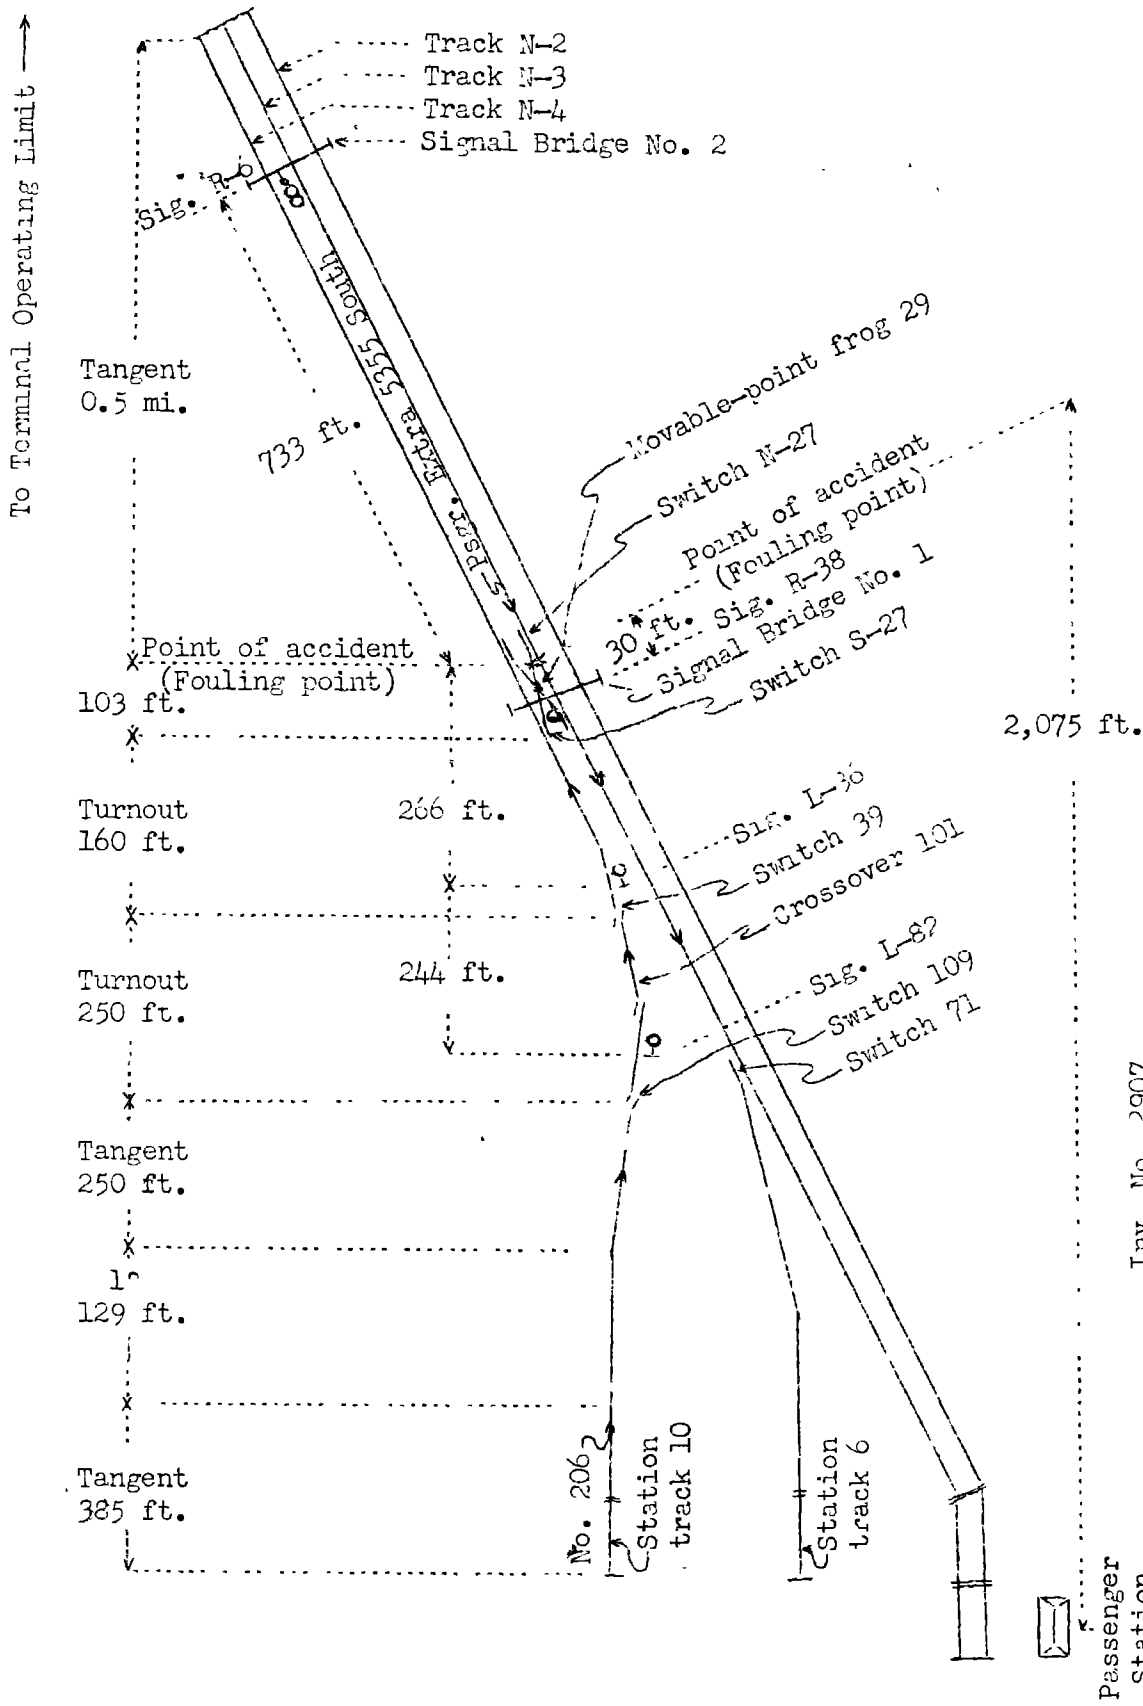
Inv. No. 2907  
Cincinnati Union Terminal Company  
Cincinnati, Ohio  
July 1, 1945

No. 206 passed signal L-36, entered switch S-27, ran through movable-point frog 29, which was lined in reverse position, and struck the fifth car of Passenger Extra 5355 South 266 feet north of signal L-36, at the fouling point of switch N-27 and track N-3. As No. 206 was approaching signal L-36 the speed
