REPORT NO. 3564  
CINCINNATI UNION TERMINAL COMPANY  
IN RE ACCIDENT  
AT CINCINNATI, OHIO, ON  
APRIL 7, 1954

Date: April 7, 1954

Location: Cincinnati, Ohio

Kind of accident: Side collision

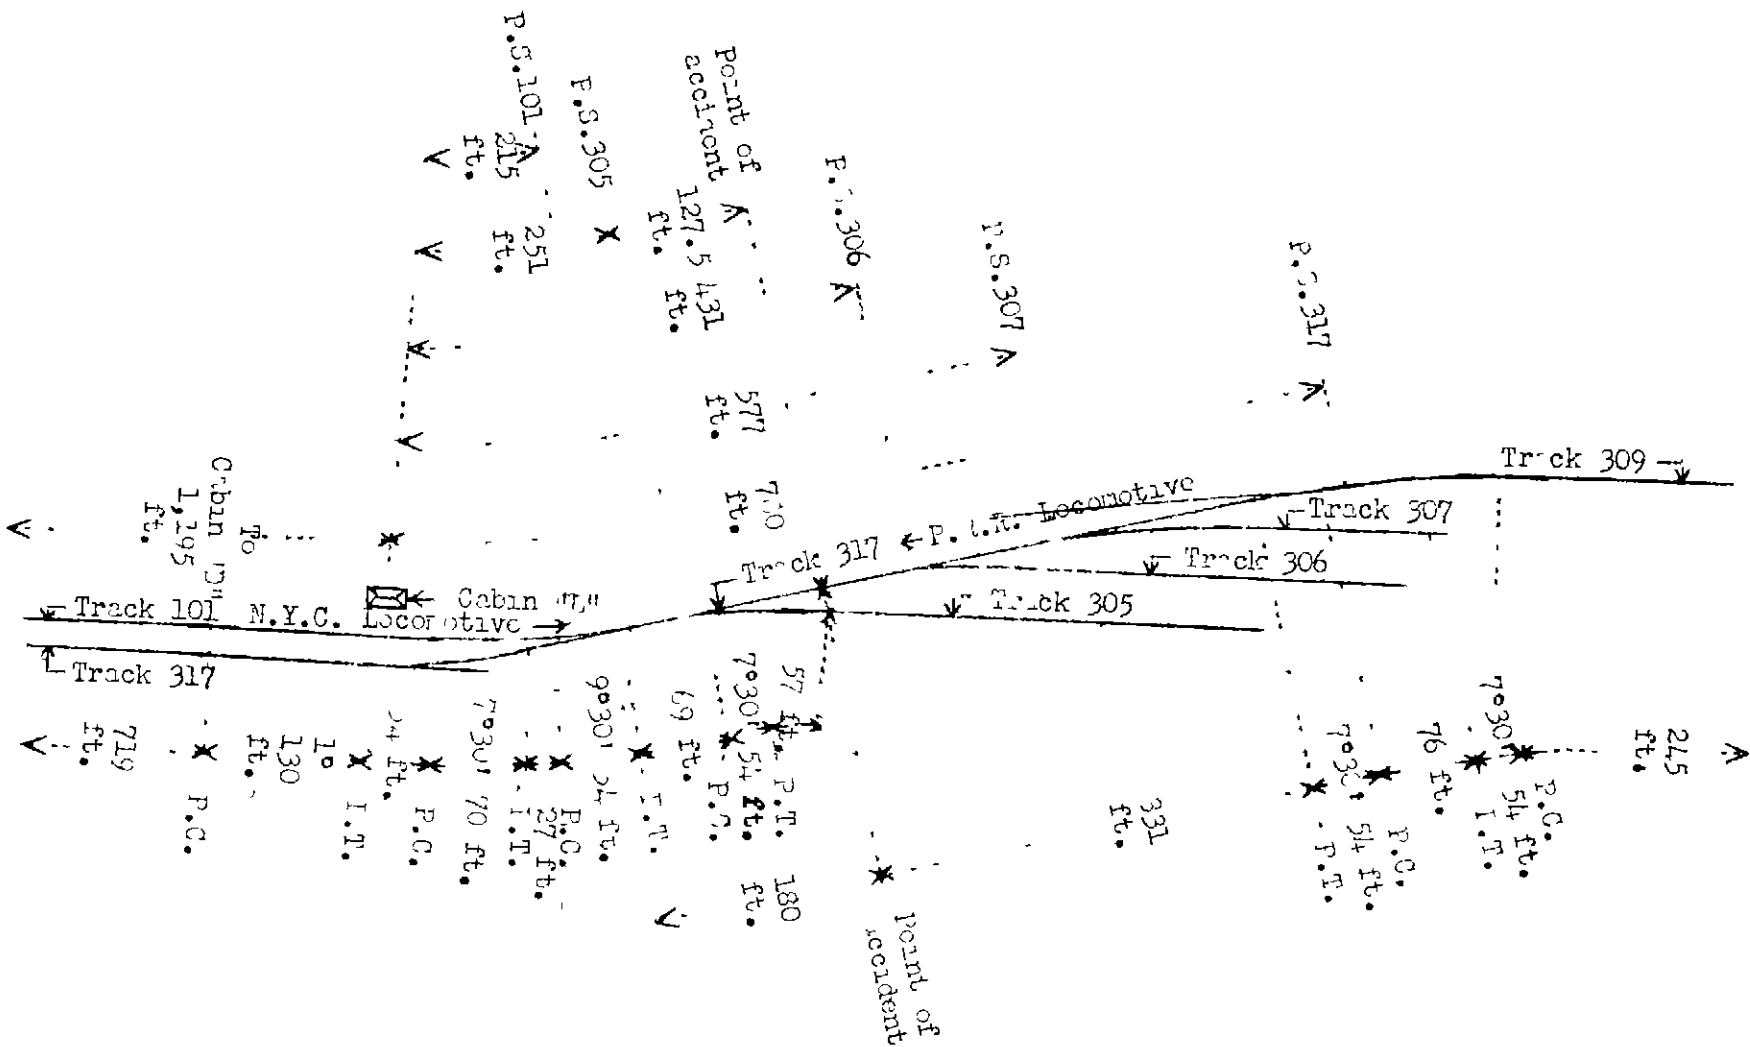
Report No. 3564  
 Cincinnati Union Terminal Company  
 Cincinnati, Ohio  
 April 7, 1954

New York Central steam locomotive 3108, headed southward and moving in backward motion, moved from Cabin "D" to Cabin "E" on track No. 101. At Cabin "E" it was routed from track No. 101 to track No. 305, via track No. 317, and while it was moving northward at an estimated speed of 5 miles per hour it collided with a Pennsylvania locomotive at the fouling point between tracks Nos. 317 and 305, 127.5 feet north of the point-of-switch at the south end of track No. 305.

The Pennsylvania locomotive consisted of Diesel-electric units 5872A and 5842B, coupled in multiple-unit control. This locomotive, headed northward and moving in backward motion, entered track No. 317 from track No. 309, and while it was moving southward at an estimated speed of 5 miles per hour it collided with locomotive 3108.

Locomotive 3108 stopped with the rear end of the tender 37 feet north of the point of accident. The right rear corner of the cistern was bent inward, the right side of the tender and of the locomotive was somewhat damaged, and the right side of the cab was crushed inward. Steam pipes on the right side of the locomotive were broken. The south truck of Diesel-electric unit 5842B was derailed to the west. This unit stopped upright and against the side of locomotive 3108 with the south end 61 feet south of the point of accident. The right rear corner of the unit was badly damaged. Diesel-electric unit 5872A was not derailed or damaged.

If the switchtender had been required to use signals of a different color for north-bound movements than those used for south-bound movements, it is probable that this accident would have been averted. The carrier should give consideration to requiring the use of distinctive signals to authorize movements in opposite directions.
