REPORT NO. 3647

CINCINNATI, NEW ORLEANS AND TEXAS PACIFIC
RAILWAY COMPANY
SOUTHERN RAILWAY SYSTEM

IN RE ACCIDENT

AT SPRING CITY, TENN., ON

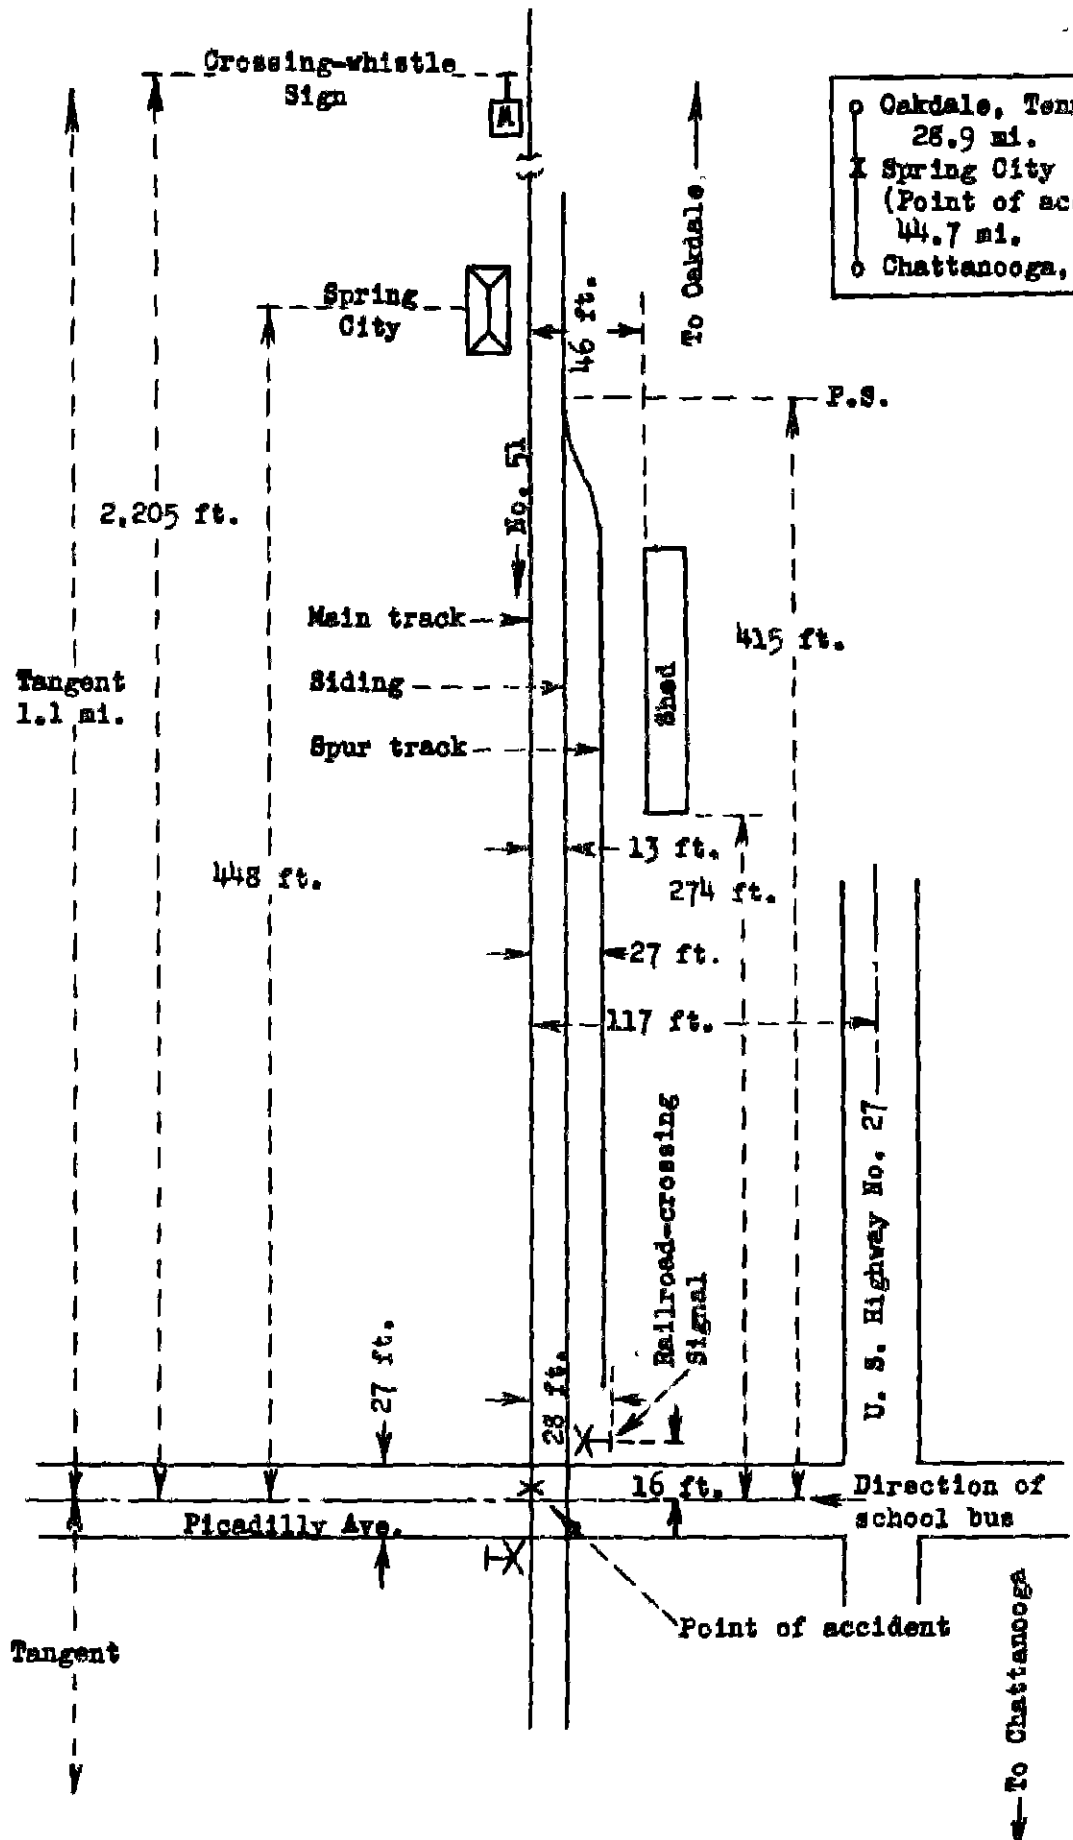
o	Oakdale, Tenn.	25.9 mi.
x	Spring City	(Point of accident)
		44.7 mi.
o	Chattanooga, Tenn.

Report No. 3647
 Cincinnati, New Orleans and Texas Pacific Railway
 Southern Railway System
 Spring City, Tenn.
 August 22, 1955
