INTERSTATE COMMERCE COMMISSION

REPORT OF THE DIRECTOR OF THE BUREAU OF SAFETY CONCERNING AN
ACCIDENT ON THE CLEVELAND, CINCINNATI, CHICAGO & ST. LOUIS
RAILWAY NEAR DeGRAFF, OHIO, ON JULY 25, 1932.

Inv. No. 1776
Cleveland, Cincinnati, Chicago & St. Louis
DeGraff, Ohio
July 25, 1932

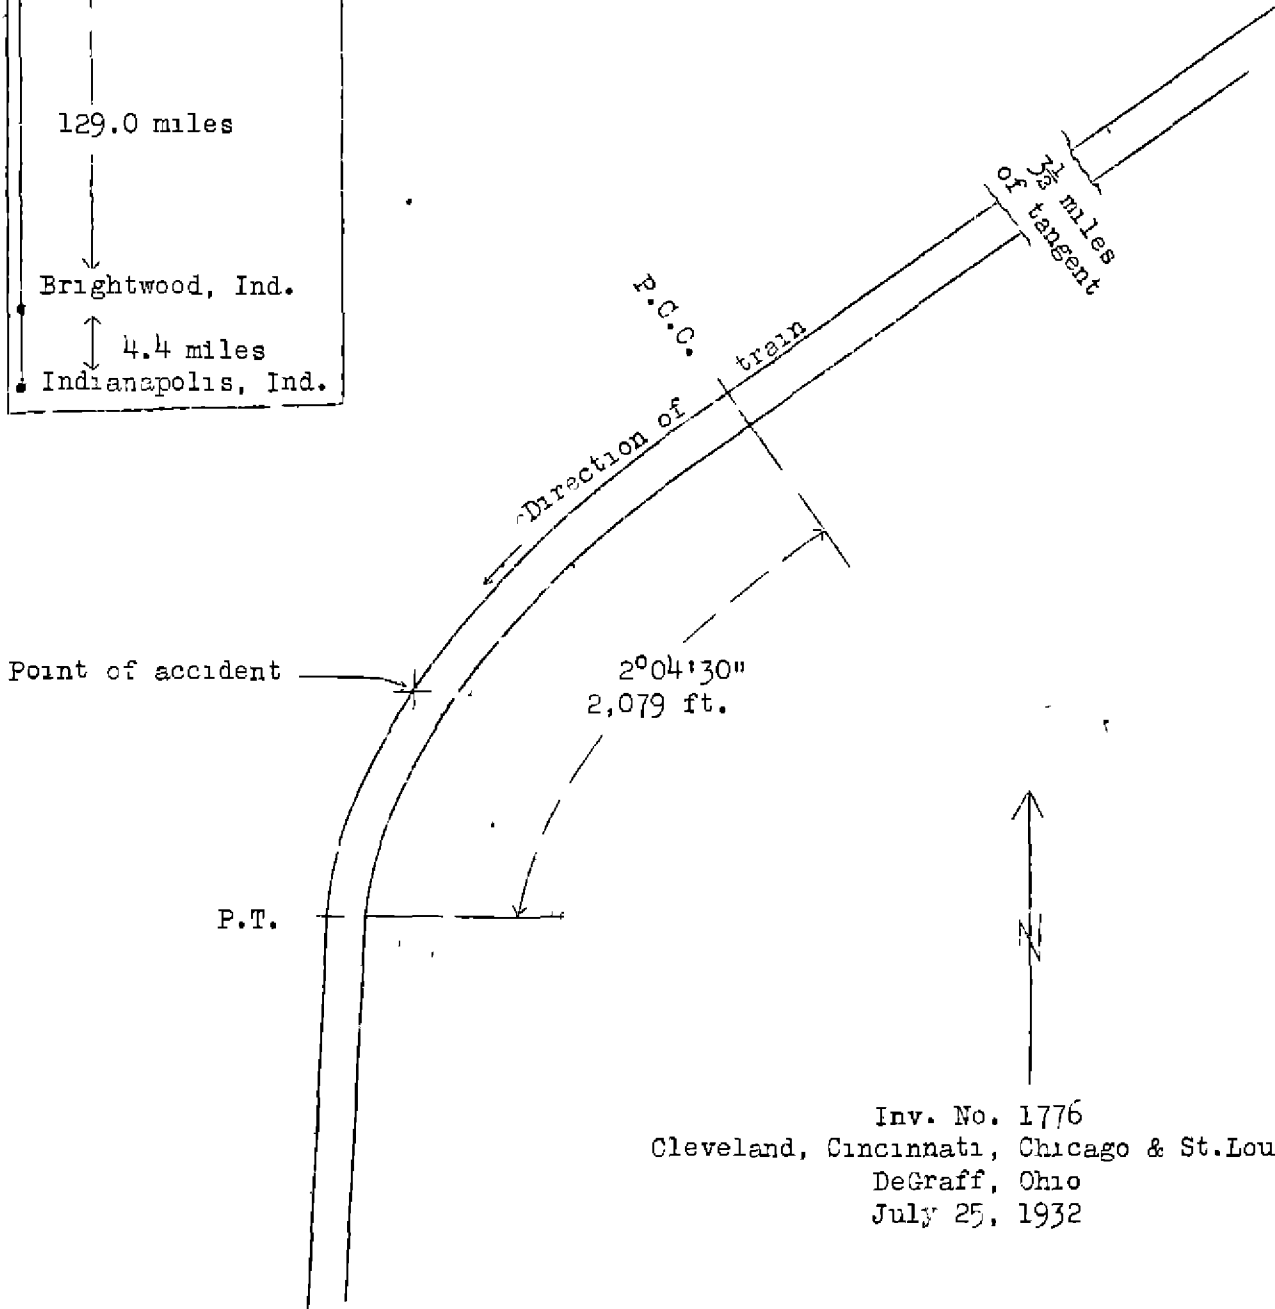
Engine 6217 was not derailed, it stopped about one-half mile beyond the point of derailment with eight cars coupled behind it, the train having broken in two between the eighth and ninth cars. Forty cars were derailed, twenty-two being so badly damaged that it was necessary to destroy them, the tenth to the forty-fifth cars, inclusive, were either overturned or resting crosswise of both main tracks. About 400 feet of the westward track was torn up and the eastward track was pushed off the roadbed for a distance of about 600 feet.

This accident was caused by a kink in the track.

The evidence indicates that the track buckled directly in front of the engine of train No. 97. Work of lining the track on the curve just east of where the accident occurred had been completed and a westbound passenger train had passed safely around the curve only a short time prior to the occurrence of the accident. Two section foremen engaged in the track work had looked along the rail just before the arrival of the freight train involved, but noticed nothing wrong with the track at that time. Examination of the track subsequent to the accident over such portion of the curve as had not been disturbed by the derailment, however, disclosed that there was a shortage of ballast at the ends of the ties and that angle bar bolts were tight enough to interfere with the adjustment of rails due to expansion during hot weather.

These conditions, attributable to inadequate track maintenance, contributed materially to the cause of this accident.
